CEMP Monitoring Report

RE: SWP Monitoring Confirms Elevated Sulfate Levels Within Temporary Development Rock Storage Area (TDRSA) Trending Down

Type of Monitoring - Permit Verification or Additional: Verification - Mine Permit MP012007

**Subject: Temporary Development Rock Storage Area (TDRSA) Leak Detection
Sump Sulfate Results – Rio Tinto Eagle Mine, Marquette County,
Michigan**

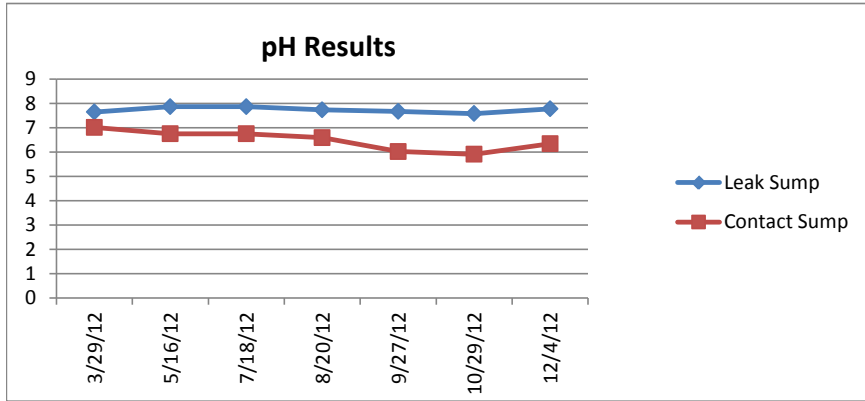
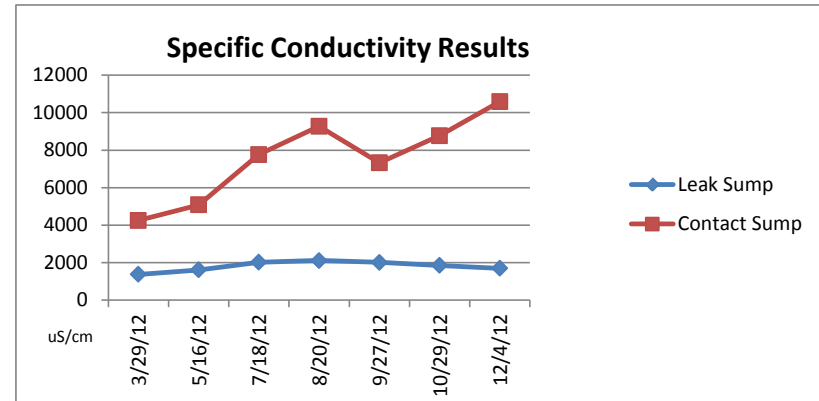
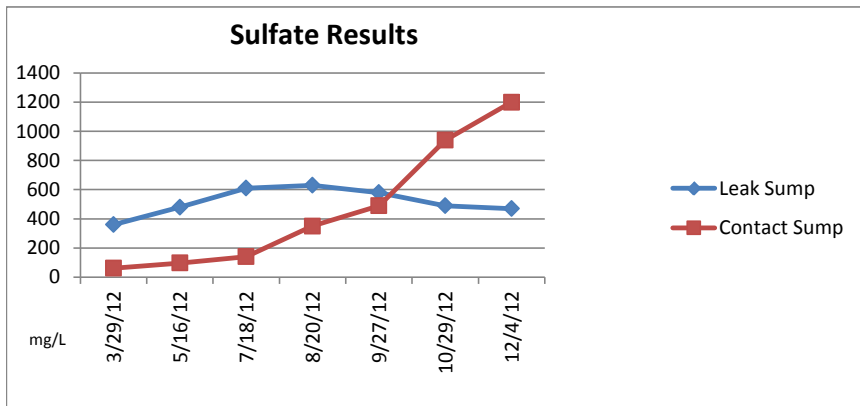
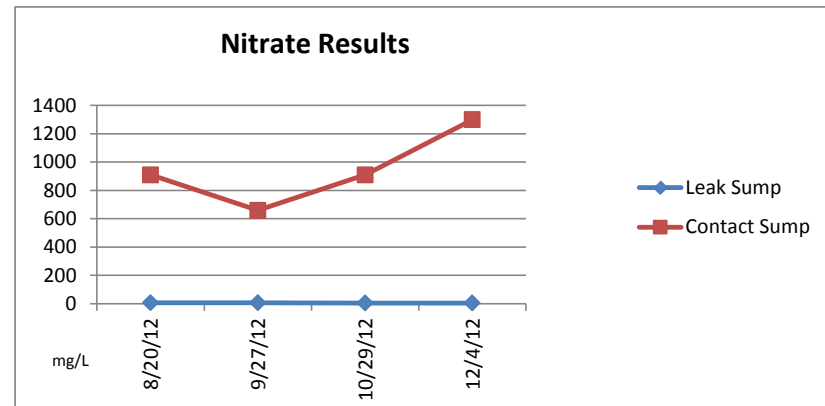
TDRSA Leak Dection and Contact Sump Results

Review of the data (attached) has identified clear differences in the concentrations of sulfate, magnesium, chloride, and nitrate between the two sumps. This indicates that it is highly unlikely that the brief period of elevated sulfate results was due to a leak in the lining system. In addition, as noted above, the sulfate results in the leak sump have decreased the last three sampling periods to a level below 500 mg/L while the sulfate results in the TDRSA contact sump have steadily increased, further indicating that there was no leakage of material from the contact sump.

Following our analysis of the data, Mark Logsdon of Geochimica also performed a review and provided input. He confirmed that the water quality from the two sumps is distinctly different. Mark noted that the most prominent difference in the contact and leak detection layer water is the nitrate results, which is a tracer from blasting emulsion. The observed values in the leak detection sump represent baseline levels near the detection limit while the observed values in the TDRSA contact sump are significantly higher. The solubility of nitrate is not controlled by any materials in the sump, which is not the case for sulfate, therefore there would be distinctly elevated nitrate in the leak detection sump if there was leakage from the primary lining system. In addition, Rio Tinto evaluated the contact and leak detection sump waters for ammonia due to the potential for nitrate to be converted to ammonia in a reducing environment. The results in the leak sump were found to be near the laboratory detection limit while ammonia results from the contact water sump were again significantly higher.
