**Investigation of the Aquatic
Communities of the Salmon Trout
River, Yellow Dog River, and Cedar
Creek in Marquette County,
Michigan.**

April 5, 2007

**ADVANCED ECOLOGICAL MANAGEMENT
2692 165th Avenue
Morley, MI 49336**

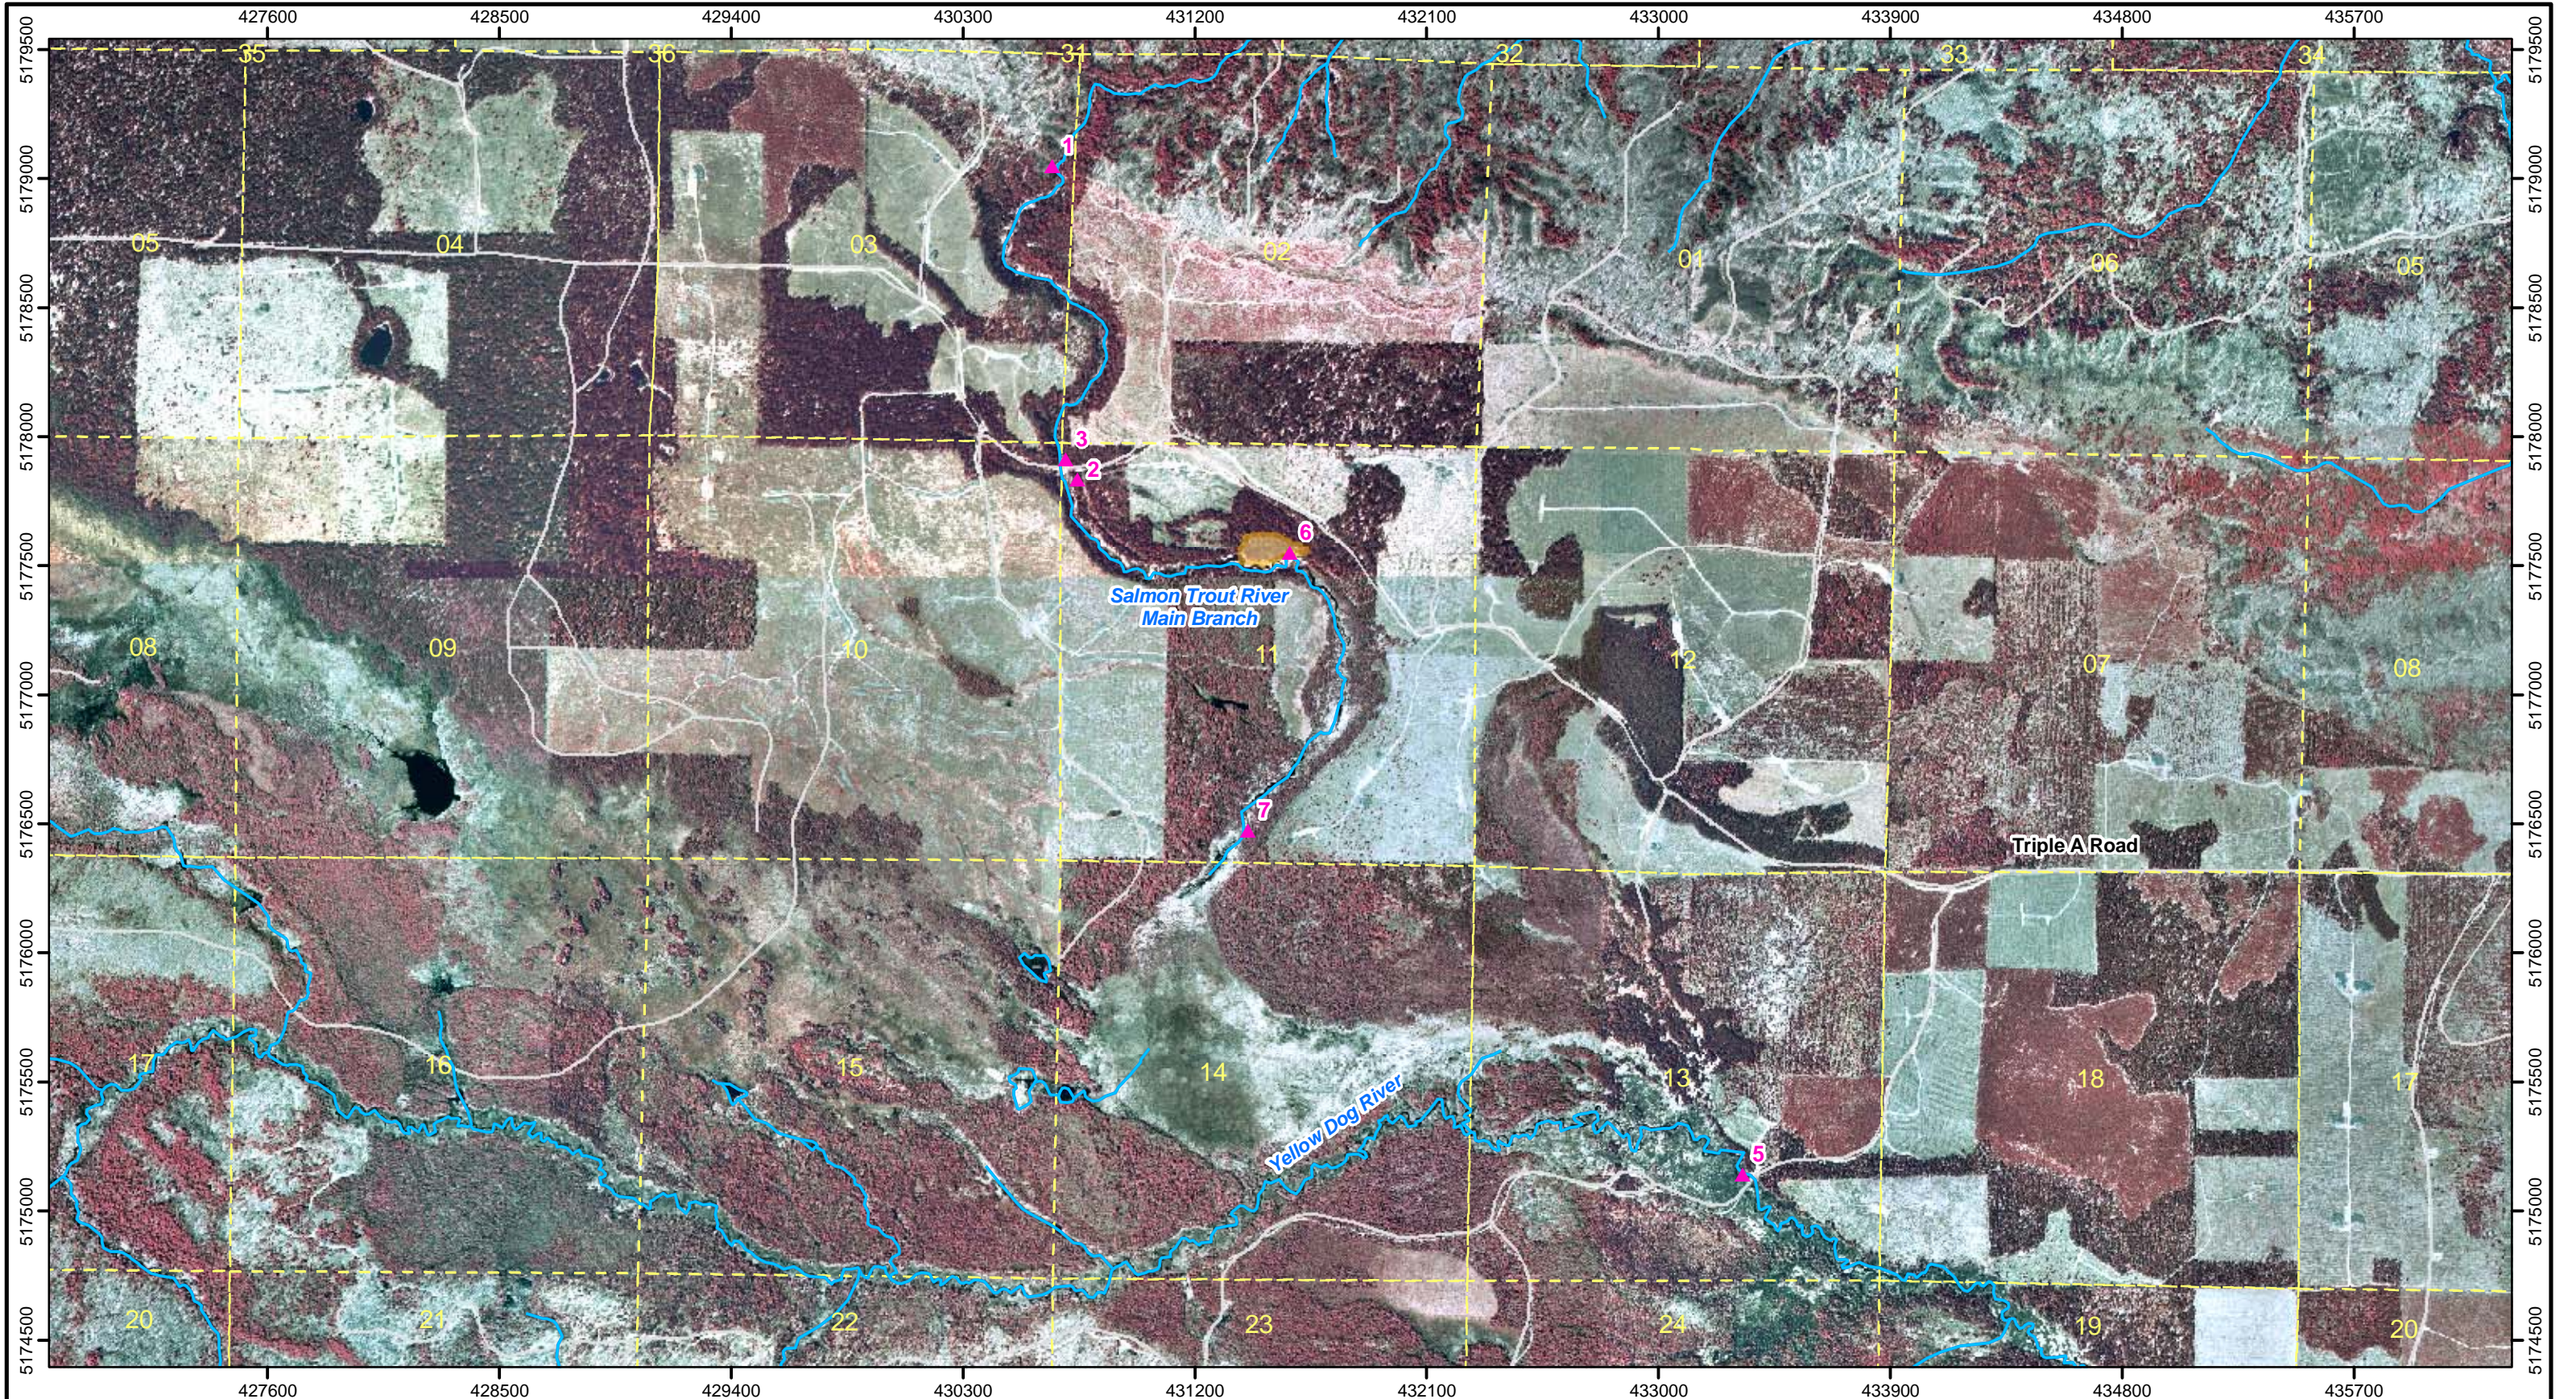
FIGURE 4-1
SAMPLE STATION LOCATIONS
- CENTRAL DETAIL

Macroinvertebrates were collected from all nine stations that were investigated in 2006. Because of beaver dams in the vicinity of Station 6 and Station 7 (Figure 4-1), the P-51 protocol for scoring macroinvertebrates was not applicable in these locations.

Stations 2 and 3 are located immediately downstream and upstream of Triple A Road (Figure 4-1). Station 2 was 100 feet in length with an average width of 5.7 feet, and Station 3 was 200 feet in length with an average width of 7.9 feet.

Station 6 is located in the vicinity of the ore body (Figure 4-1). Station 6 is 300 feet in length with an average width of 21.0 feet, and was influenced by beaver dams that were located downstream of the station. The streambanks are characterized by sedge (*Carex* sp.), iris (*Iris* sp.), rush (*Juncus* sp.), willows (*Salix* sp.) and speckled alder (Photograph C-7). Much of the aquatic vegetation was growing on relatively unconsolidated organic matter that appeared to function as a floating mat of vegetation and organic matter when traveled upon by foot traffic.

Station 9 is located approximately 1,680 feet upstream of Station 8 above the confluence of an un-named tributary (Figure 4-1). Station 9 is 200 feet in length and was confined at the upstream extent by a large tree laying across the river channel and contributing to habitat structure within this station. The average width of Station 9 is 15.4 feet.

The aquatic habitat within Station 4 was consistent with previous descriptions provided by WCR and the MDEQ (WCR, 2005; MDEQ/Premo, 2005). Station 4 was 300 feet in length with an average width of 16.8 feet. The downstream extent of Station 4 was located approximately 117 feet upstream of Northwestern Road (Figure 4-1).

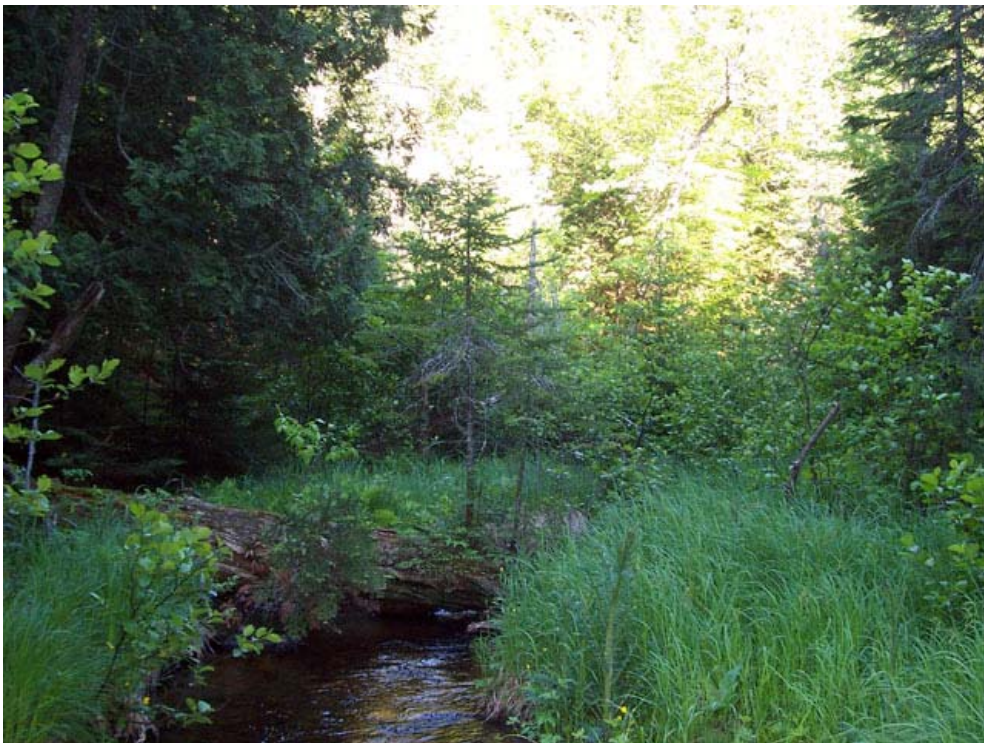
Photograph C-2. Station 1 - Upstream Extent View North.

Station 1 is located in a narrow valley with relatively steep slopes rising more than 100 feet to the Yellow Dog Plains. Station 1 was 120 feet in length with an average width of 8.3 feet. The streambanks were vegetated with herbaceous and woody vegetation (Photograph C-1). The streambed is characterized by a relatively steep gradient and the substrate was comprised of a variety of particles including sand, gravel, cobble, and boulders. Woody debris was frequently observed throughout the station (Photograph C-2).

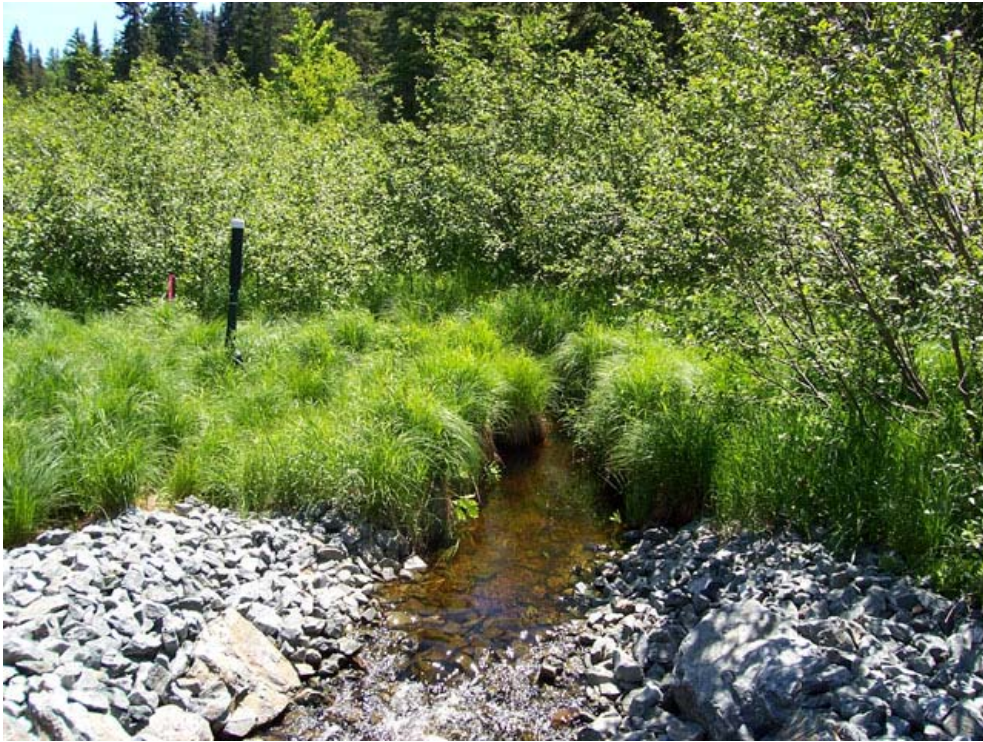
Photograph C-3. Station 2 – Downstream Extent View South.

Station 2 was surrounded by an abundance of speckled alder (*Alnus rugosa*) and bluejoint grass (*Calamagrostis canadensis*, Photographs C-3 and C-4). The vegetation within Station 3 was predominantly characterized as speckled alder, which contributed woody debris to the stream

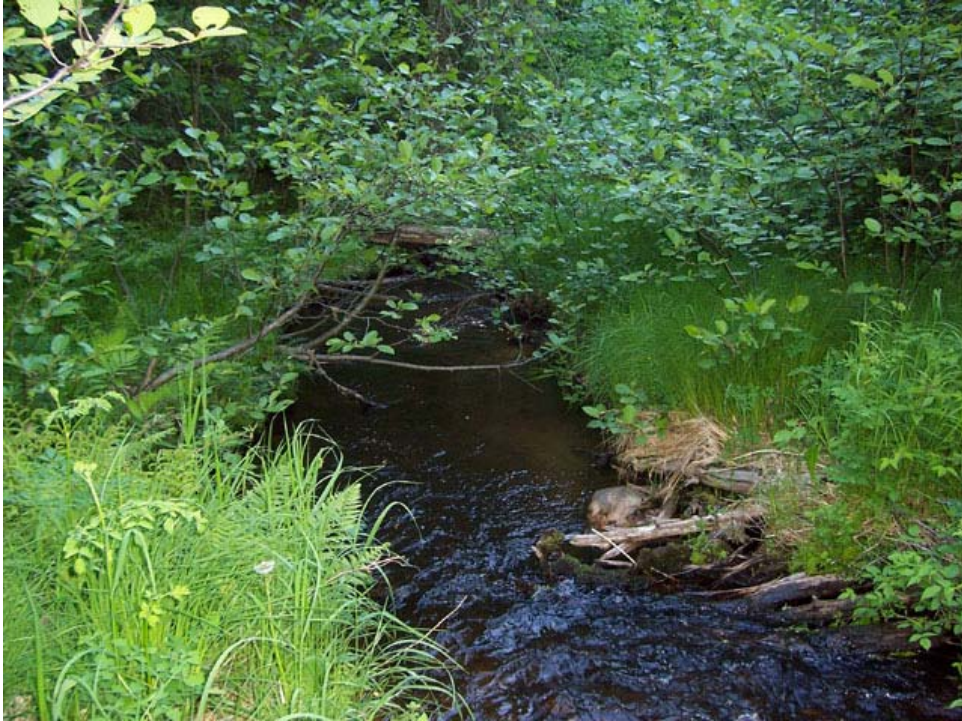
Photograph C-5. Station 3 – Upstream Extent View North.

(Photographs C-5). Watercress (*Nasturtium* sp.) was present within the stream channel of Station 3 (Photographs C-6).

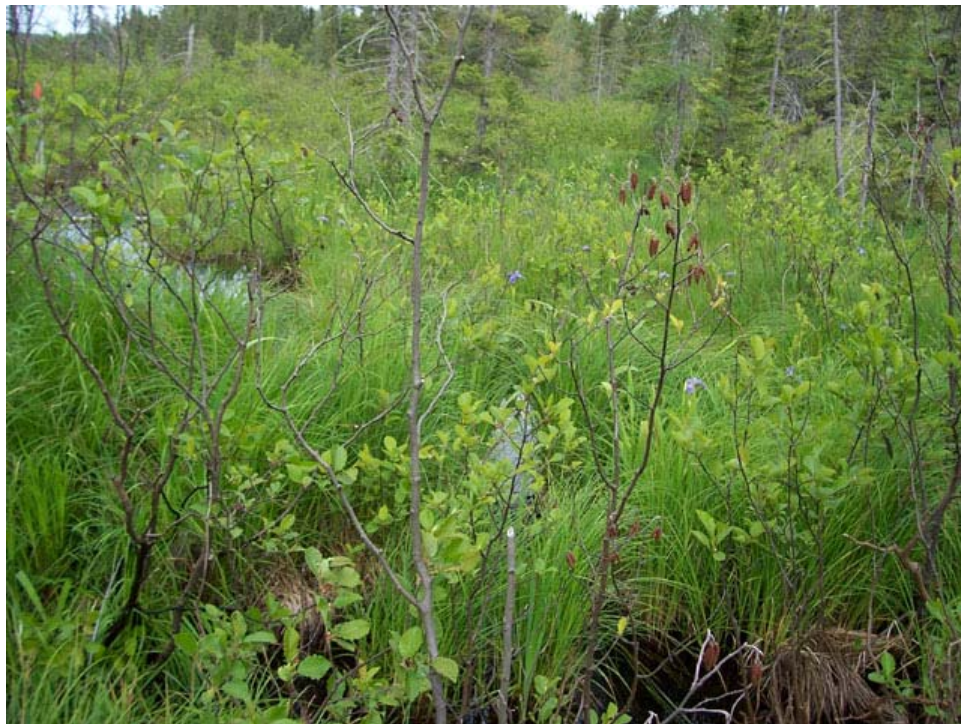
Photograph C-8. Station 7 – Downstream Extent View Southwest.

The streambanks of Station 7 were vegetated with speckled alder, sedge, rush, and iris (Photographs C-8 and C-9). The substrate was comprised of organic matter and silt. Woody debris was abundant throughout this station.

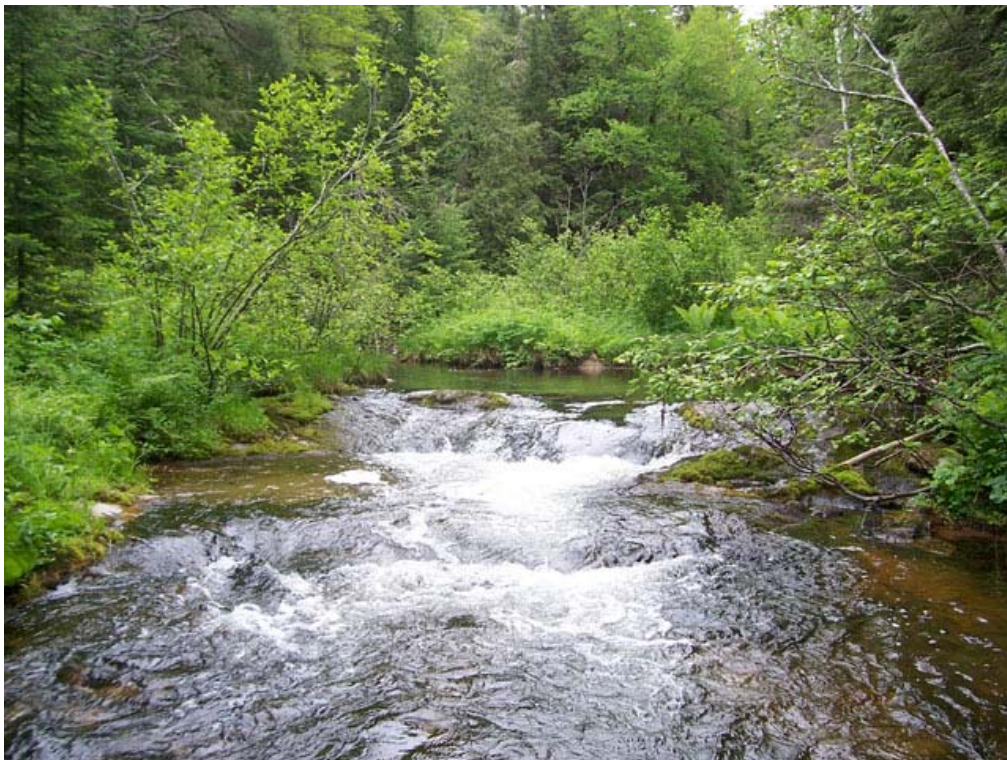
Photograph C-10. Station 8 – Downstream Extent View South.

Station 8 is characterized by a high gradient channel with a substrate predominantly comprised of bedrock, boulders, cobble, and some sand and gravel (Photographs C-10). The streambanks are lined with woody vegetation including speckled alder and black spruce (*Picea mariana*), northern white cedar (*Thuja occidentalis*), and balsam fir (*Abies balsamea*), which contribute woody debris to the stream (Photographs C-11).

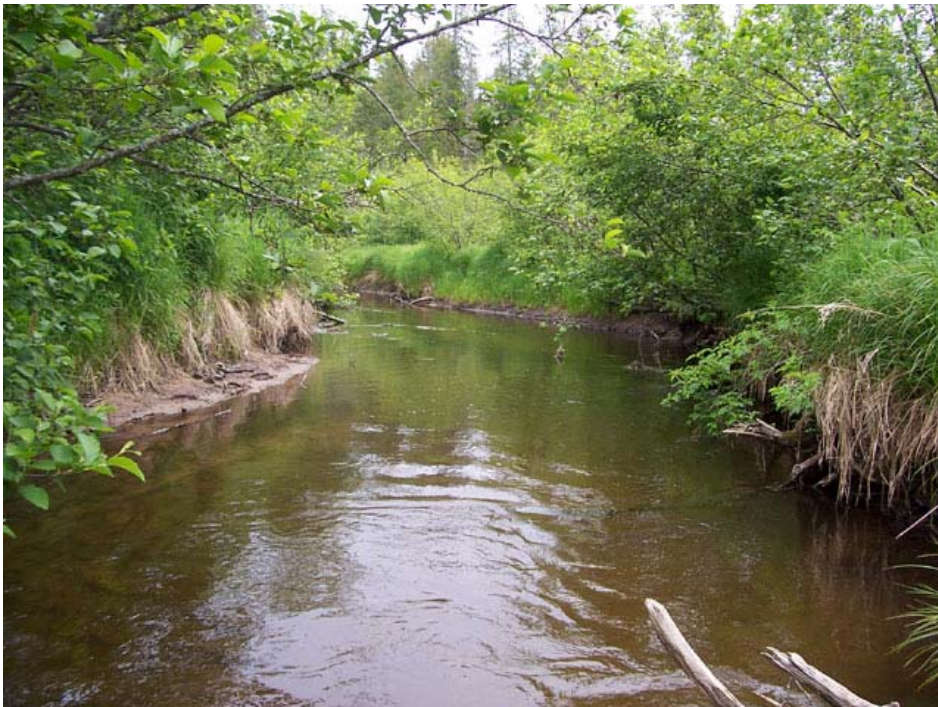
Photograph C-12. Station 9 – Downstream Extent View Southwest.

The streambanks throughout Station 9 were partially vegetated and rose approximately 3 to 4 feet above the water surface. The streambanks were vegetated with speckled alder, bluejoint grass, and other herbaceous vegetation (Photographs C-12 and C-13).

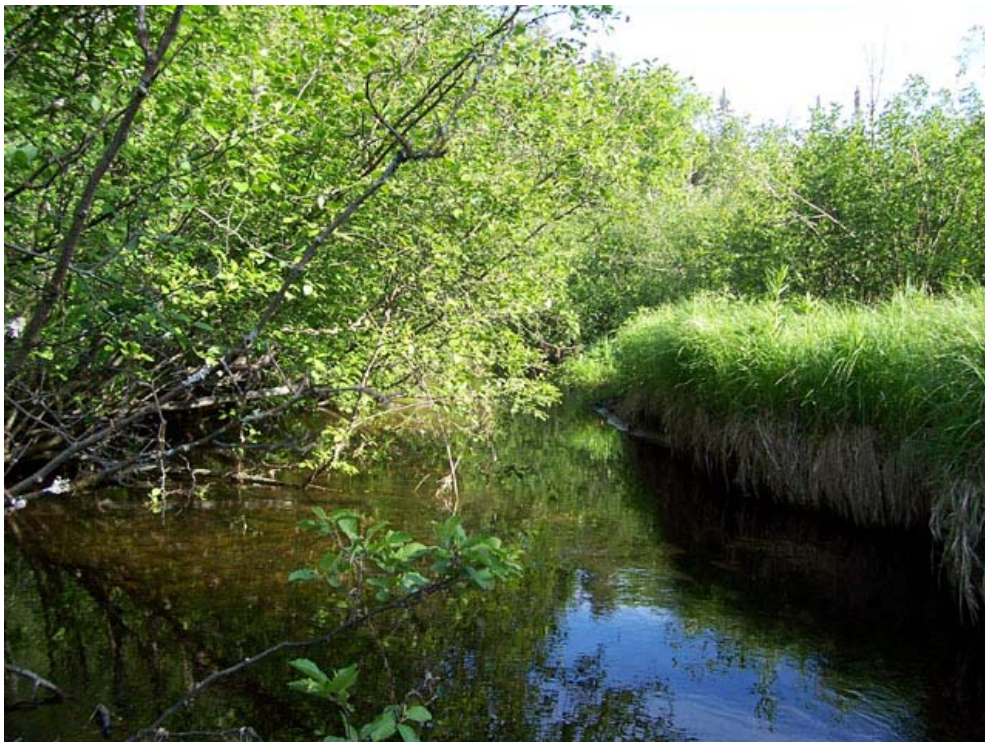
Photograph C-16. Station 4 – Downstream Extent View South.

The riparian vegetation throughout much of the station was predominantly speckled alder (Photograph C-16). Herbaceous vegetation was more abundant near the upstream and downstream extents of the station. A remnant beaver dam was located near the upstream extent of the station and did not appear to impound water (Photograph C-17).
