**Investigation of the Aquatic
Communities of the Salmon Trout
River, Yellow Dog River, and Cedar
Creek in Marquette County,
Michigan.**

March 28, 2008

Kennecott Eagle Minerals Company

ADVANCED ECOLOGICAL MANAGEMENT

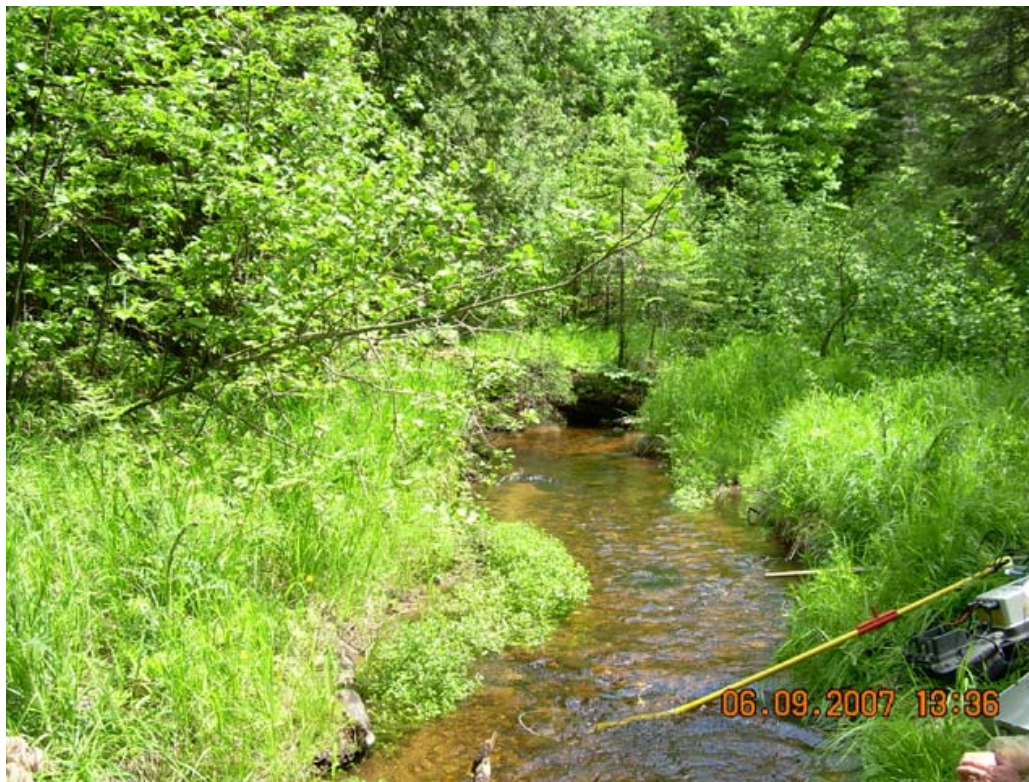
Photograph C-1. Station 1 - Downstream Extent View South.

The streambanks of Station 1 were vegetated with herbaceous and woody vegetation (Photograph C-1). The streambed is characterized by a relatively steep gradient and the substrate was comprised of a variety of particles including sand, gravel, cobble, and boulders. Woody debris was frequently observed throughout the station (Photograph C-2).

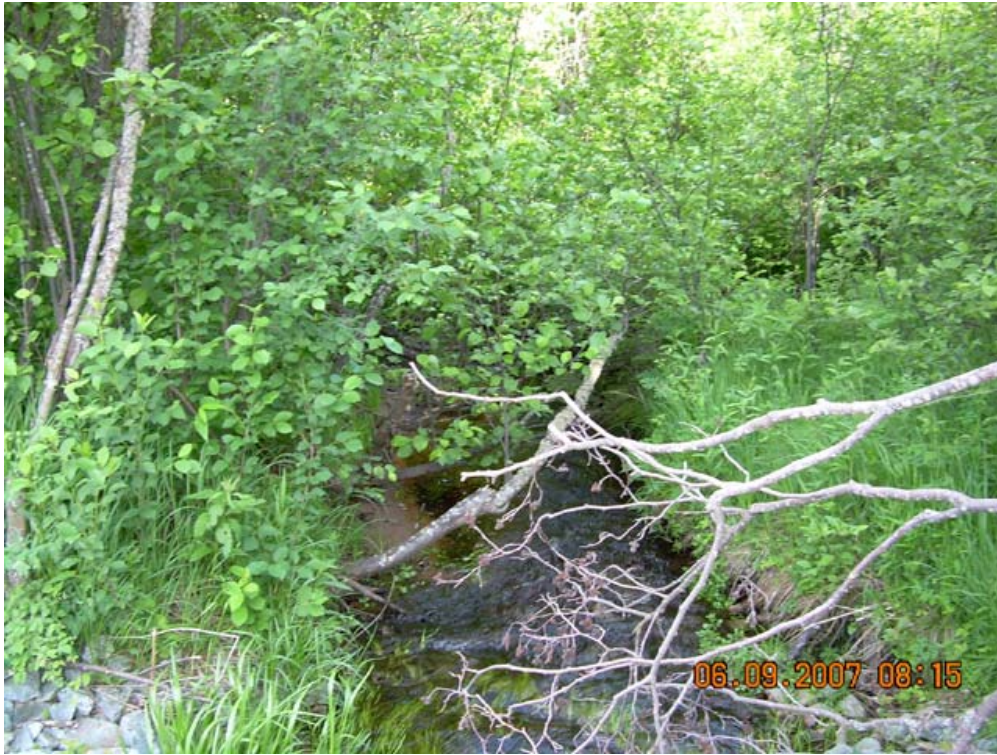
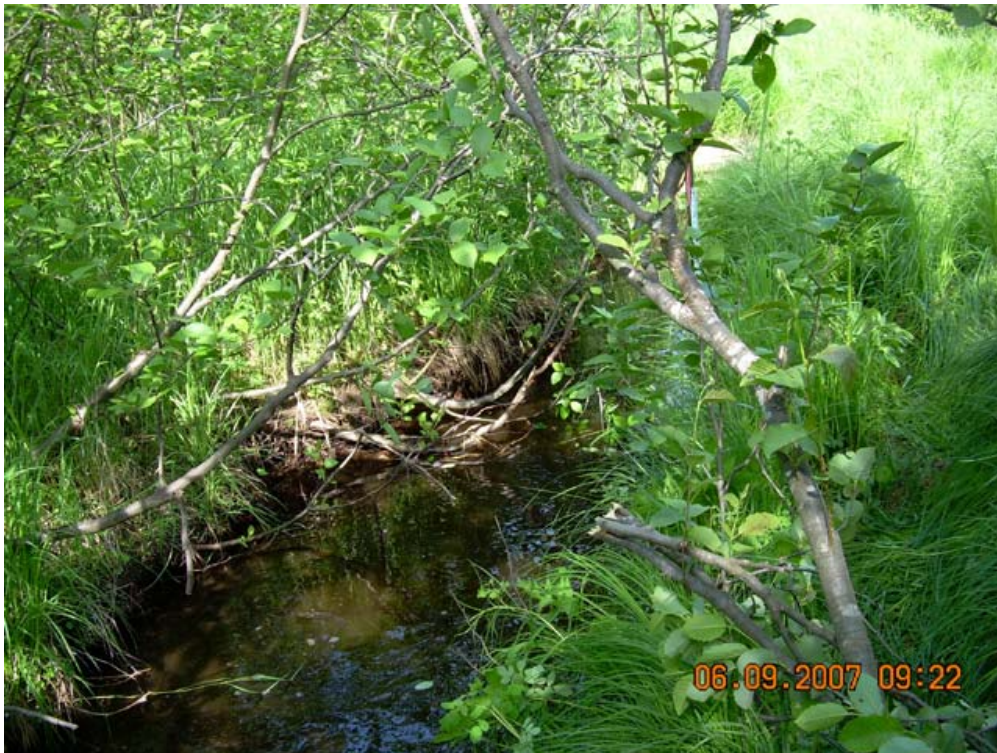
Photograph C-3. Station 2 – Downstream Extent View South.

Station 2 was surrounded by an abundance of speckled alder (*Alnus rugosa*) and bluejoint grass (*Calamagrostis canadensis*, Photograph C-3 and Photograph C-4). The vegetation within Station 3 was predominantly characterized as speckled alder, which contributed woody debris to the stream (Photograph C-5). Watercress (*Nasturtium* sp.) was present within the stream channel of Station 3 (Photograph C-6).

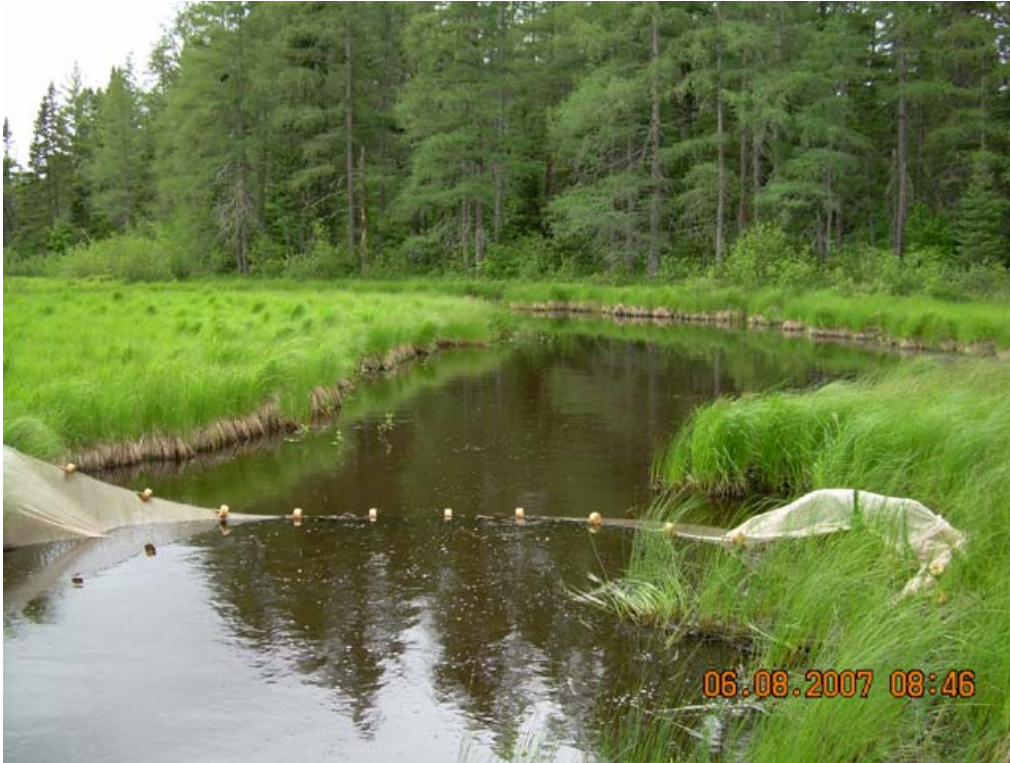
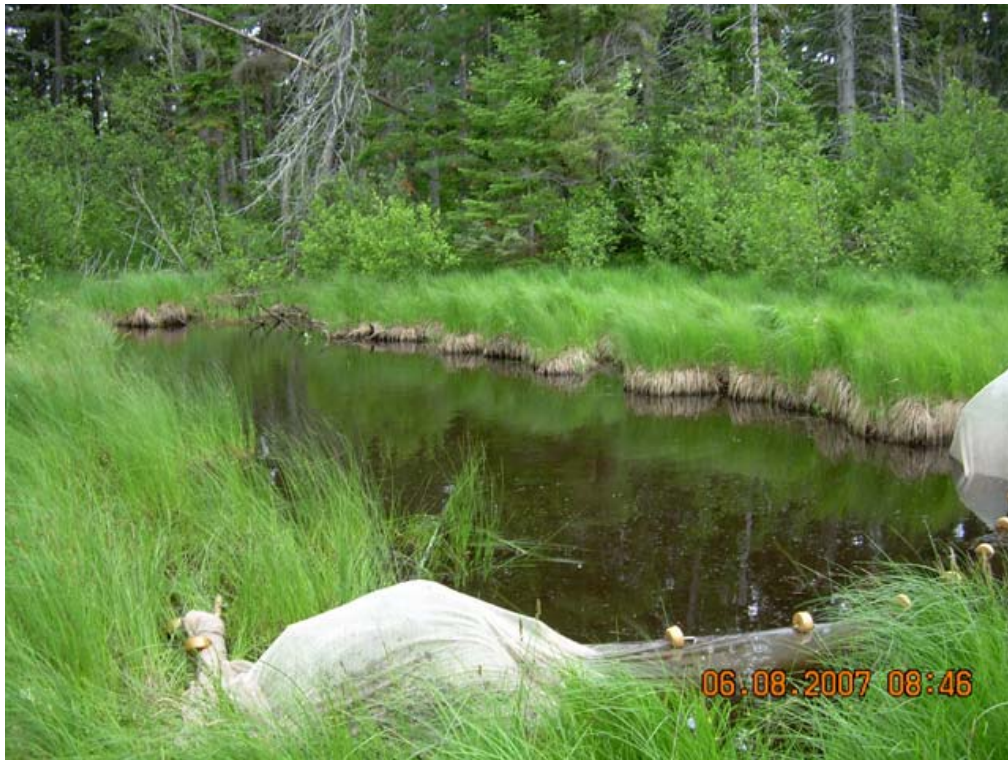
Photograph C-7. Station 6 – Upstream Extent View Southwest.

The streambanks are characterized by sedge (*Carex* sp.), iris (*Iris* sp.), rush (*Juncus* sp.), willows (*Salix* sp.) and speckled alder (Photograph C-7 and Photograph C-8). Much of the aquatic vegetation was growing on organic matter that appeared to function as a floating mat of vegetation. The substrate of Station 6 was predominantly comprised of organic matter and fine sediments, such as silt and clay. Large woody debris was present throughout the stream channel.

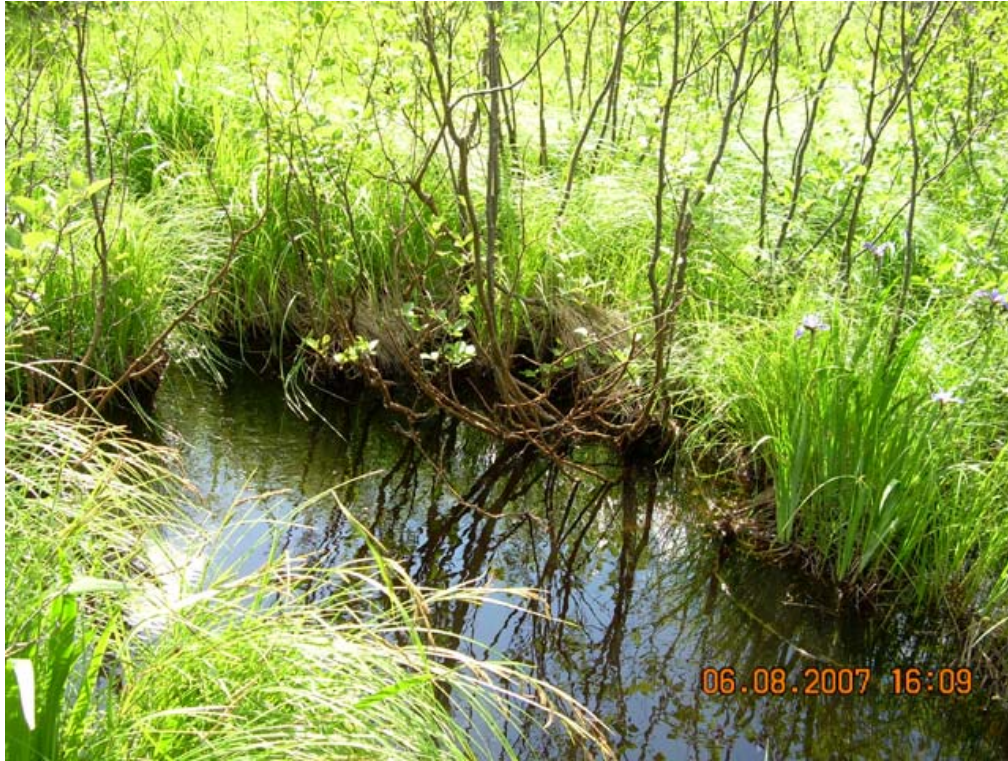
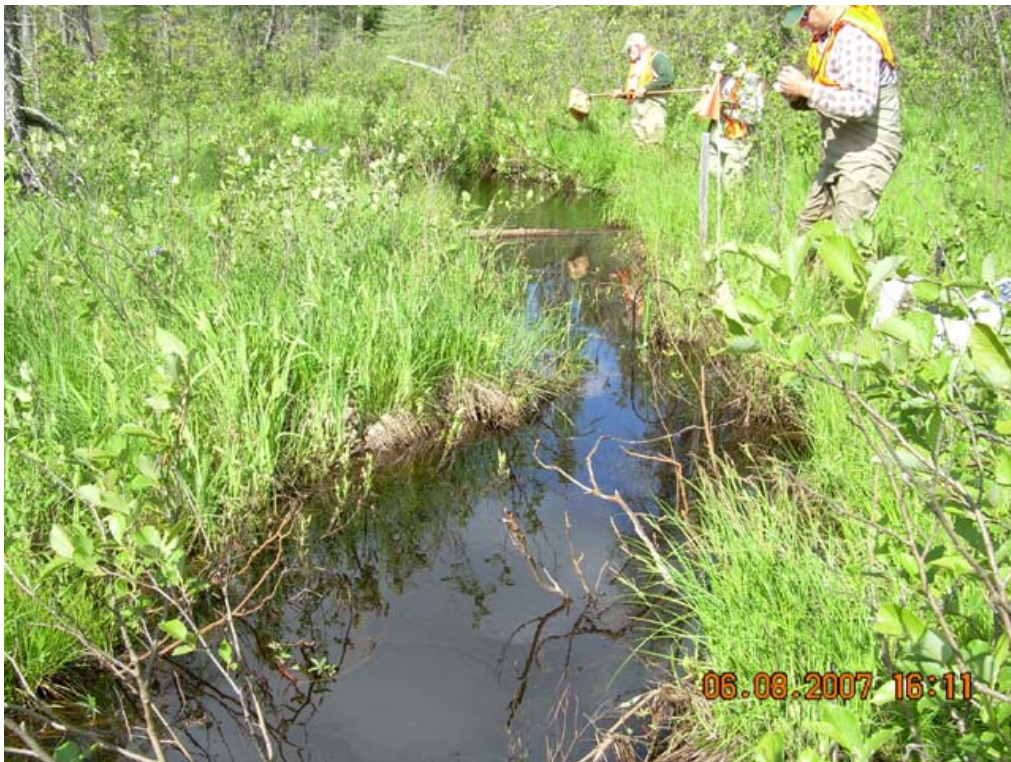
Photograph C-9. Station 7 – Downstream Extent View Southwest.

The streambanks of Station 7 were vegetated with speckled alder, sedge, rush, and iris (Photograph C-9 and Photograph C-10). The substrate was comprised of organic matter and silt. Woody debris was abundant throughout this station.

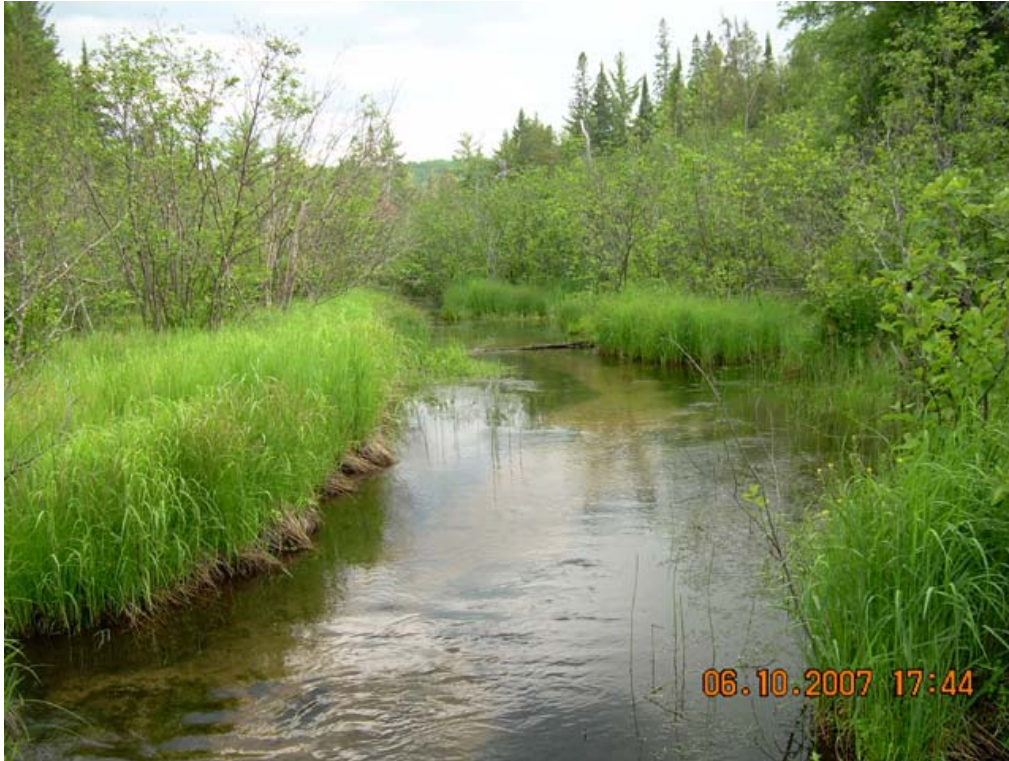
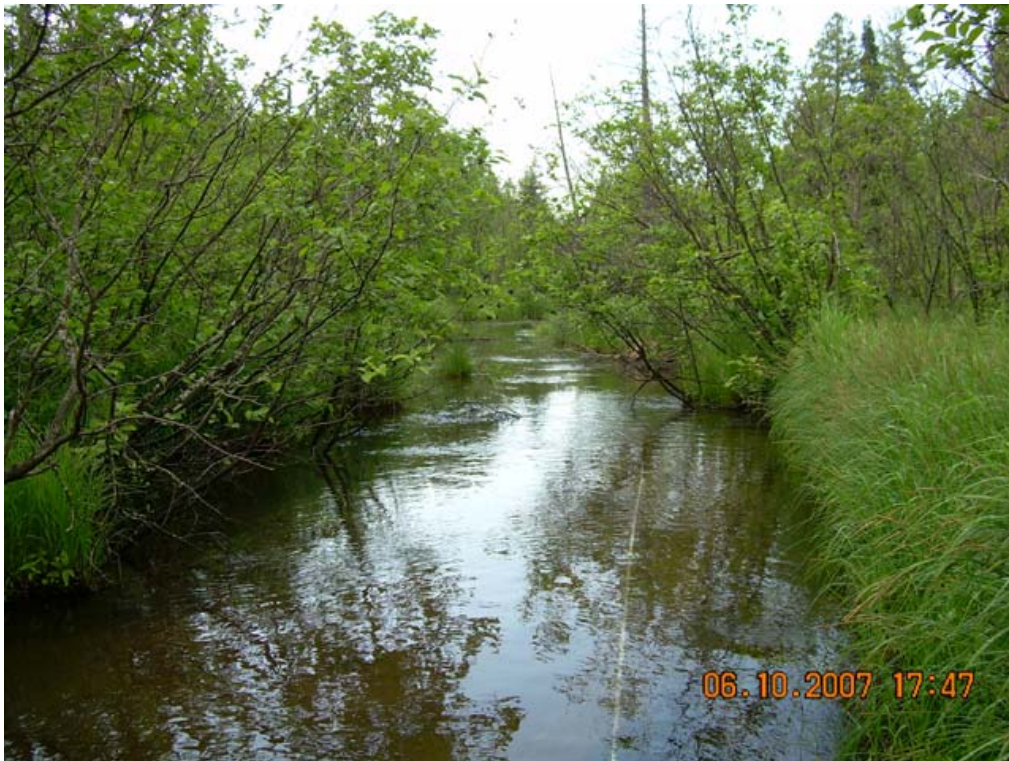
Photograph C-11. Station 8 – Downstream Extent View North.

The stream channel was braided upstream and downstream of the station and streambanks were predominately vegetated with speckled alder and tussock sedge (Photograph C-11 and Photograph C-12). Substrate was predominantly comprised of sand and silt throughout Station 8.

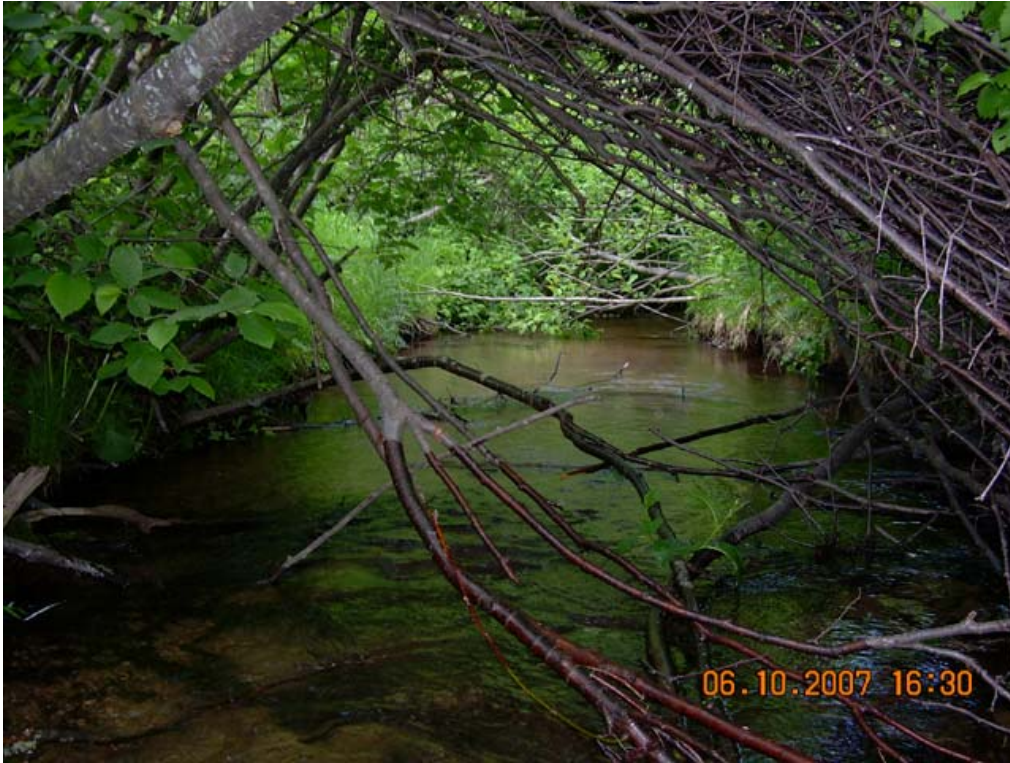
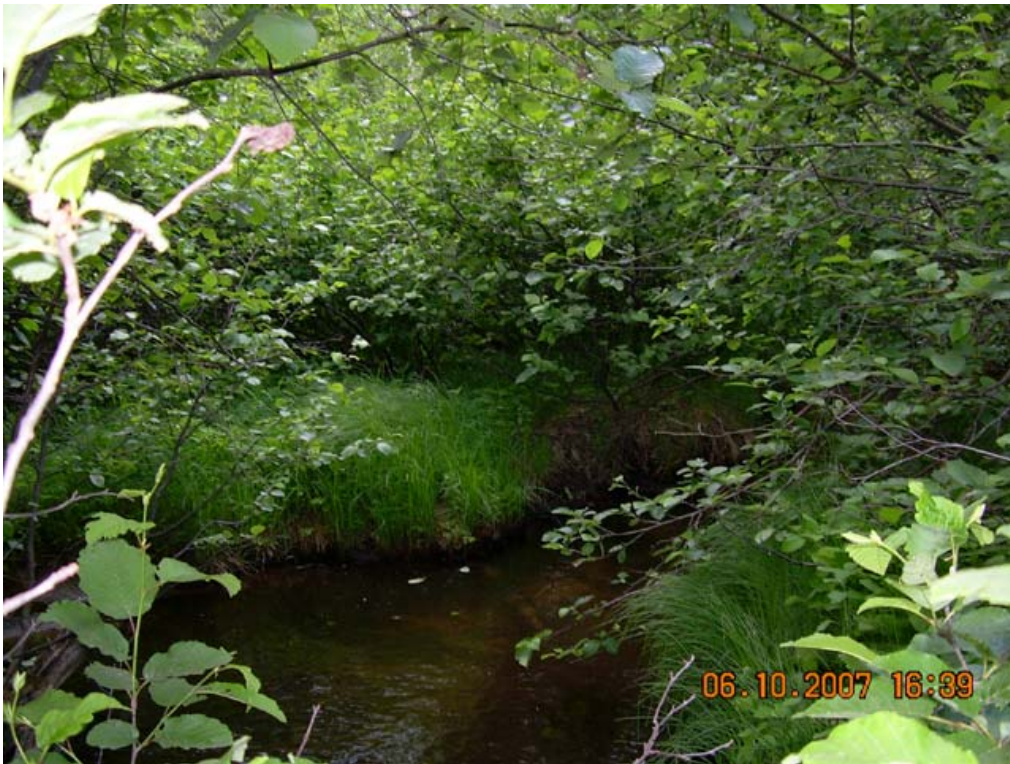
Photograph C-13. Station 9 – Downstream Extent View Southwest.

Speckled alder covered much of the stream channel and contributed to in-stream cover, while the understory was predominately tussock sedge (Photograph C-13 and Photograph C-14). The substrate was predominantly comprised of sand and silt.

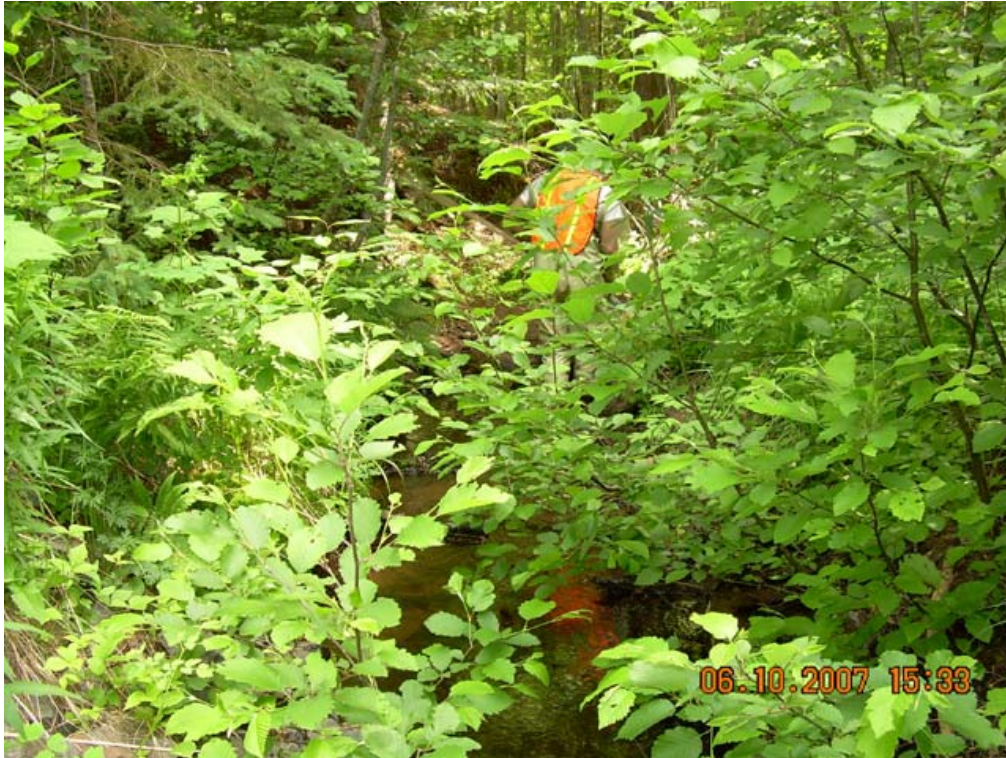
Photograph C-15. Station 10 – Downstream Extent View West.

The streambanks within Station 10 were vegetated with large deciduous trees, speckled alder, and other herbaceous vegetation (Photograph C-15). Large woody debris and undercut banks provided in-stream cover throughout this station (Photograph C-16). The substrate was predominantly comprised of sand and silt, although cobble and large boulders were also present.

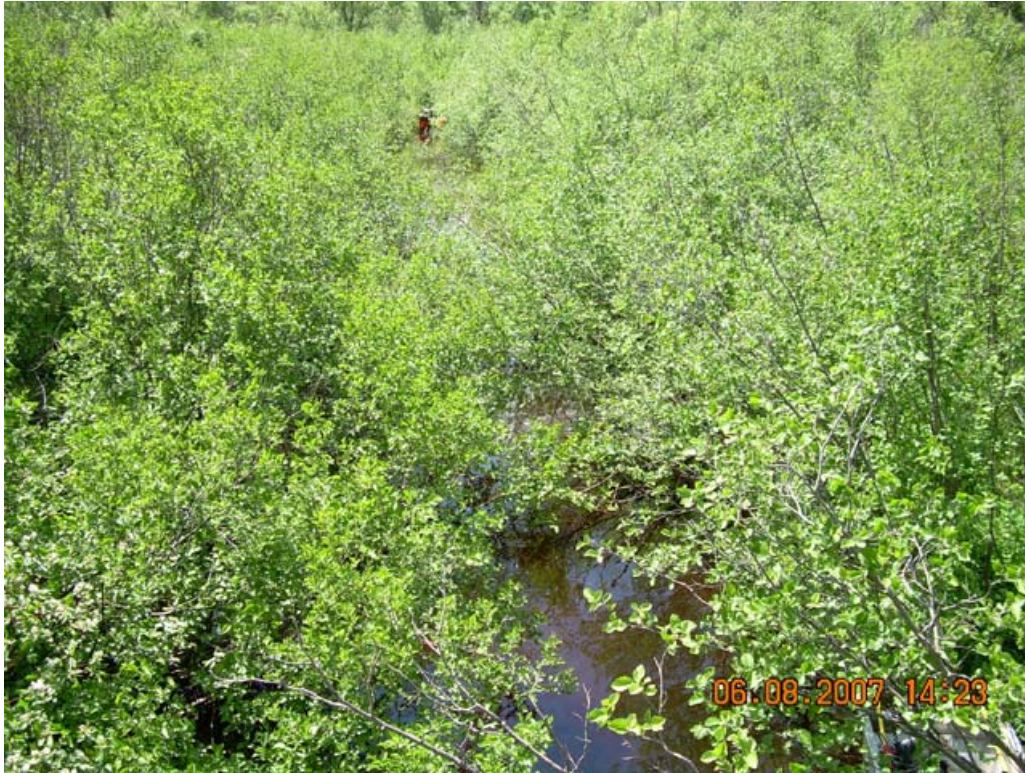
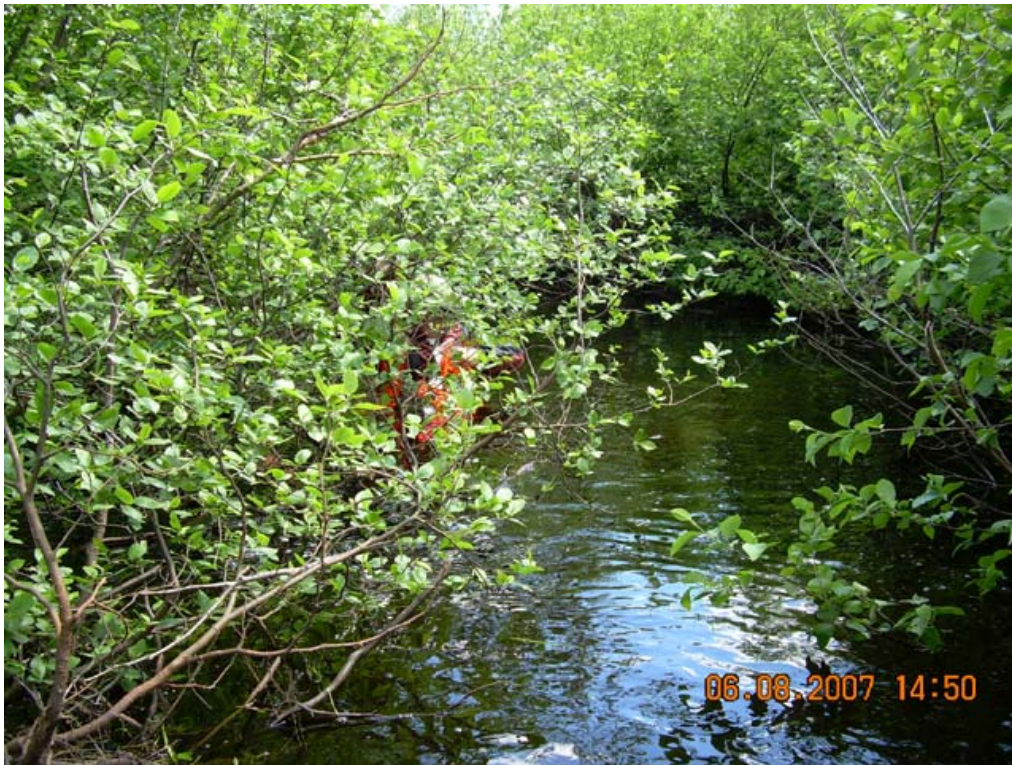
Photograph C-17. Station 5 – Downstream Extent View West.

Streambanks were vegetated with a dense covering of speckled alder, which contributed to instream cover and woody debris within the channel (Photograph C-17 and Photograph C-18). The substrate was predominantly comprised of sand and silt.

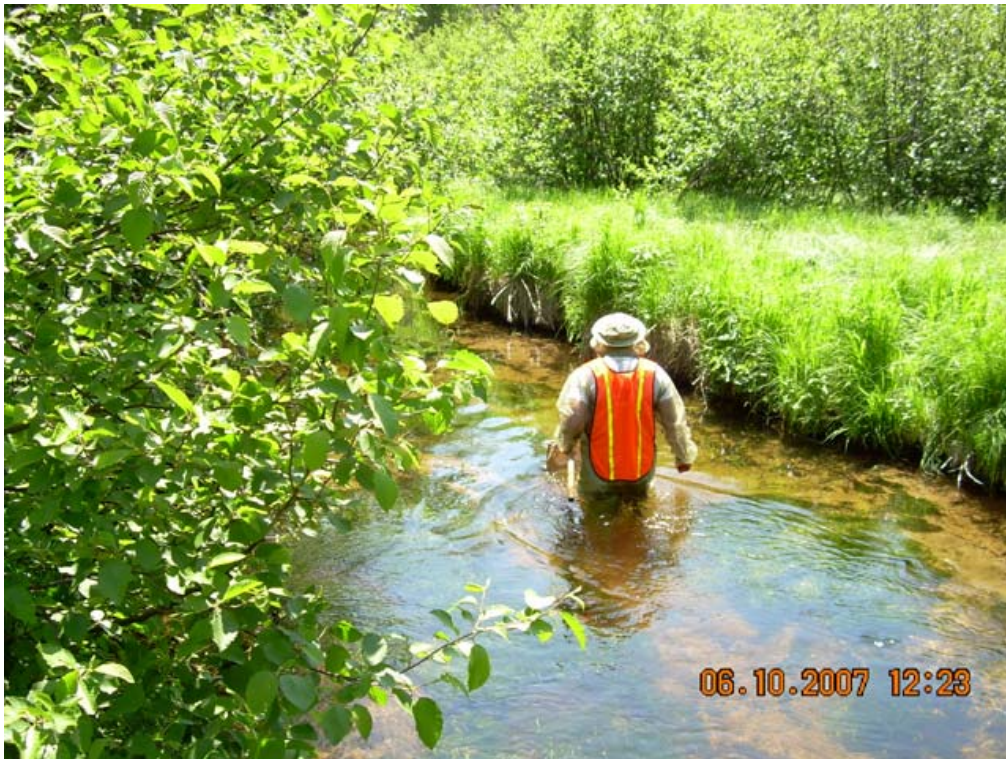
Photograph C-19. Station 4 – Downstream Extent View South.

The riparian vegetation throughout much of the station was predominantly speckled alder (Photograph C-19). Herbaceous vegetation was more abundant near the upstream and downstream extents of the station. A beaver dam was located near the upstream extent of the station and appeared to impound some water (Photograph C-20).
