Investigation of the Aquatic Communities of the Salmon Trout River, Yellow Dog River, and Cedar Creek in Marquette County, Michigan, 2011.

February 3, 2012

Kennecott Eagle Minerals Company

**ADVANCED ECOLOGICAL MANAGEMENT
22071 7 Mile Road
Reed City, MI 49677**

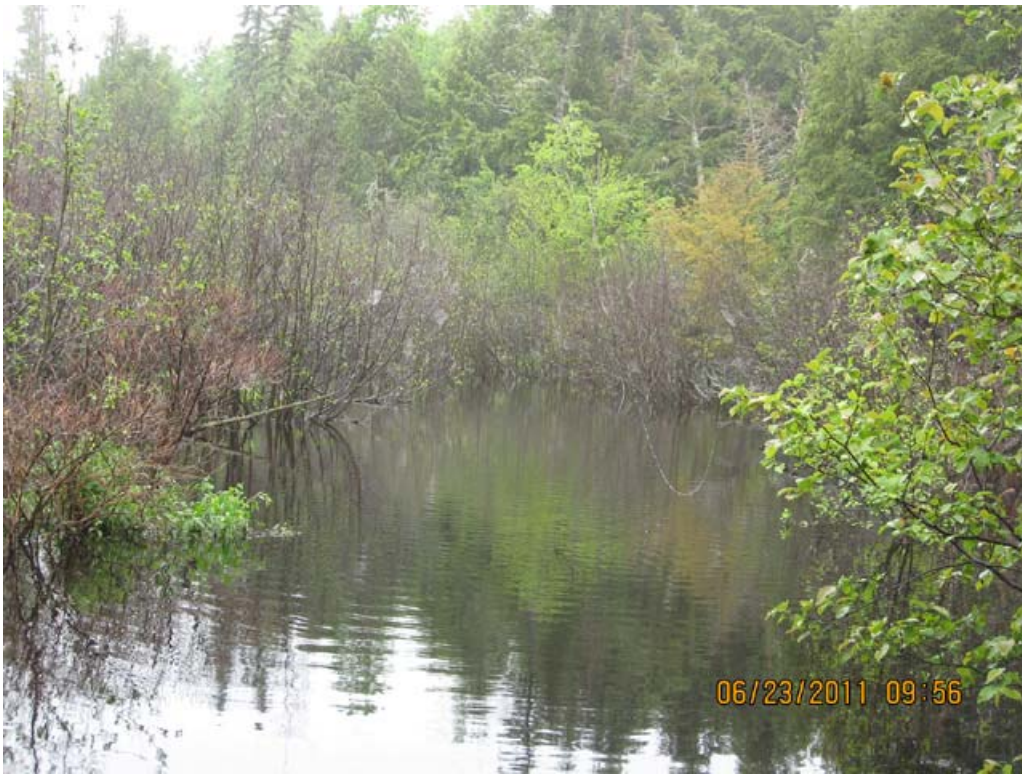
Station 4 is located in Cedar Creek outside of the project area drainage basin. Except for October 2008, all Station 4 aquatic surveys have been conducted south (upstream) of Northwestern Road. Beavers constructed a dam upstream of Northwestern Road in the fall of 2008 and the dam and floodwaters now extend all the way to the Northwestern Road crossing (Photograph C-1). Because of high water conditions caused by beaver activity, the 2011 aquatic survey was conducted north (downstream) of Northwestern Road. In addition, because of a braided channel occurred throughout much of the station, adequate blocking with nets was not possible. Therefore, a single pass removal was conducted in Station 4. A total of 44 brook trout were collected in Station 4 (Table 5-2). Brook trout ranged in length from 1.7 inches to 8.3 inches, with an average length of 3.5 inches (standard deviation $s = 1.8$ inches; sample size $n = 44$).

Photograph C-1. Cedar Creek upstream of Northwestern Road. South View, July, 2011.

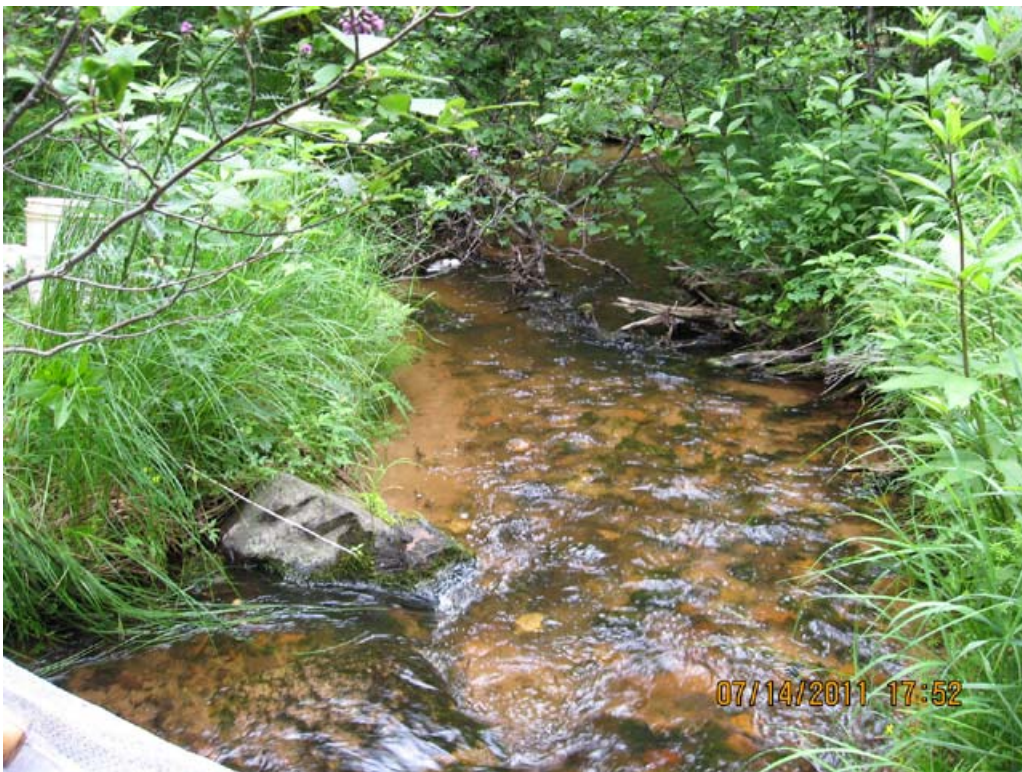
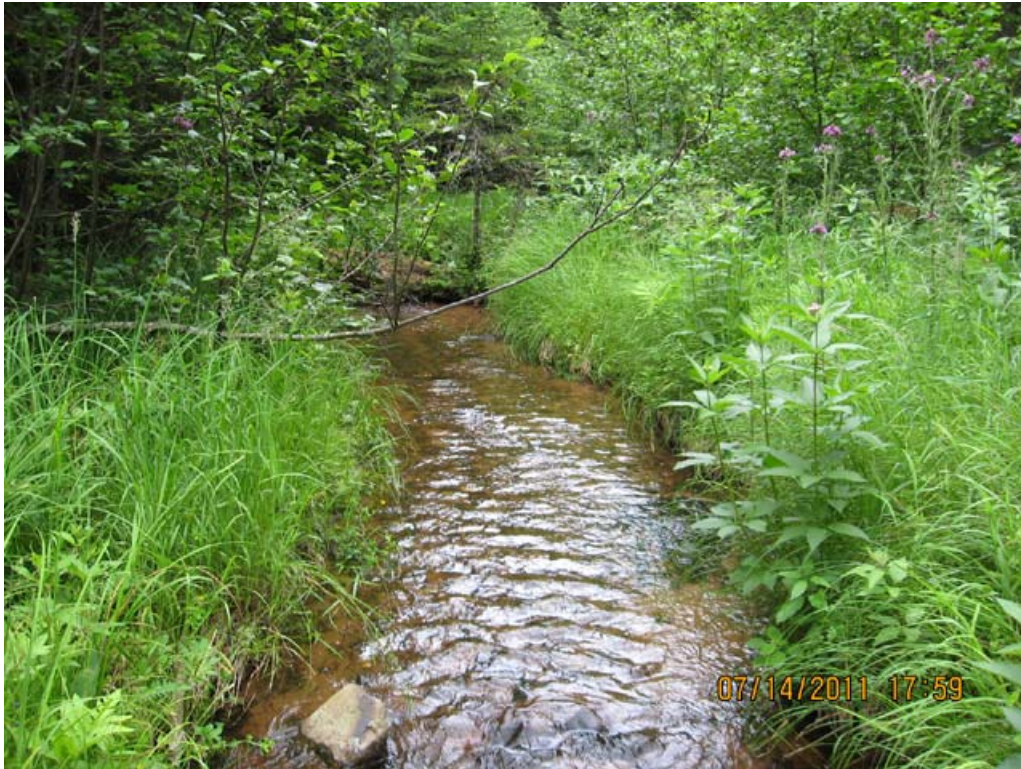
The streambanks of Station 1 appeared consistent with conditions observed in 2008, and were vegetated with herbaceous and woody vegetation (Photographs C-2 and C-3). The streambed was characterized by a relatively steep gradient and the substrate was comprised of a variety of particles including sand, gravel, cobble, and boulders (Photographs C-2 and C-3). Woody debris was frequently observed throughout the station.

Photograph C-2. Station 1 – Upstream Extent North View, July, 2011.

Photograph C-3. Station 1 - Downstream Extent View South, July, 2011.

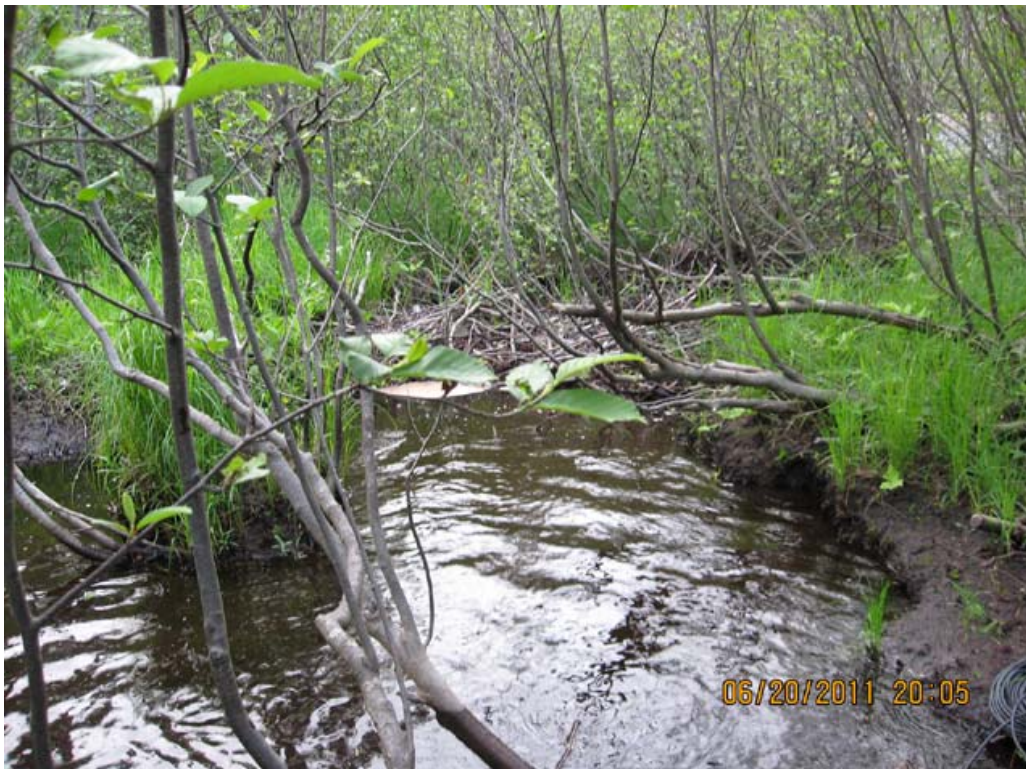
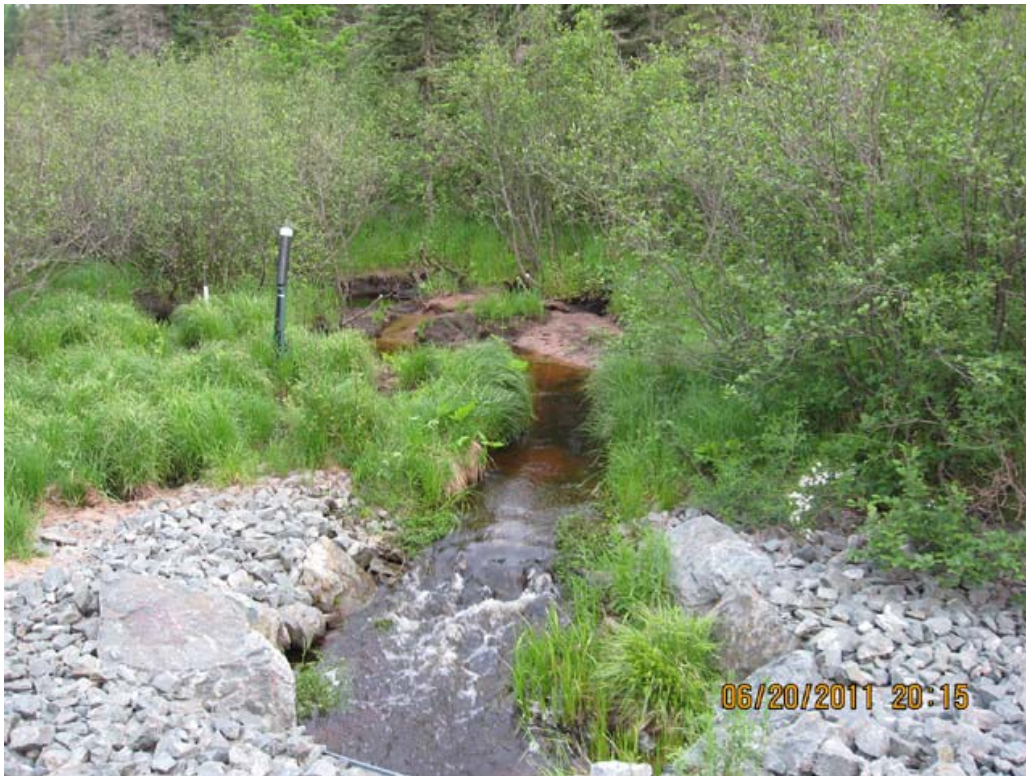
Station 2 was surrounded by an abundance of speckled alder (*Alnus rugosa*) and bluejoint grass (*Calamagrostis canadensis*, Photographs C-4 to C-5). Evidence of recent beaver activity was present with the upstream extent of Station 2. Two partially constructed dams were present within the stream channel, and silt and organic matter appeared to be more abundant within the upstream extent compared to previous surveys.

Photograph C-4. Station 2 – Upstream Extent View North, June, 2011.

Photograph C-5. Station 2 – Downstream Extent View South, June, 2011.

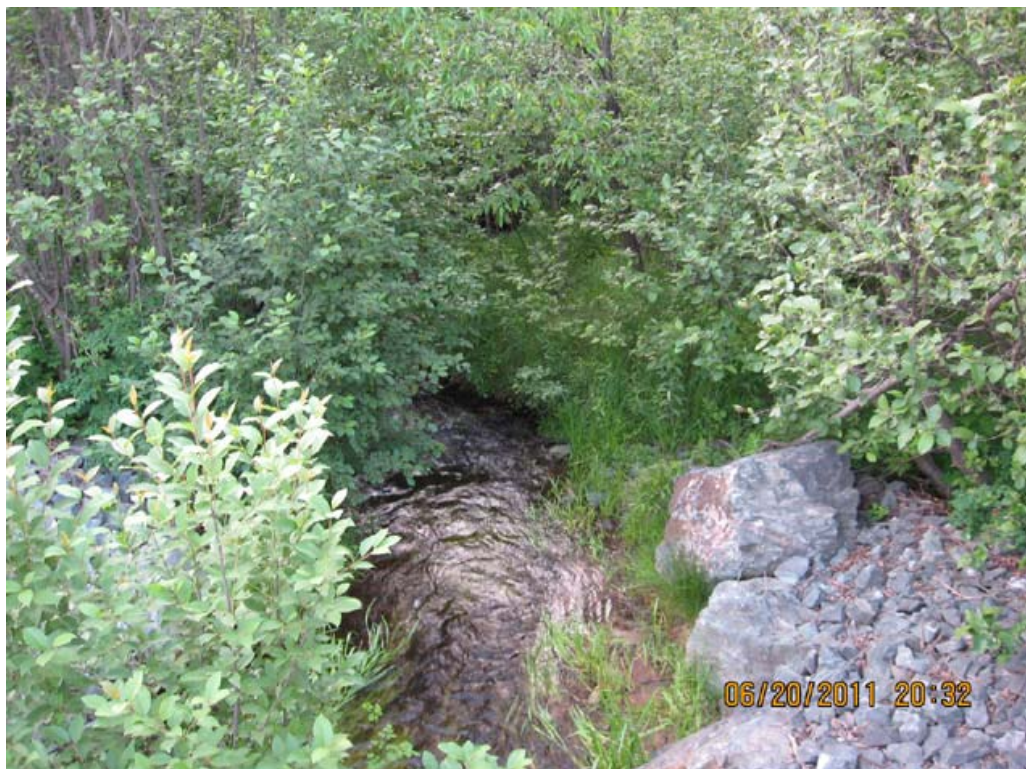
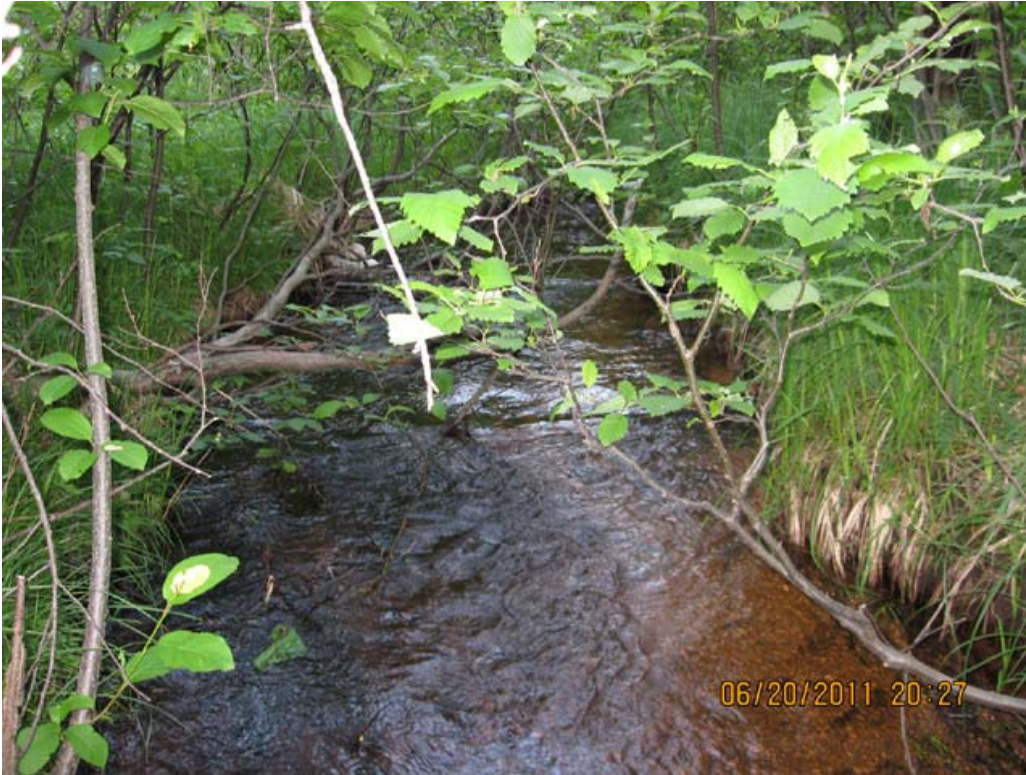
The streambank vegetation within Station 3 appeared similar to conditions observed in 2008. The vegetation within Station 3 was predominantly speckled alder with an understory of bluejoint grass and sedge (*Carex* sp., Photographs C-6 to C-7). Watercress (*Nasturtium* sp.) was present within portions of the stream channel of Station 3.

Photograph C-6. Station 3 – Upstream Extent View North, June, 2011.

Photograph C-7. Station 3 –Downstream Extent View South, June, 2011.

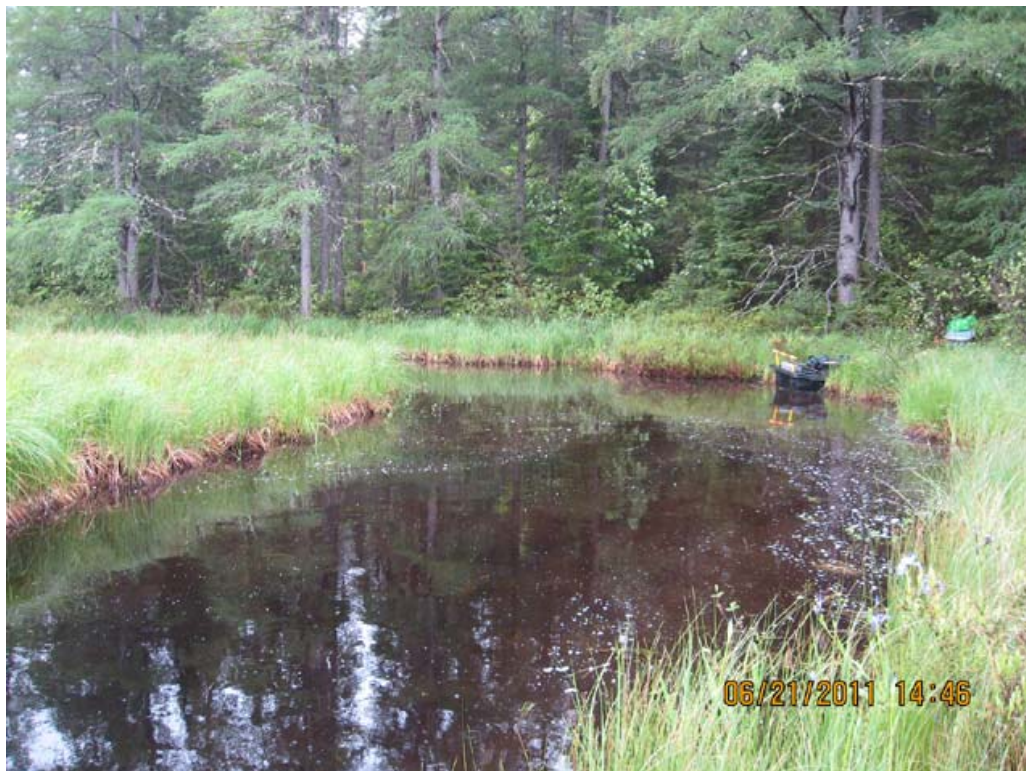
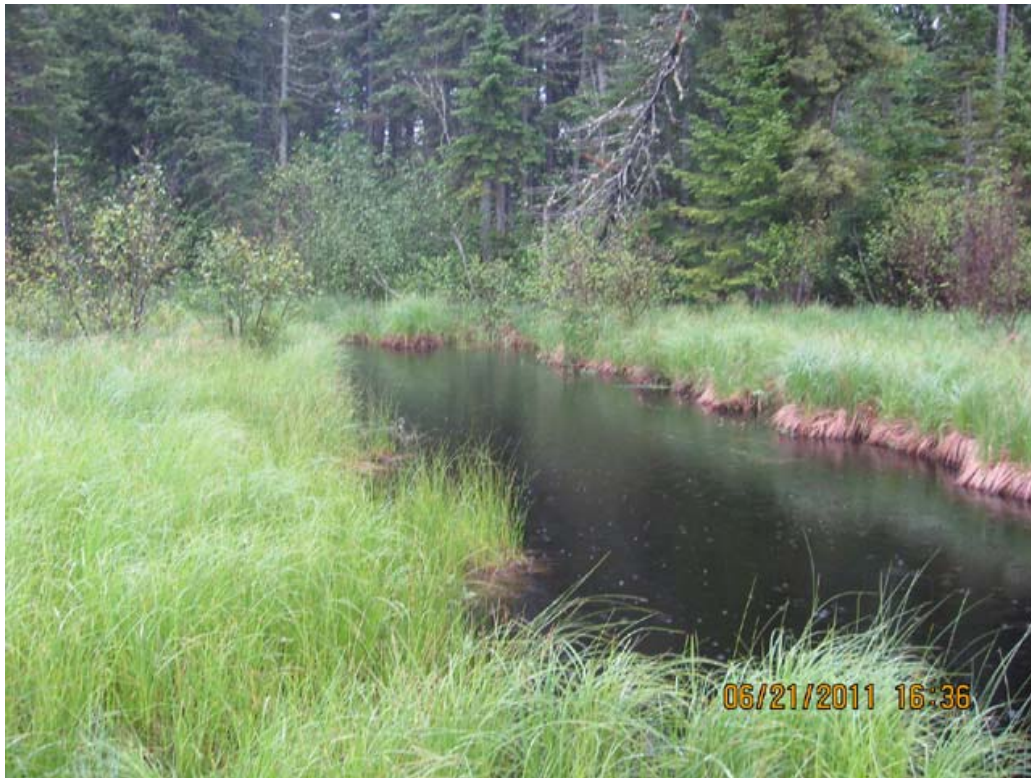
The streambanks in Station 6 appeared similar to conditions observed in 2008, and were characterized by tussock sedge (*Carex stricta*), iris (*Iris* sp.), rush (*Juncus* sp.), willows (*Salix* sp.) and speckled alder (Photographs C-8 to C-9). Much of the aquatic vegetation seen during the summer sampling event was growing on organic matter that appeared to function as a floating mat of vegetation. The substrate of Station 6 was predominantly comprised of organic matter and fine sediments, such as silt and clay. Woody debris was present throughout the stream channel.

Photograph C-8. Station 6 – Upstream Extent View Southwest, June, 2011.

Photograph C-9. Station 6 – Downstream Extent View Southwest, June, 2011.

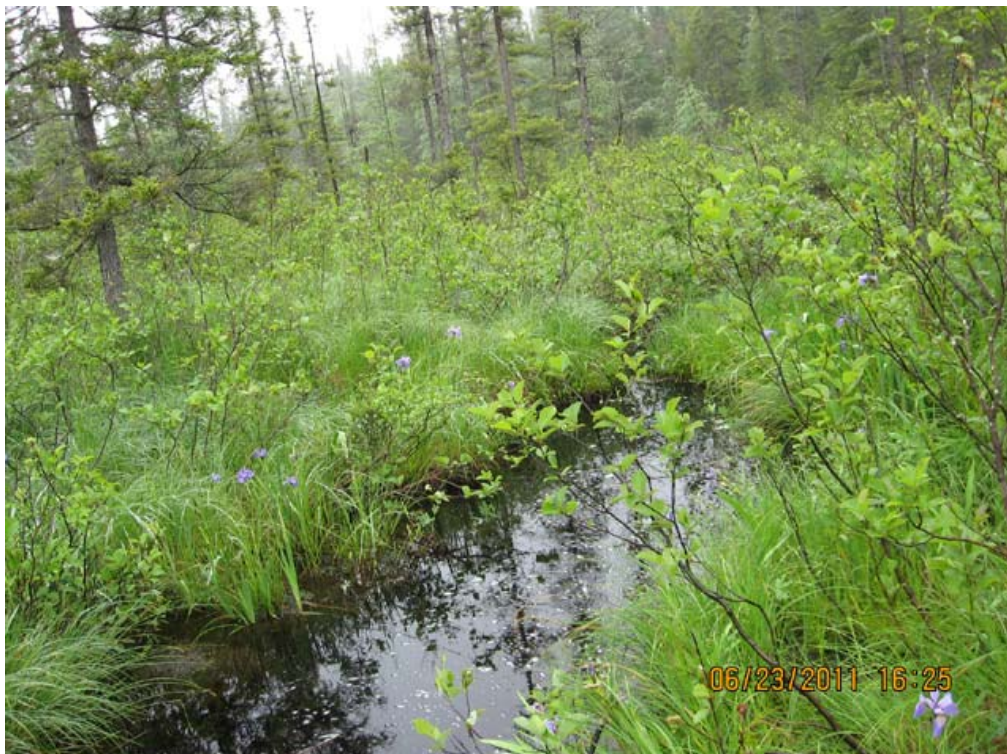
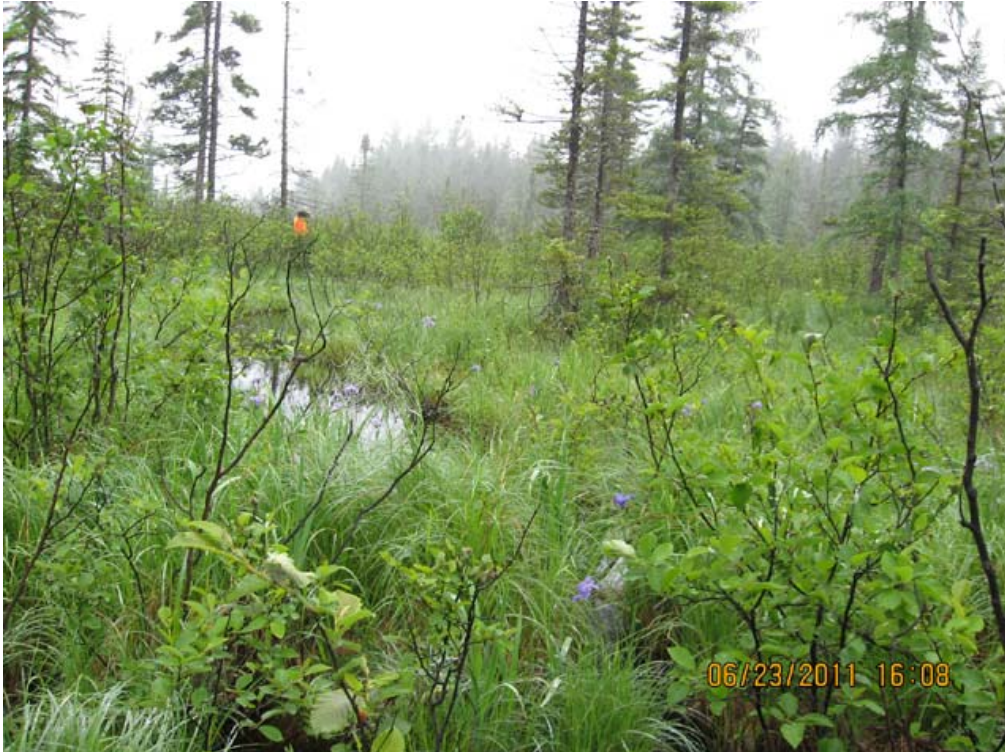
The streambanks of Station 7 were vegetated with speckled alder, tussock sedge, rush, and iris (Photographs C-10 and C-11), and appeared similar to conditions observed in 2008. The substrate was comprised of organic matter and silt. Woody debris was abundant throughout this station.

Photograph C-10. Station 7 – Downstream Extent View Southwest, June, 2011.

Photograph C-11. Station 7 – Upstream Extent View North, June, 2011.

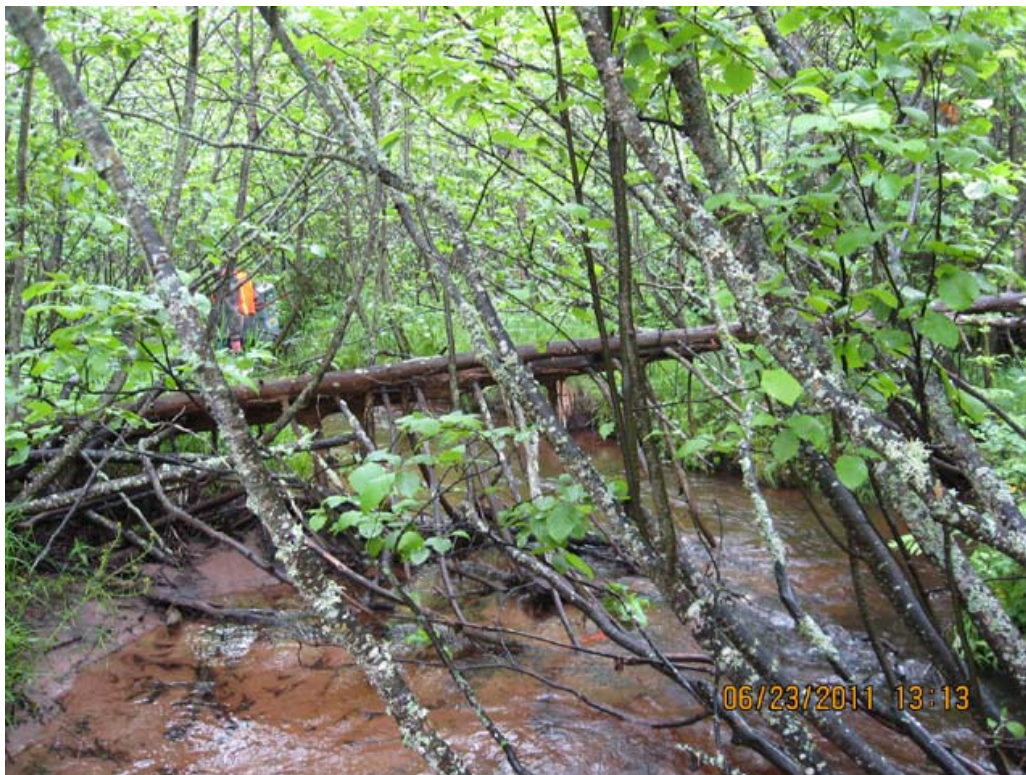
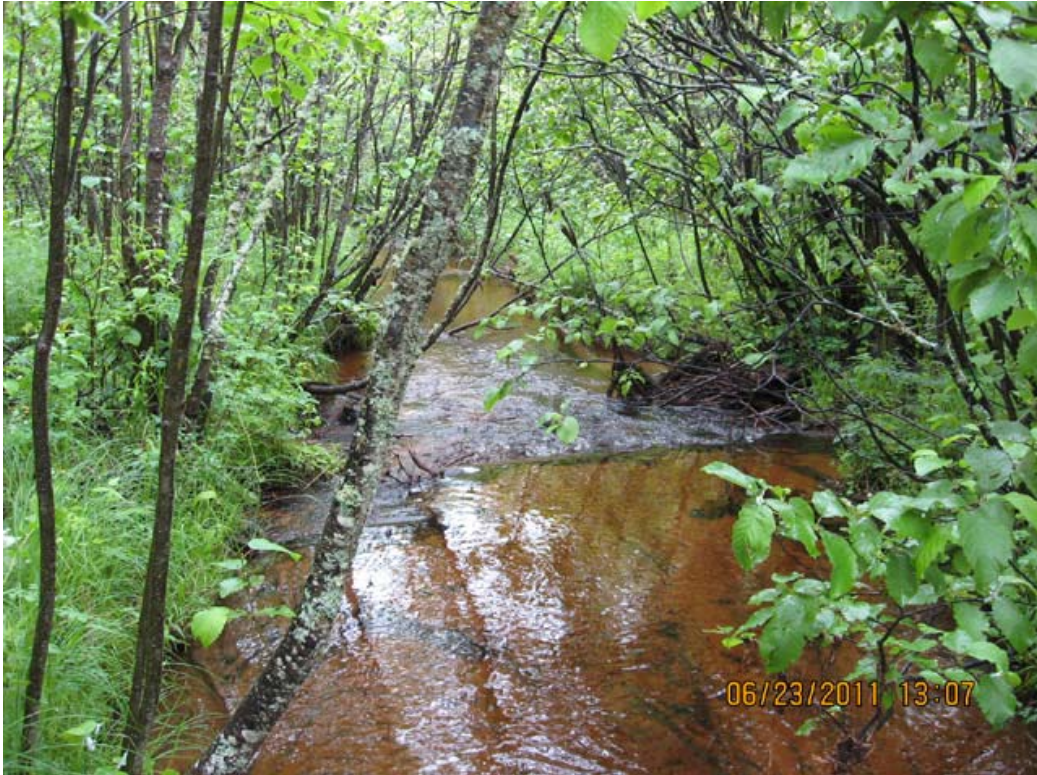
The stream channel of Station 8 was largely shaded by a dense canopy of speckled alder with an abundance of sedge growing along the streambank (Photograph C-12 and Photograph C-13). Small woody debris and undercut banks were present throughout the station, and the stream substrate was predominantly comprised of sand and small gravel.

Photograph C-12. Station 8 – Downstream Extent View South, June, 2011.

Photograph C-13. Station 8 – Upstream Extent View North, June, 2011.

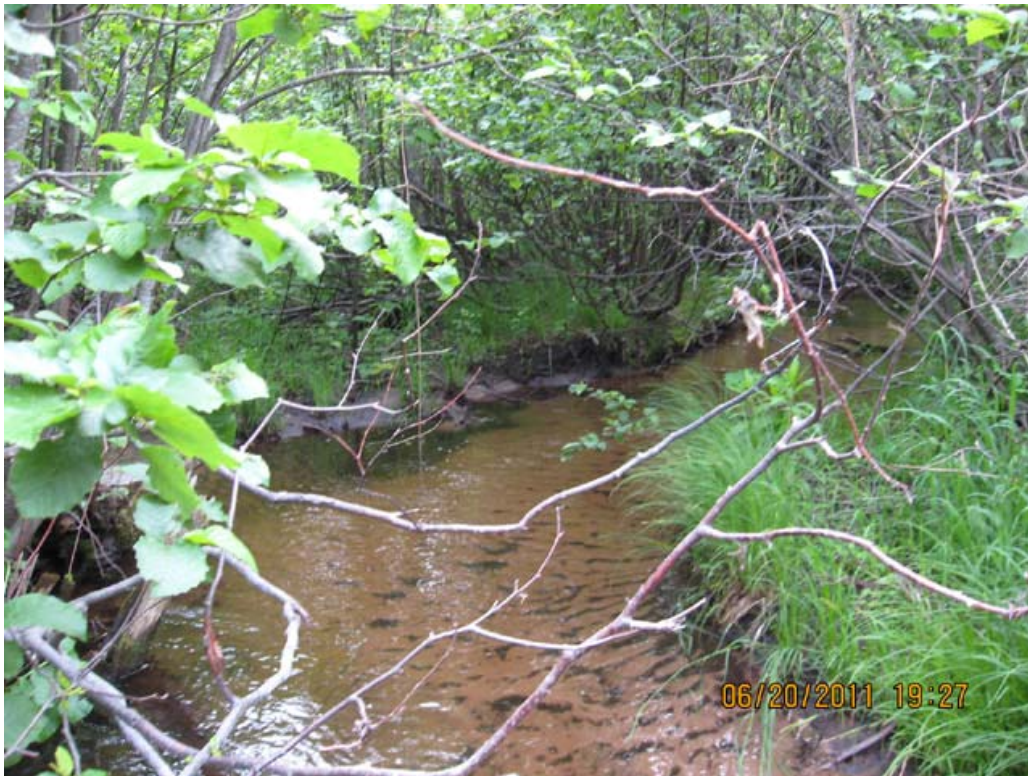
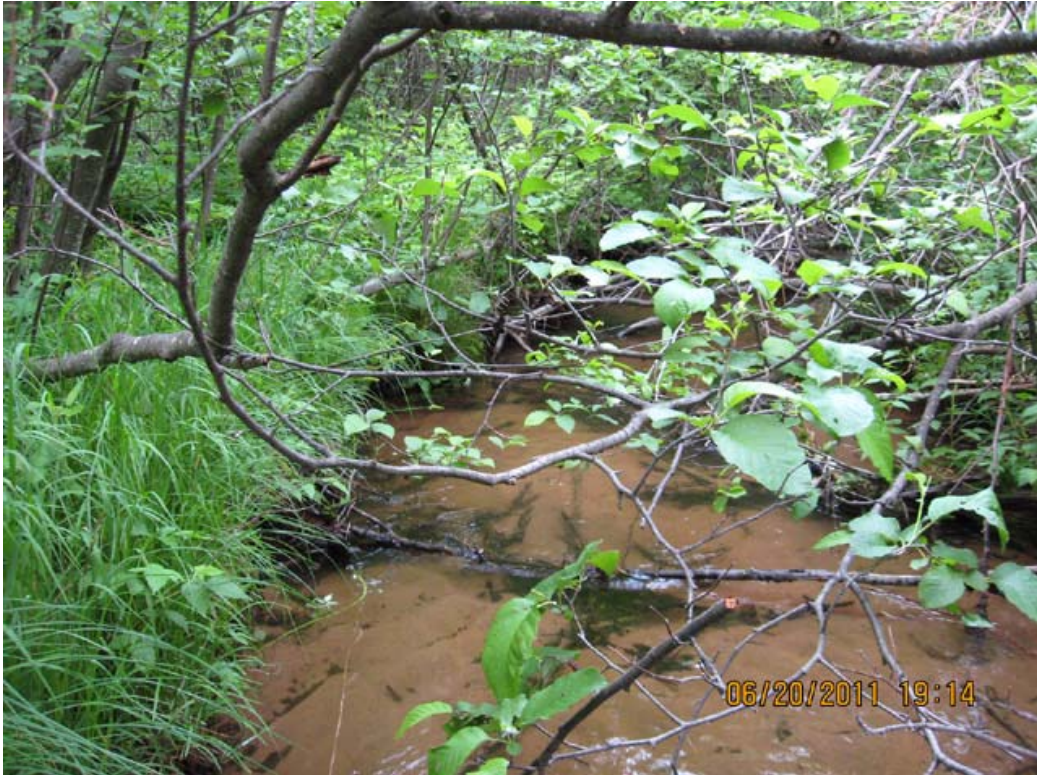
Habitat conditions within Station 9 appeared similar to conditions observed in 2008. The understory of Station 9 was predominately sedge, while speckled alder covered much of

the stream channel and contributed to in-stream cover (Photographs C-14 to C-15). The substrate was predominantly comprised of sand and silt.

Photograph C-14. Station 9 – Downstream Extent View Southwest, June, 2011.

Photograph C-15. Station 9 – Upstream Extent View Northeast, June, 2011.

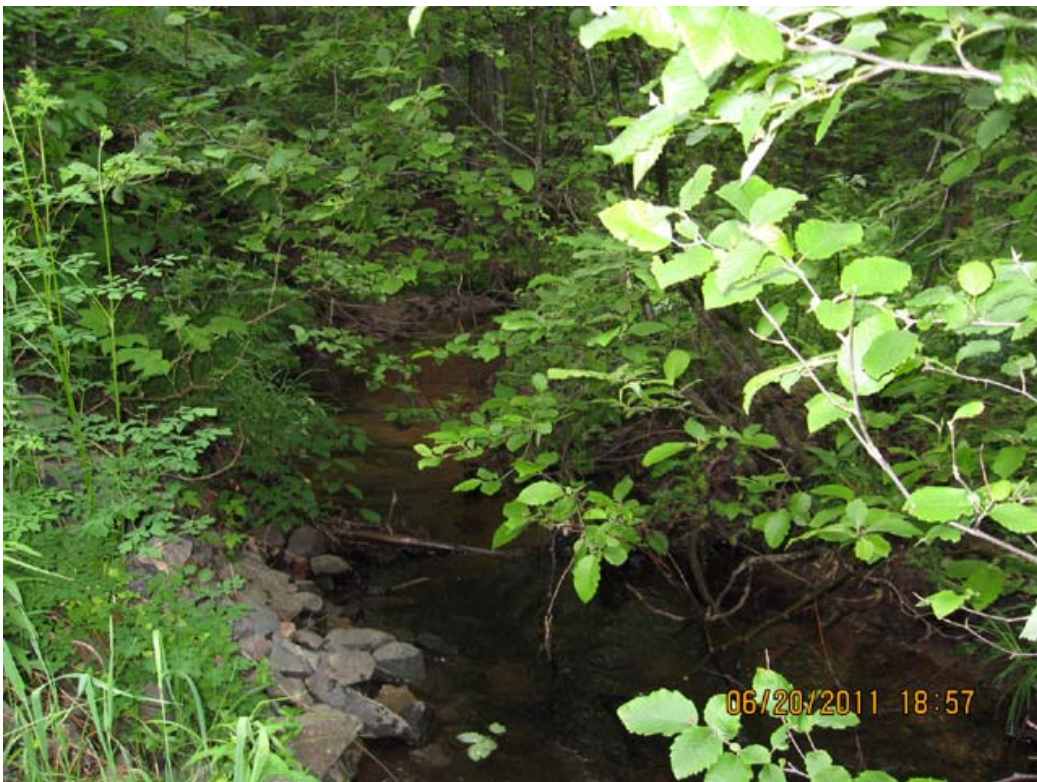
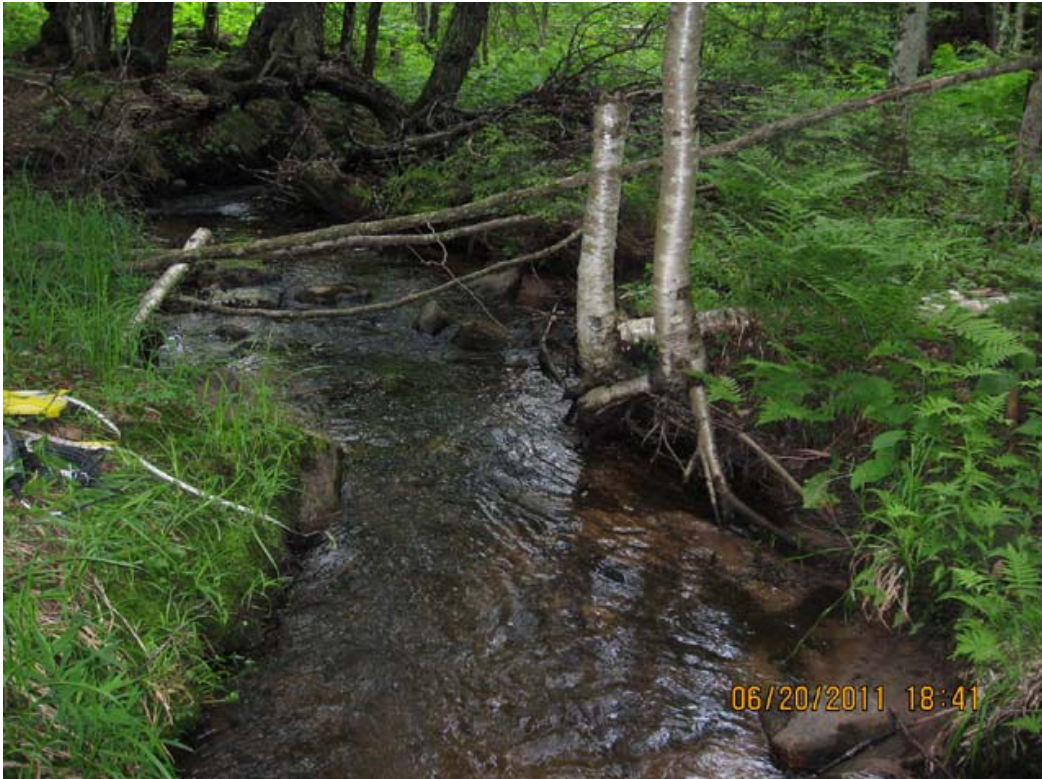
The streambanks within Station 10 were vegetated with large deciduous trees, speckled alder, and other herbaceous vegetation (Photographs C-16 and C-17), and appeared similar to conditions observed in 2008. Woody debris and undercut banks provided in-stream cover throughout this station. The substrate was predominantly comprised of sand, silt and some gravel; although cobble and large boulders were also present (Photographs C-16 and C-17).

Photograph C-16. Station 10 – Downstream Extent View Southwest, June, 2011.

Photograph C-17. Station 10 – Upstream Extent View Northeast, June, 2011.

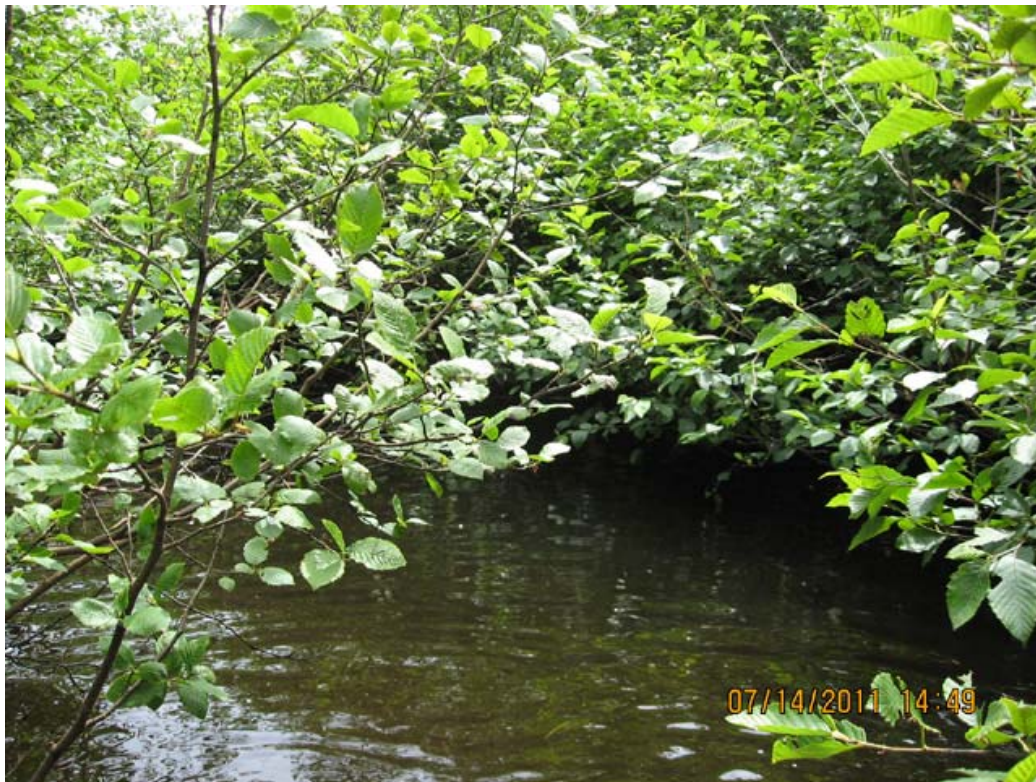
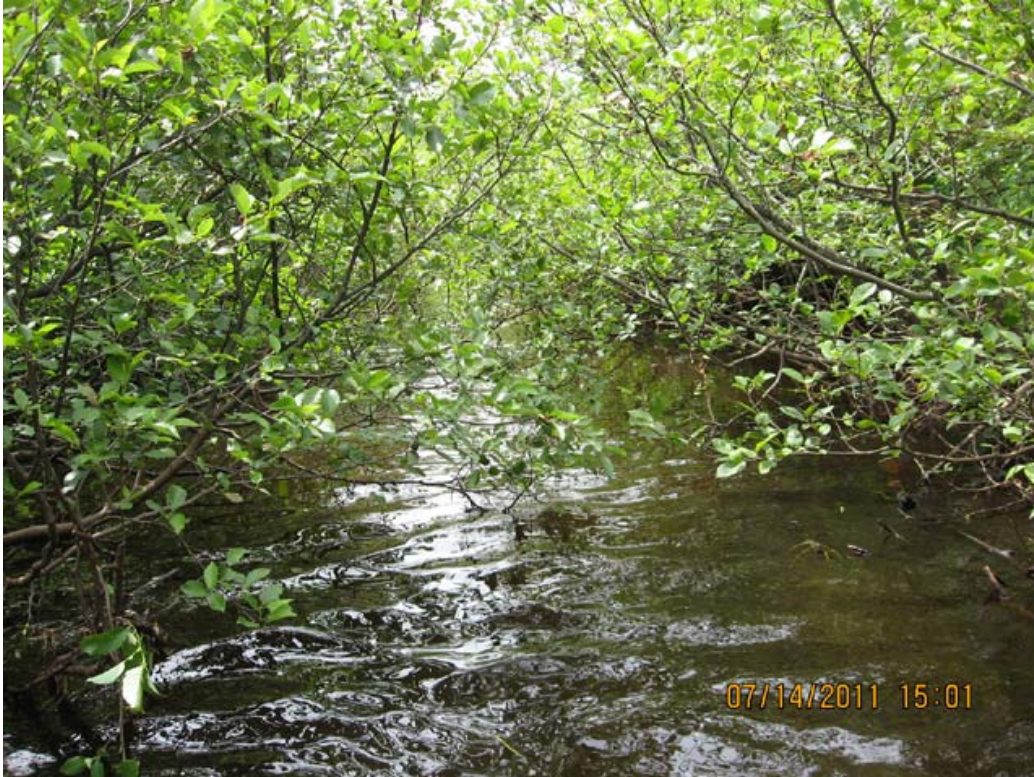
Streambanks appeared consistent with the 2008 survey and were vegetated with a dense covering of speckled alder, which contributed to in-stream cover and woody debris within the channel (Photographs C-18 to C-19). The substrate was predominantly comprised of sand and silt.

Photograph C-18. Station 5 – Downstream Extent View West, July, 2011.

Photograph C-19. Station 5 – Upstream Extent View East, July, 2011.

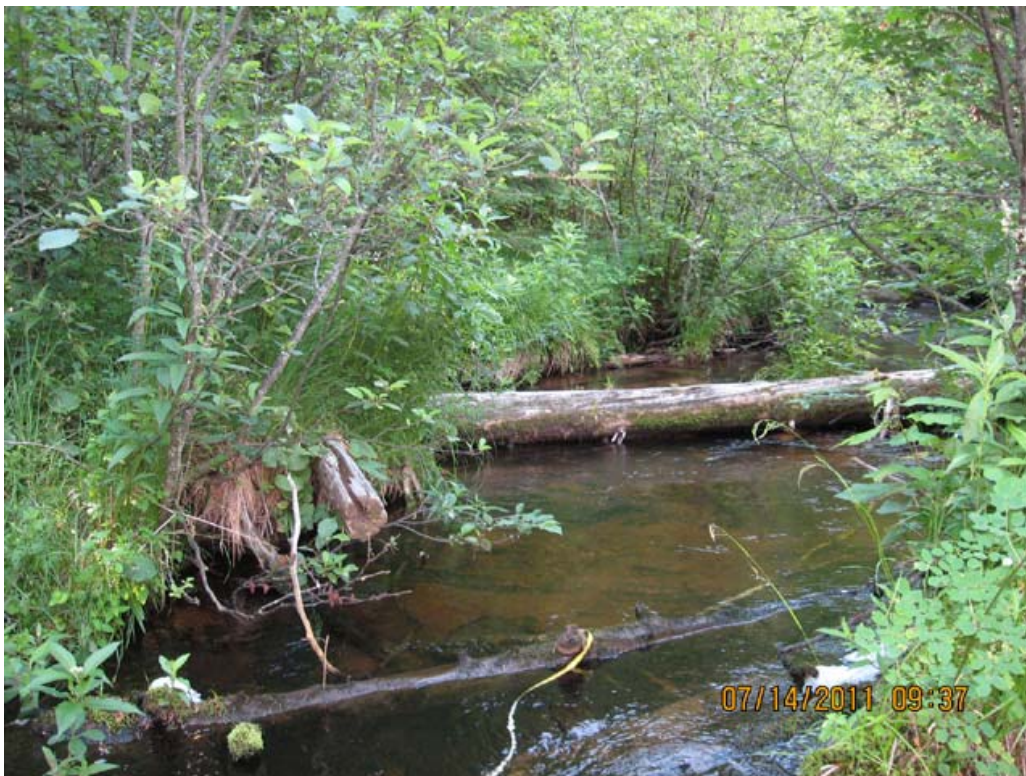
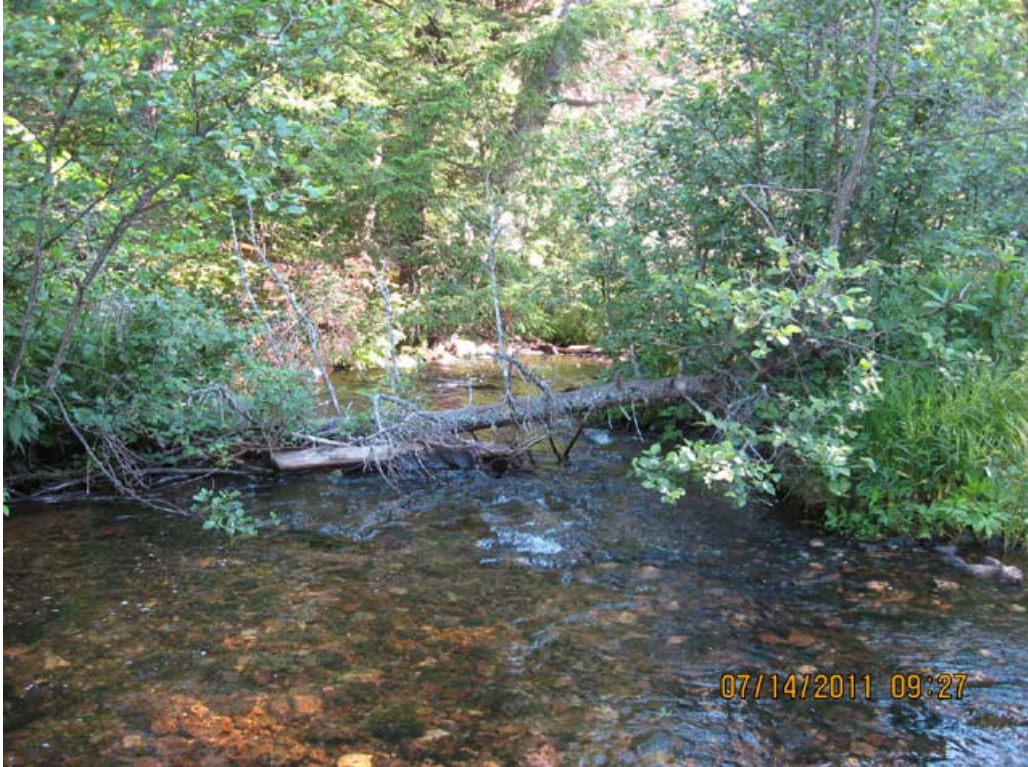
The riparian vegetation throughout much of the relocated Station 4 was mature northern white cedars (*Thuja occidentalis*), and white pines (*Pinus strobus*). Speckled alder was also present along the stream channel in the upstream and downstream extents of the station (Photographs C-20 and C-21). The river channel was braided throughout the middle portion of the station, with frequent undercut banks, large woody debris and variety of substrate, including sand, gravel, cobble and boulders contributing to habitat complexity.

Photograph C-20. Station 4 – Downstream Extent View South, July, 2011.

Photograph C-21. Station 4 – Upstream Extent View North, July, 2011.
