# **Investigation of the Aquatic Communities of the Salmon Trout River, Yellow Dog River, and Cedar Creek in Marquette County, Michigan, 2012.**

**August 10, 2012**

**Rio Tinto – Eagle Mine**

**ADVANCED ECOLOGICAL MANAGEMENT  
22071 7 Mile Road  
Reed City, MI 49677**

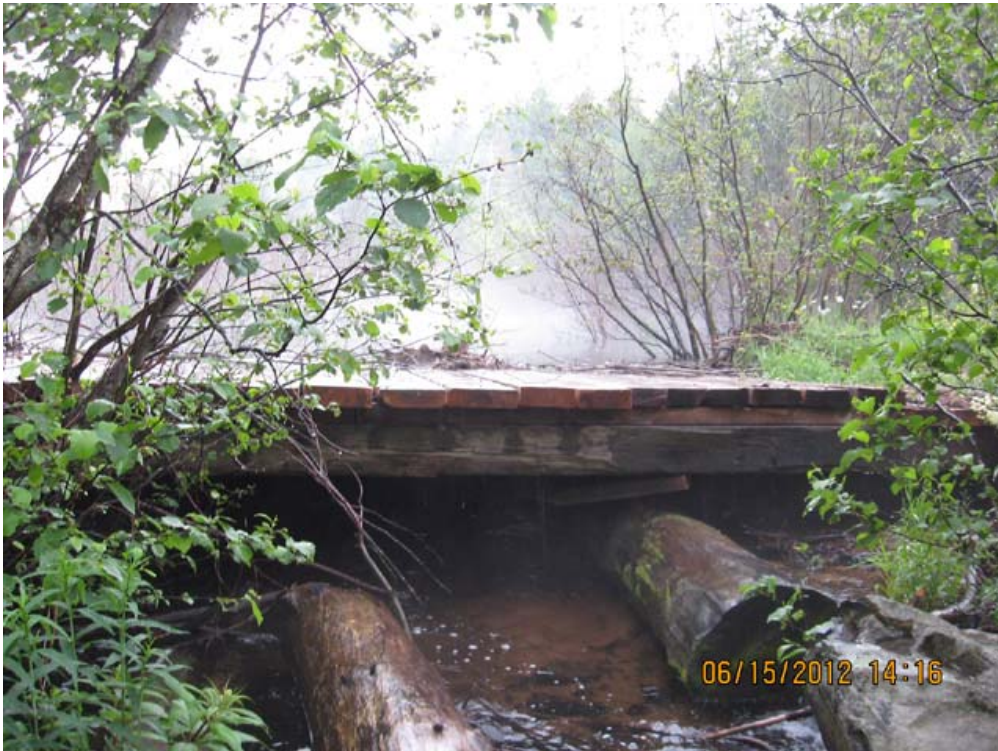
**Photograph C-1. Cedar Creek and beaver dam upstream of Northwestern Road. South View, June, 2012.**

Station 4 is located in Cedar Creek outside of the project area drainage basin. Consistent with the 2011 aquatic survey, a beaver dam was located immediately upstream of the Northwestern Road crossing (Photograph C-1). Because of high water conditions caused by beaver activity, the 2012 aquatic survey was conducted north (downstream) of Northwestern Road. In addition, because of a channel braiding that occurred throughout much of the station, adequate blocking with nets was not possible. Therefore, a single pass removal was conducted in Station 4. A total of 10 brook trout were collected from Station 4 in 2012 (Table 5-2) compared to a total of 44 that were collected in 2011. The fewer numbers of brook trout that were collected in 2012 were believed to be related to a malfunctioning of the electroshocking gear. Cedar Creek

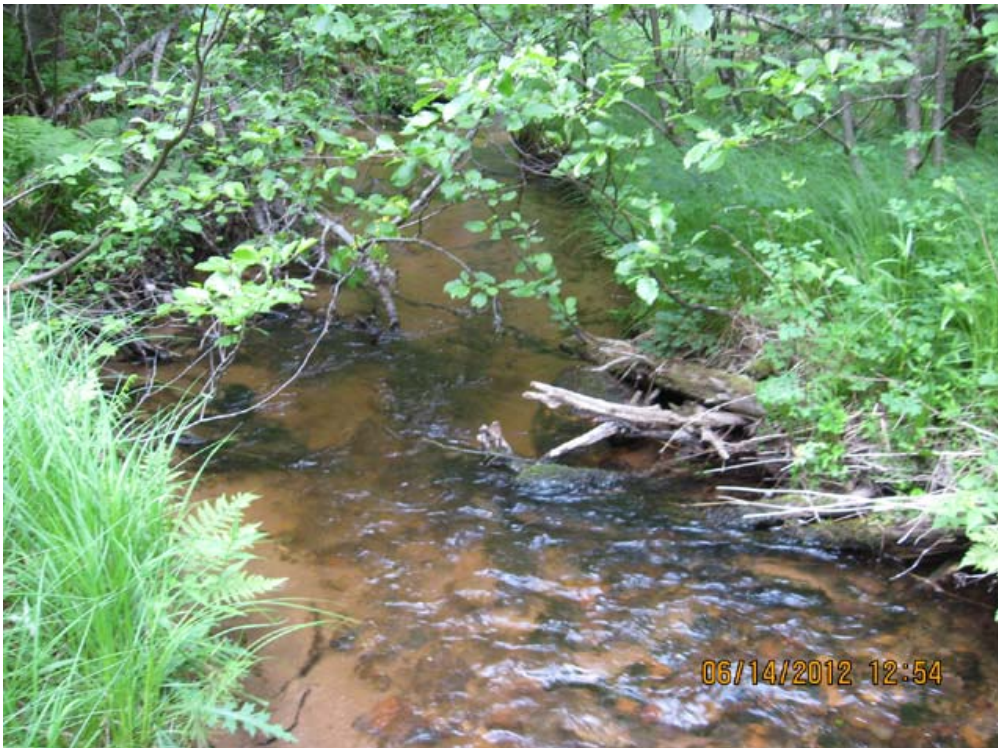
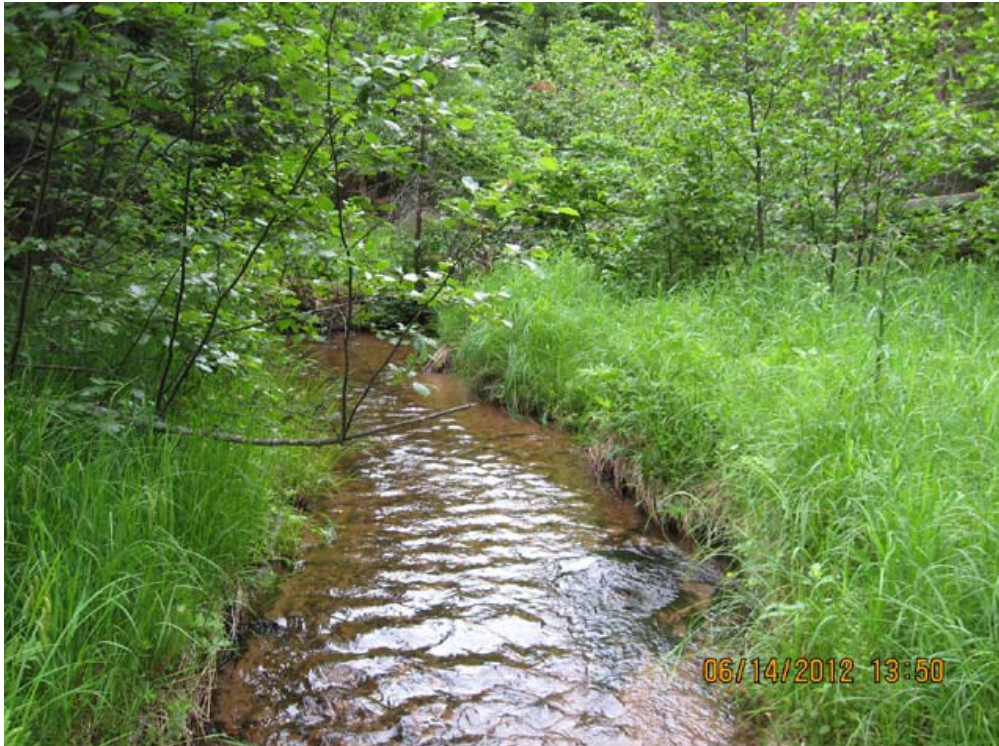
The streambanks of Station 1 appeared consistent with conditions observed in previous surveys, and were vegetated with herbaceous and woody vegetation (Photographs C-2 and C-3). The streambed was characterized by a relatively steep gradient and the substrate was comprised of a variety of particles including sand, gravel, cobble, and boulders (Photographs C-2 and C-3). Woody debris was frequently observed throughout the station and an additional large tree had fallen into the river approximately at the midpoint of Station 1 since the previous 2011 site visit and was functioning as additional woody debris (Photograph C-4).

**Photograph C-2. Station 1 – Upstream Extent North View, June, 2012.**

**Photograph C-3. Station 1 - Downstream Extent View South, June, 2012.**

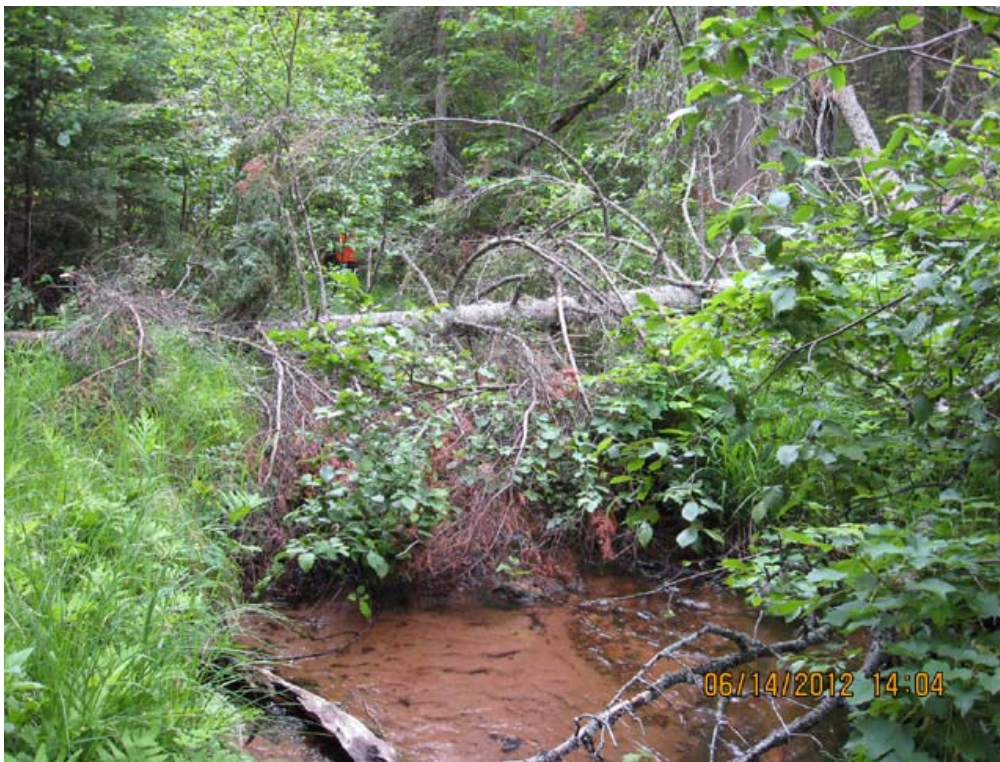
**Photograph C-4. Station 1 – Woody debris mid-reach extent View South, June, 2012.**

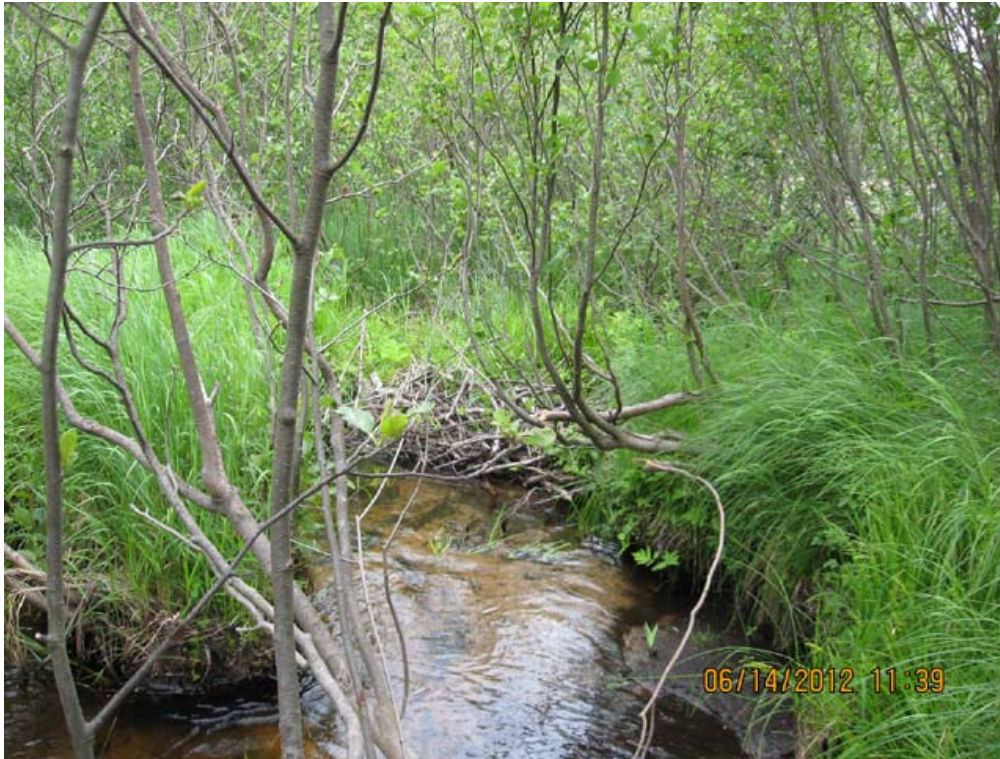
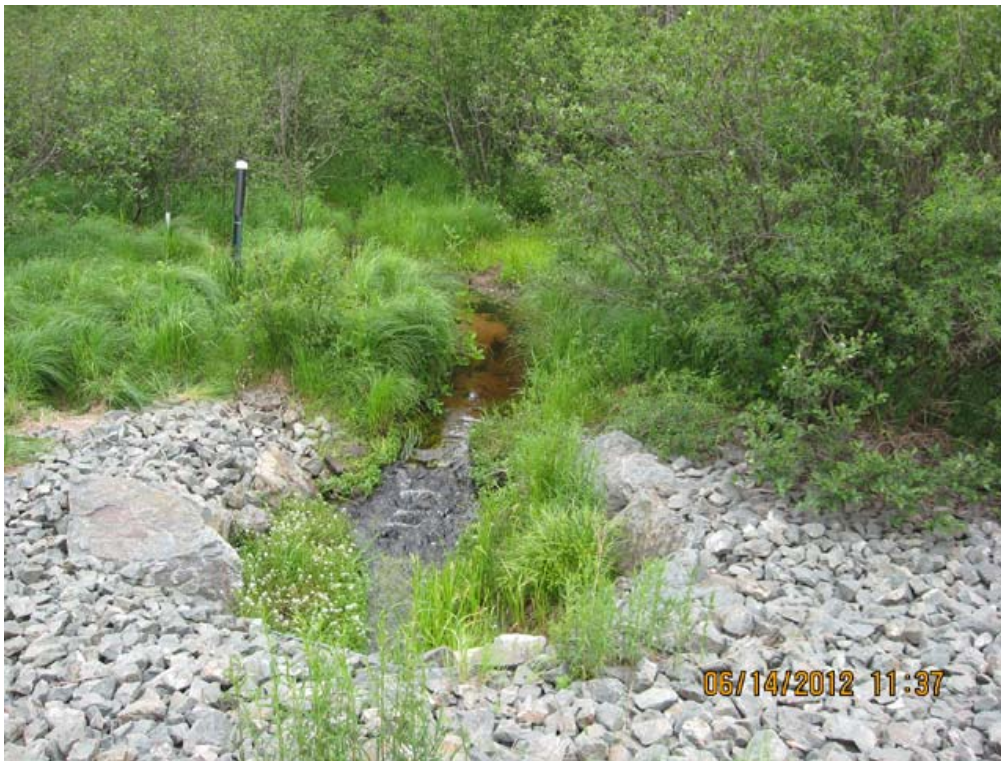
Station 2 was surrounded by an abundance of speckled alder (*Alnus rugosa*) and bluejoint grass (*Calamagrostis canadensis*, Photographs C-5 to C-6). Habitat conditions of Station 2 were consistent with 2011 observations. Evidence of beaver activity was present with the upstream extent of Station 2 and two partially constructed dams were present within the stream channel. Silt and organic matter appeared to be more abundant within the upstream extent of Station 2.

**Photograph C-5. Station 2 – Upstream Extent View North, June, 2012.**

**Photograph C-6. Station 2 – Downstream Extent View South, June, 2012.**

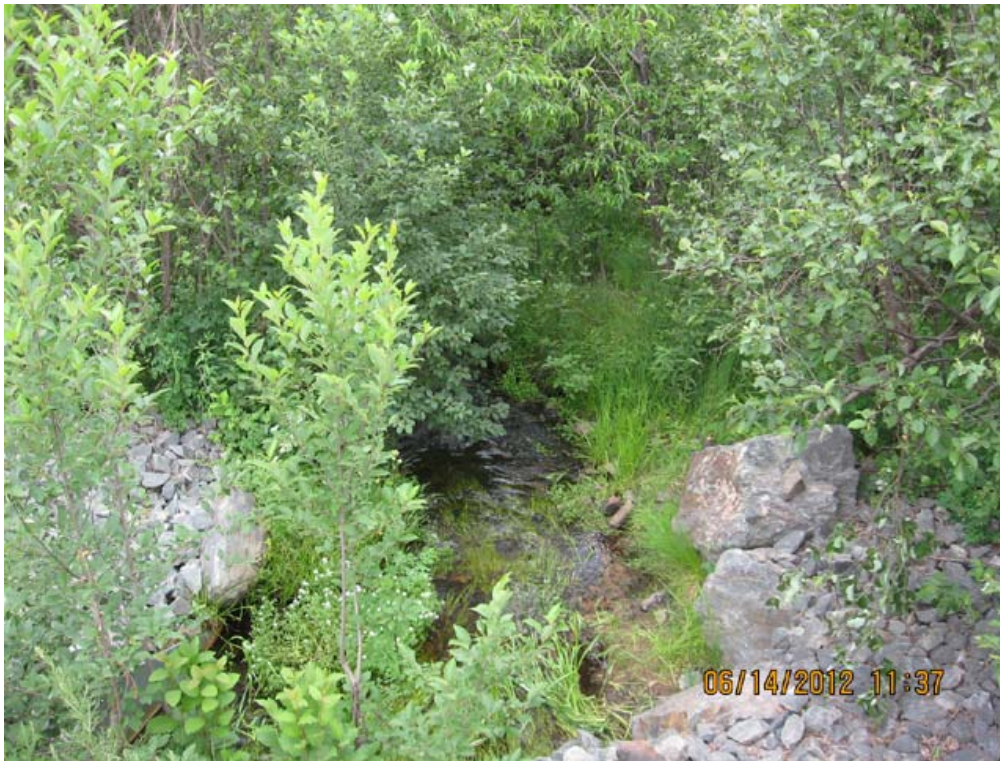
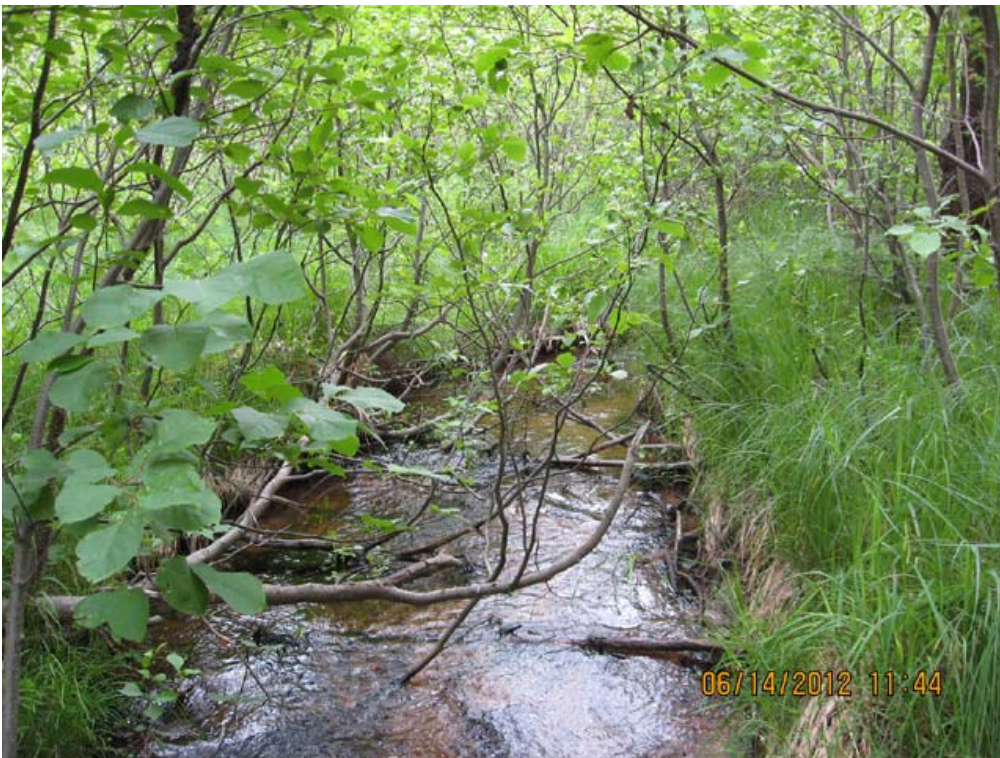
The streambank vegetation within Station 3 appeared similar to conditions observed in 2011. The vegetation within Station 3 was predominantly speckled alder with an understory of bluejoint grass and sedge (*Carex* sp., Photographs C-7 to C-8). Watercress (*Nasturtium* sp.) was present within portions of the stream channel of Station 3.

**Photograph C-7. Station 3 – Upstream Extent View North, June, 2012.**

**Photograph C-8. Station 3 –Downstream Extent View South, June, 2012.**

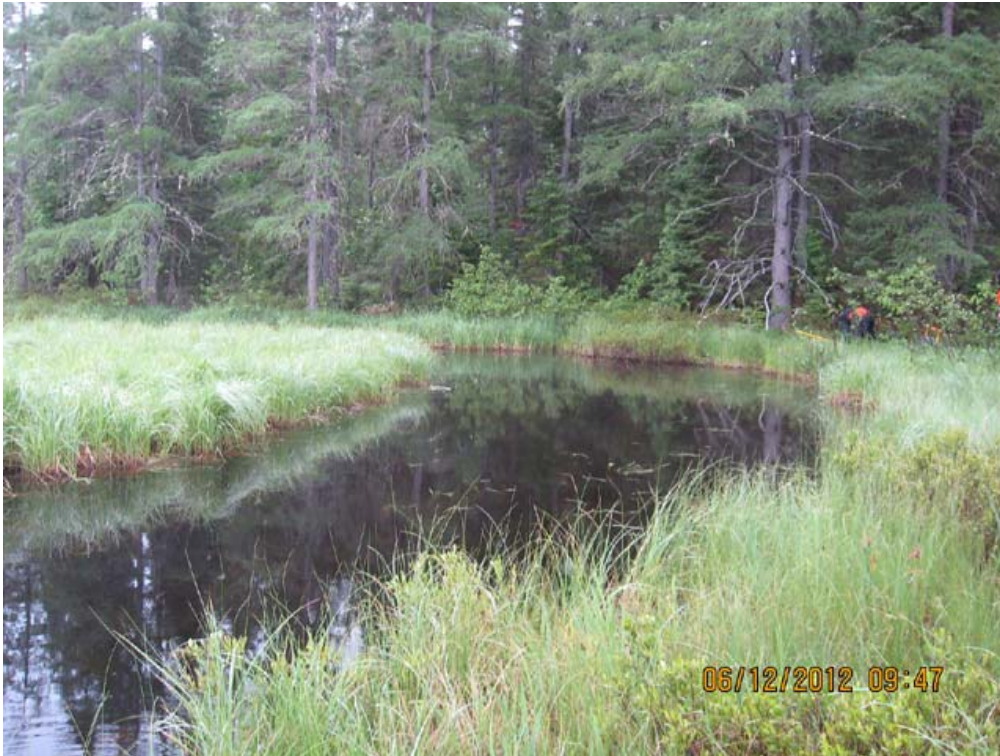
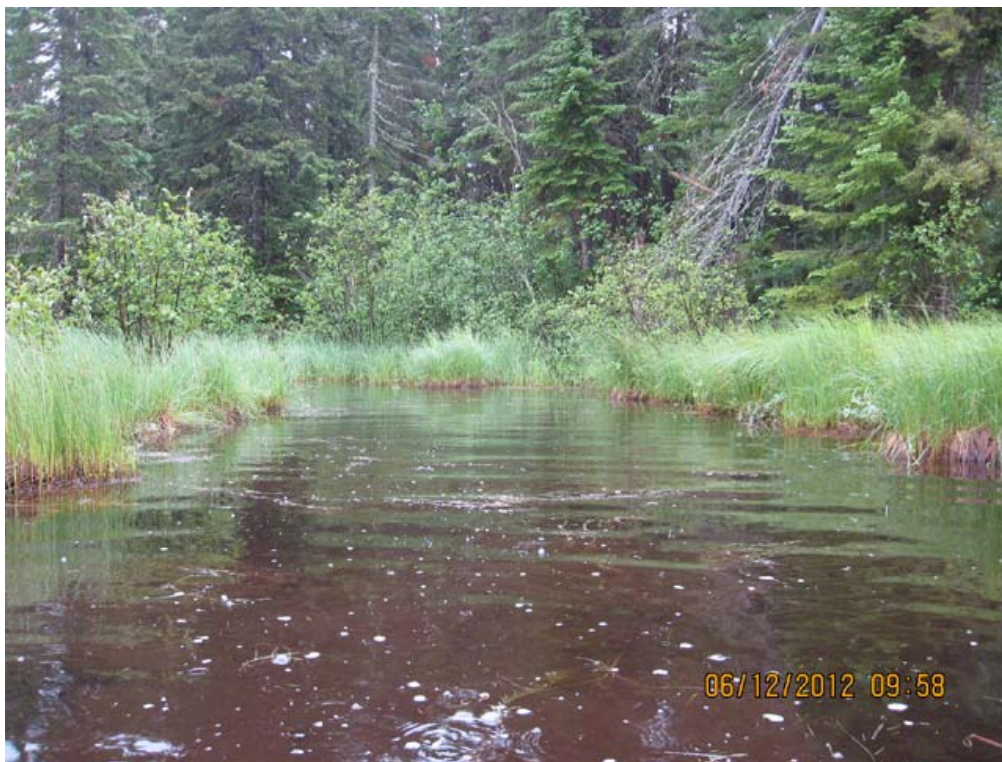
The streambanks in Station 6 appeared similar to conditions observed in 2011, and were characterized by tussock sedge (*Carex stricta*), iris (*Iris* sp.), rush (*Juncus* sp.), willows (*Salix* sp.) and speckled alder (Photographs C-9 to C-10). Much of the aquatic vegetation seen during the summer sampling event was growing on organic matter that appeared to function as a floating mat of vegetation. The substrate of Station 6 was predominantly comprised of organic matter and fine sediments, such as silt and clay. Woody debris was present throughout the stream channel.

**Photograph C-9. Station 6 – Upstream Extent View Southwest, June, 2012.**

**Photograph C-10. Station 6 – Downstream Extent View Southwest, June, 2012.**

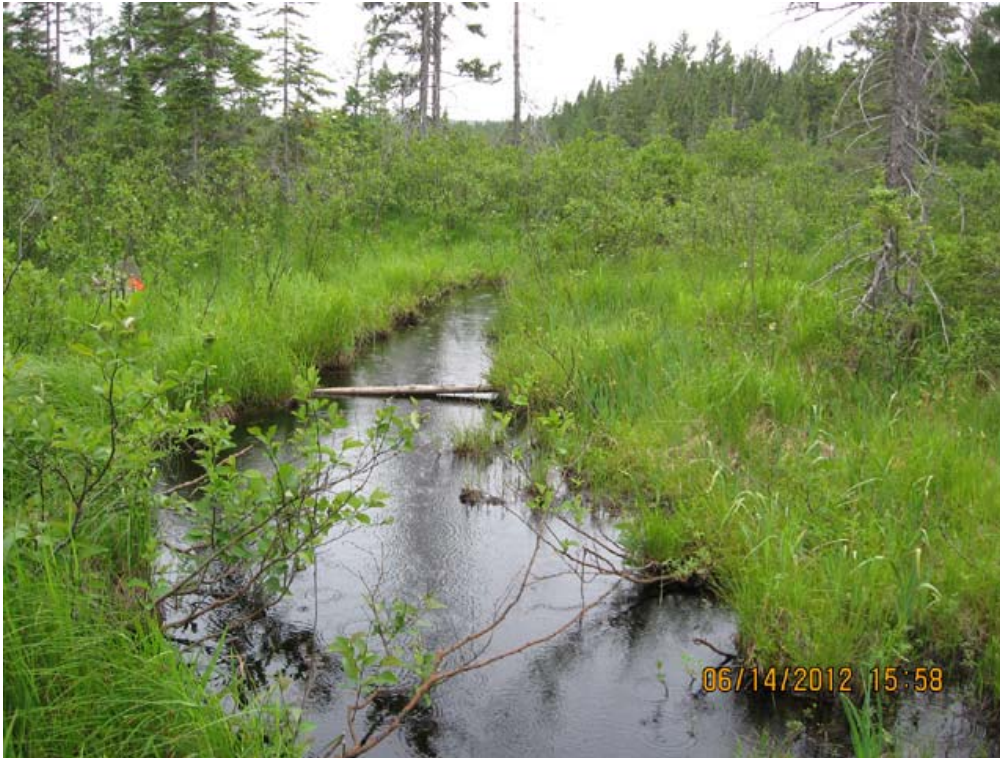
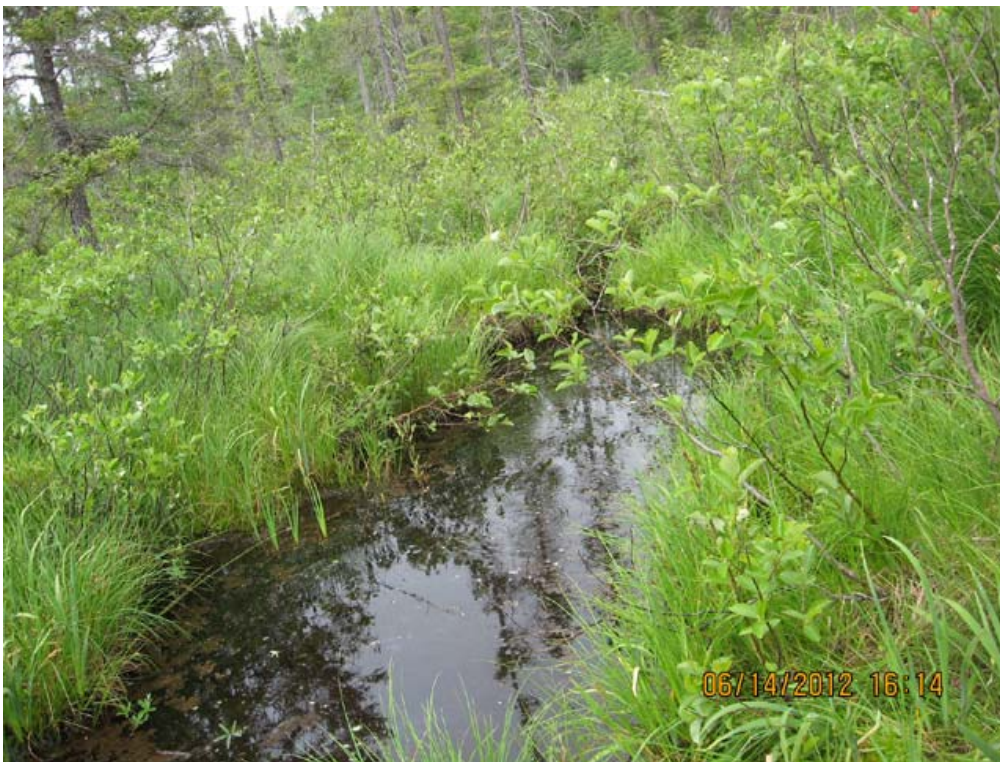
The streambanks of Station 7 were vegetated with speckled alder, tussock sedge, rush, and iris (Photographs C-11 and C-12), and appeared similar to conditions observed in 2011. The substrate was comprised of organic matter and silt. Woody debris was abundant throughout this station.

**Photograph C-11. Station 7 – Downstream Extent View Southwest, June, 2012.**

**Photograph C-12. Station 7 – Upstream Extent View North, June, 2012.**

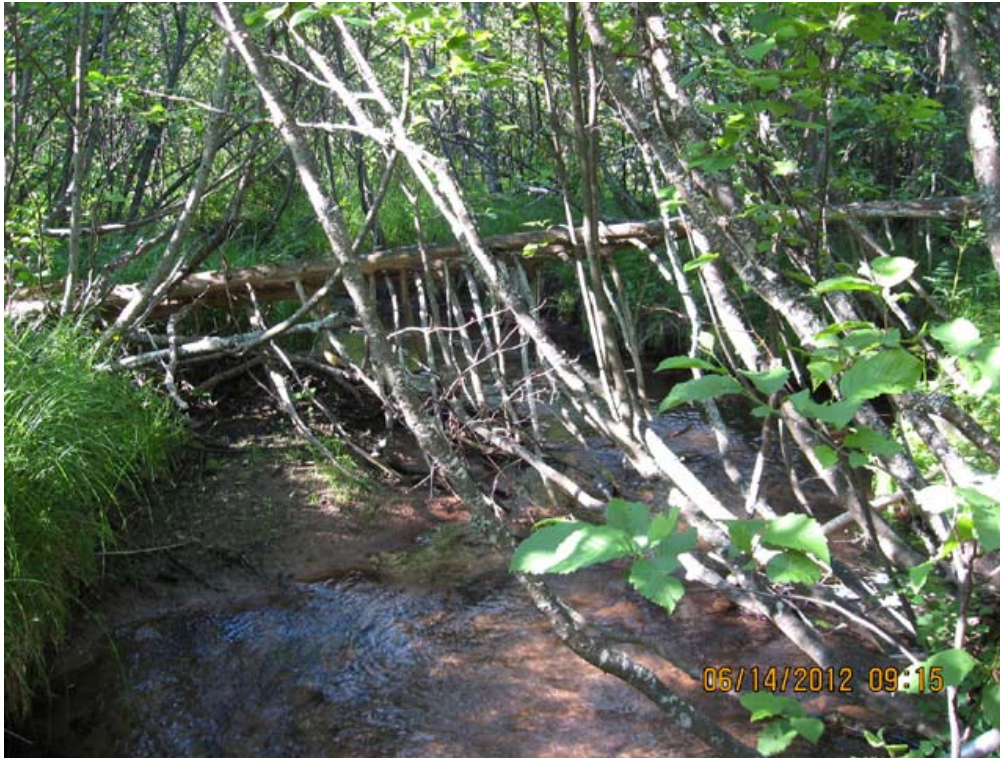
The stream channel of Station 8 was largely shaded by a dense canopy of speckled alder with an abundance of sedge growing along the streambank (Photograph C-13). Small woody debris and undercut banks were present throughout the station, and the stream substrate was predominantly comprised of sand and small gravel. A green-metal fence post was observed in the substrate of the stream channel at the upstream extent of Station 8 during the 2012 aquatic survey. The fence post appeared to be indicative of other ongoing aquatic surveys that may be taking place within the Station 8 vicinity.

**Photograph C-13. Station 8 – Downstream Extent View South, June, 2012.**

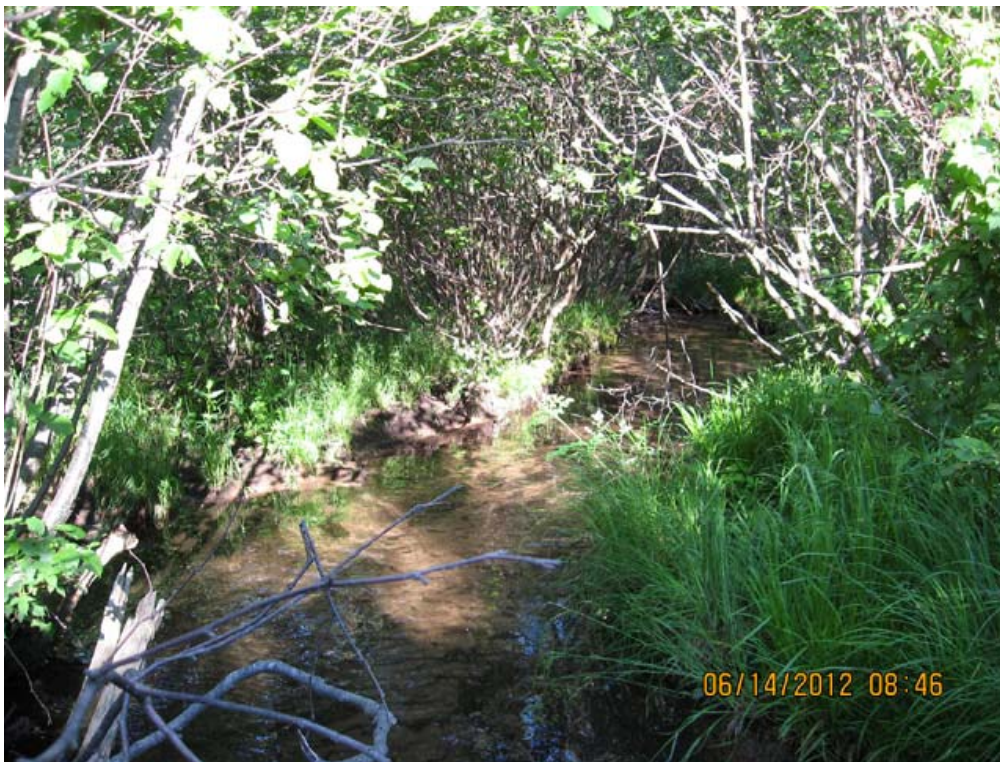
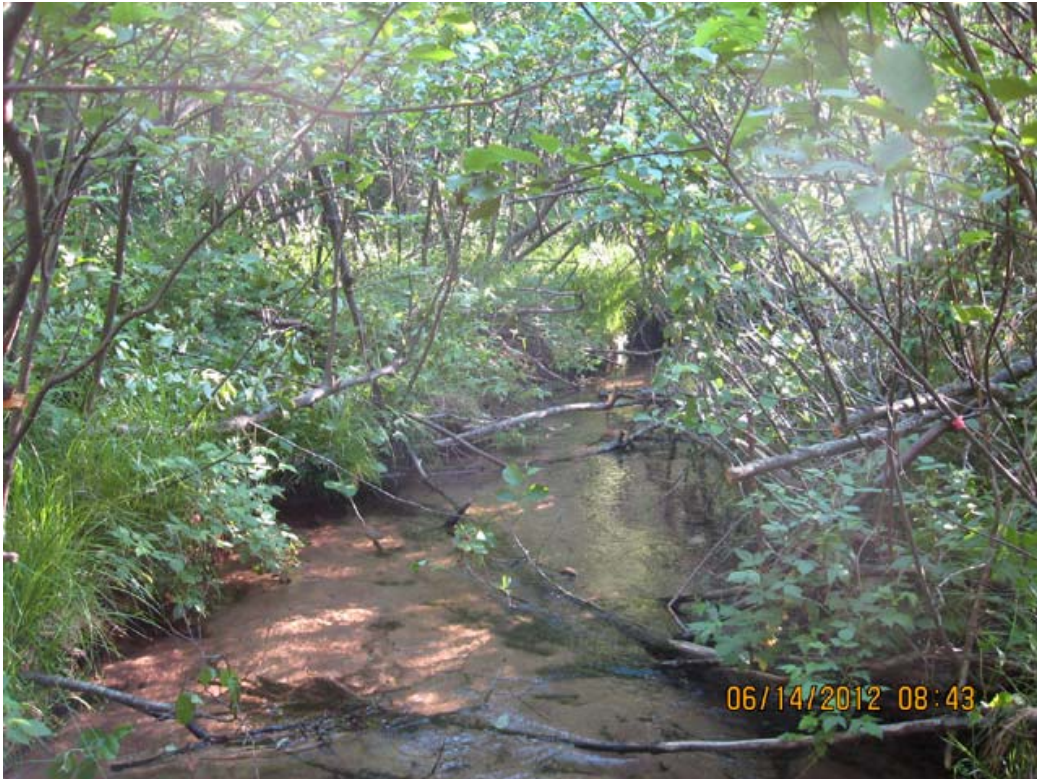
Habitat conditions within Station 9 generally appeared similar to conditions observed in 2011 except for the downstream extent of the station where a green-metal fence post was observed in the substrate of the stream channel, and at the upstream extent of the station where numerous speckled alders had been removed. The understory of Station 9 was predominately sedge, while speckled alder covered much of the stream channel and contributed to in-stream cover (Photographs C-14 to C-15). The substrate was predominantly comprised of sand and silt.

**Photograph C-14. Station 9 – Downstream Extent View Southwest, June, 2012.**

**Photograph C-15. Station 9 – Upstream Extent View Northeast, June, 2012.**

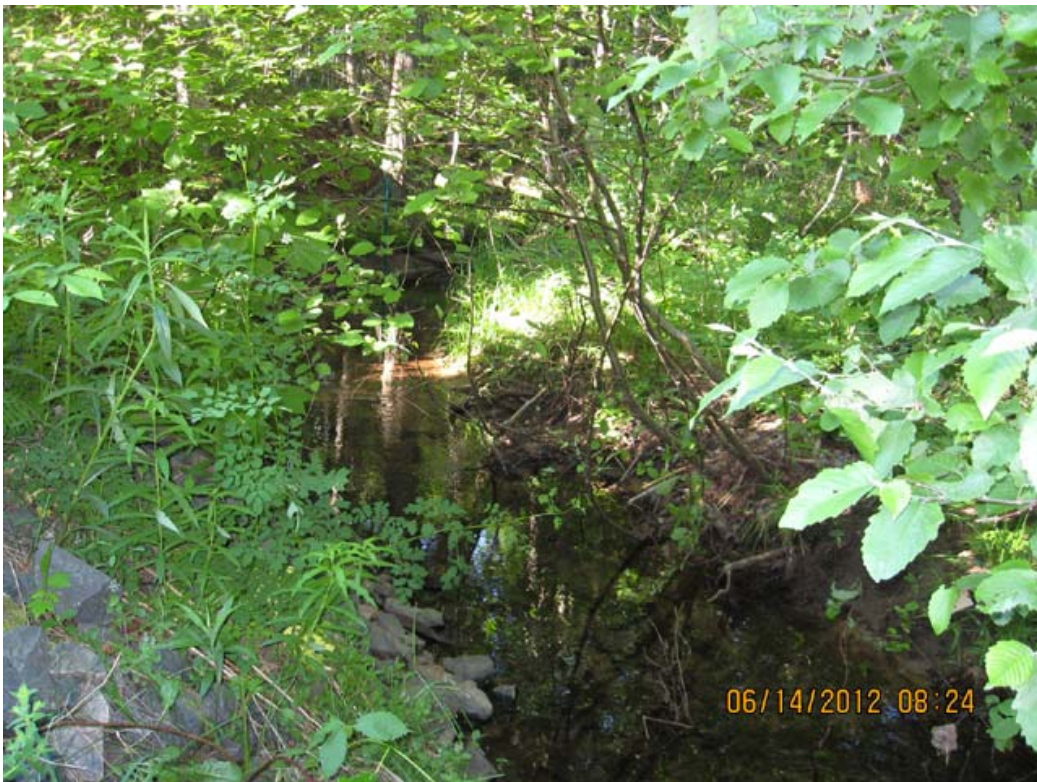
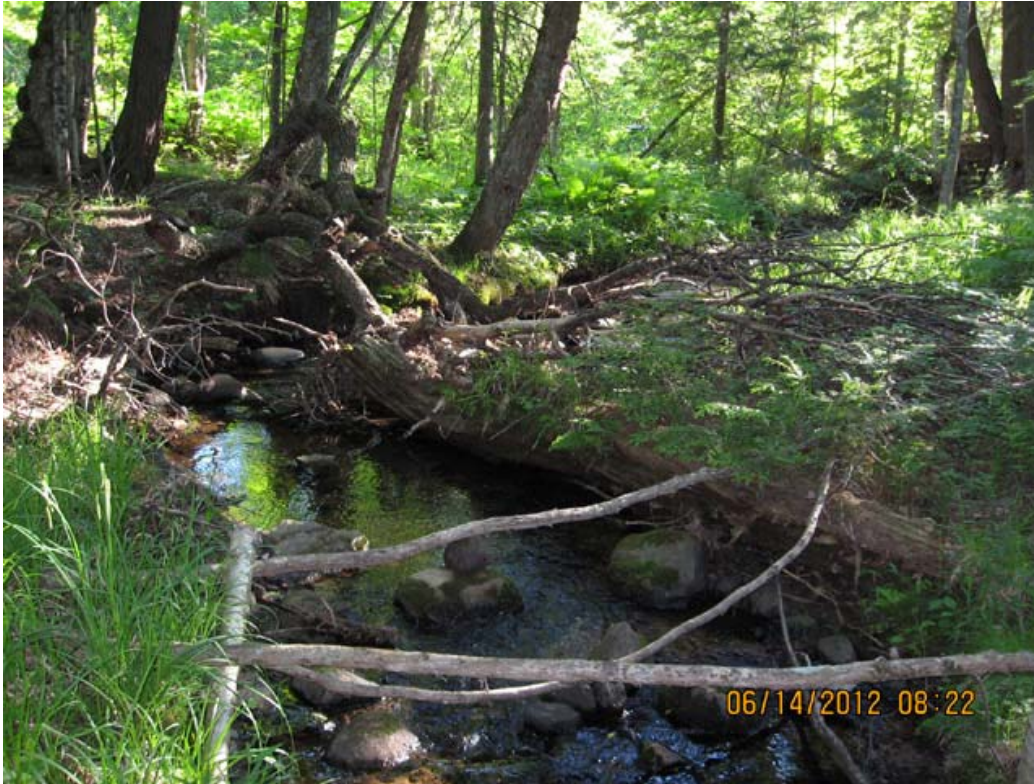
The streambanks within Station 10 were vegetated with large deciduous trees, speckled alder, and other herbaceous vegetation (Photographs C-16 and C-17), and appeared similar to conditions observed in 2011. Woody debris and undercut banks provided in-stream cover throughout this station. The substrate was predominantly comprised of sand, silt and some gravel; although cobble and large boulders were also present (Photographs C-16 and C-17). A green-metal fence post was observed in the substrate

of the stream channel and at the downstream extent of the station and was not observed in the 2011 aquatic survey.

**Photograph C-16. Station 10 – Downstream Extent View Southwest, June, 2012.**

**Photograph C-17. Station 10 – Upstream Extent View Northeast, June, 2012.**

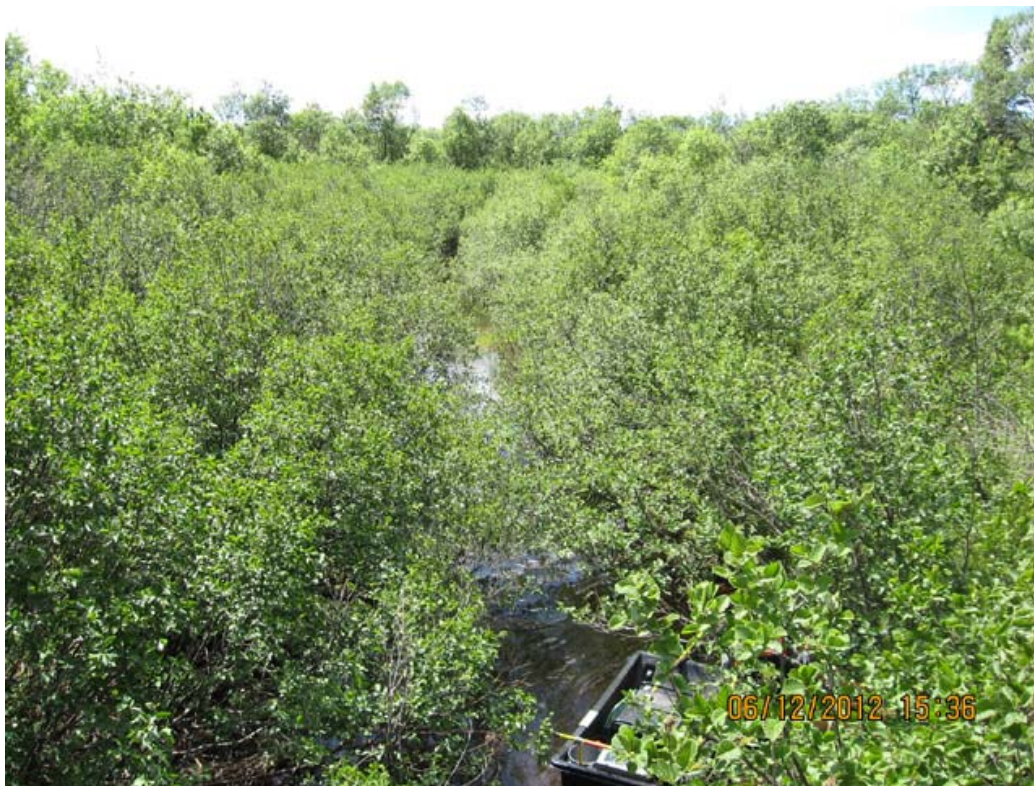
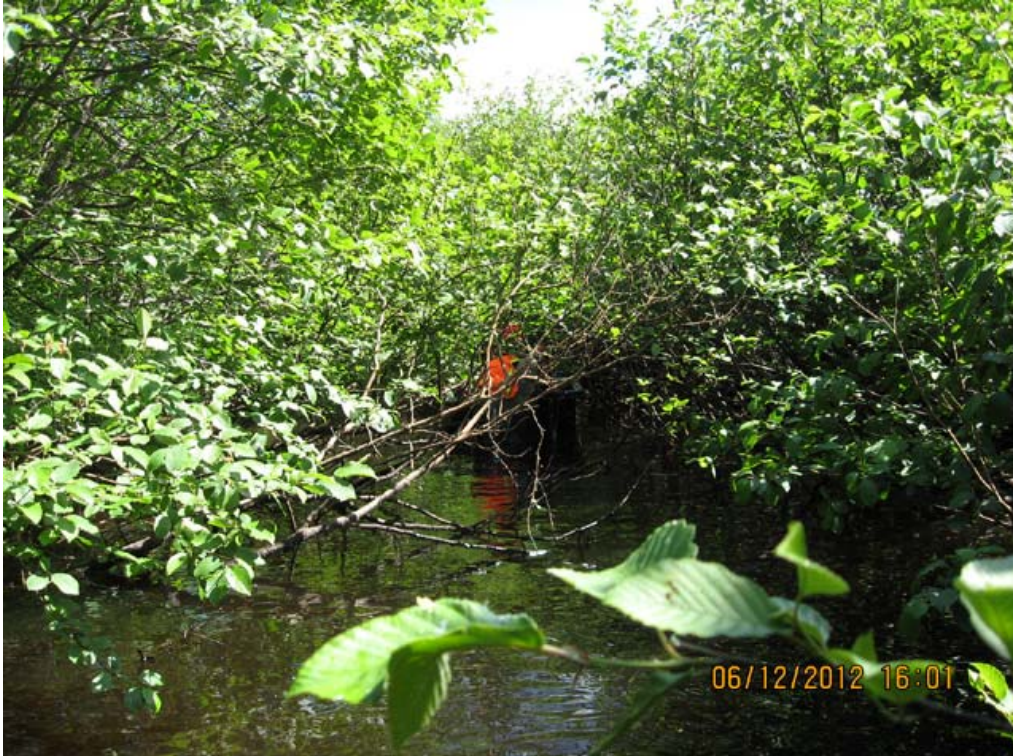
Streambanks appeared consistent with the 2011 survey and were vegetated with a dense covering of speckled alder, which contributed to in-stream cover and woody debris within the channel (Photographs C-18 to C-19). The substrate was predominantly comprised of sand and silt.

**Photograph C-18. Station 5 – Downstream Extent View West, June, 2012.**

**Photograph C-19. Station 5 – Upstream Extent View East, June, 2012.**

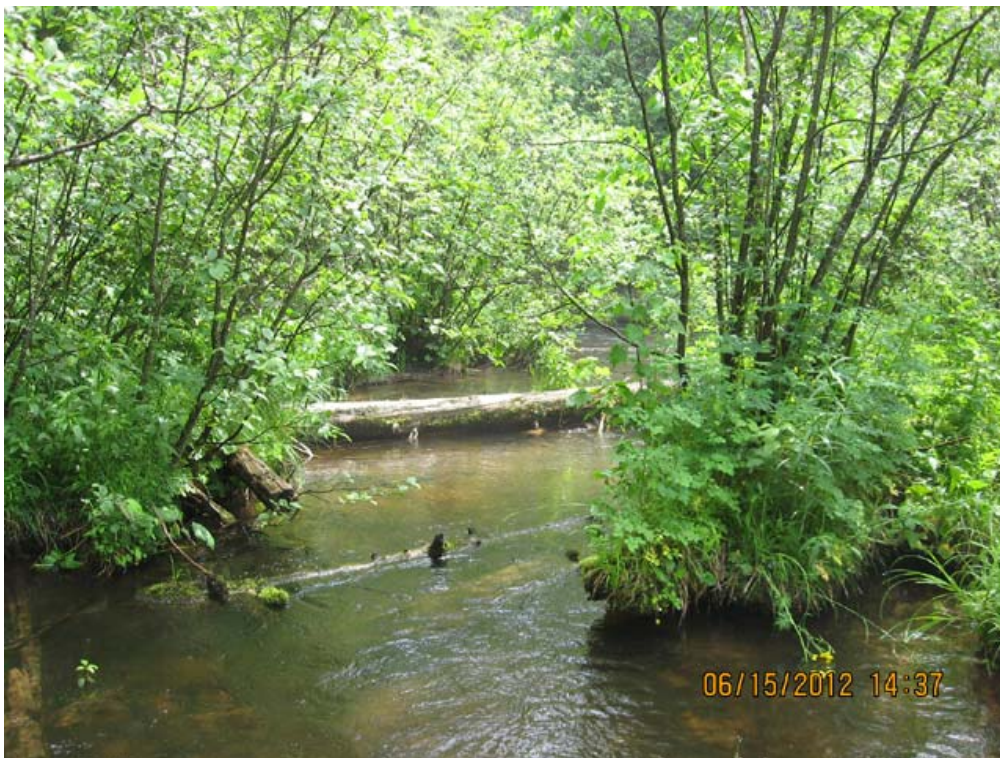
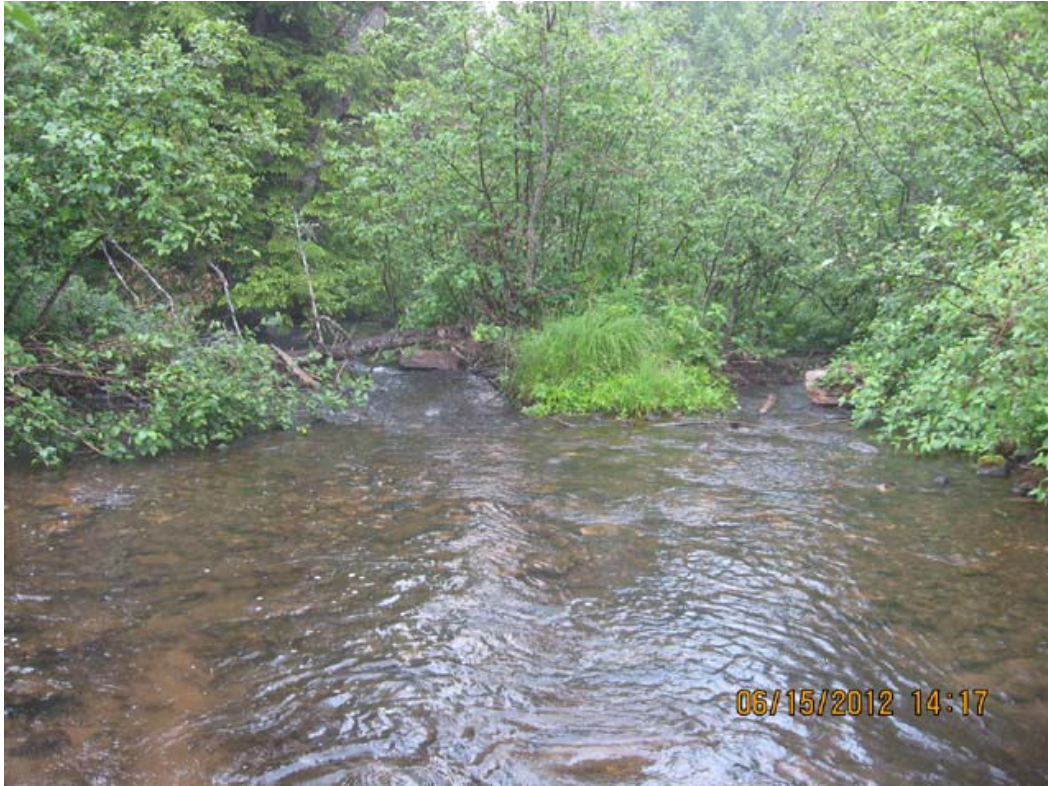
The riparian vegetation throughout much of the relocated Station 4 was mature northern white cedars (*Thuja occidentalis*), and white pines (*Pinus strobus*). Speckled alder was also present along the stream channel in the upstream and downstream extents of the station (Photographs C-20 and C-21). The river channel was braided throughout the middle portion of the station, with frequent undercut banks, large woody debris and variety of substrate, including sand, gravel, cobble and boulders contributing to habitat complexity.

**Photograph C-20. Station 4 – Downstream Extent View South, June, 2012.**

**Photograph C-21. Station 4 – Upstream Extent View North, June, 2012.**
