Investigation of the Aquatic Communities of the Salmon Trout River, Yellow Dog River, and Cedar Creek in Marquette County, Michigan, 2013.

December 15, 2013

Eagle Mine

**ADVANCED ECOLOGICAL MANAGEMENT
22071 7 Mile Road
Reed City, MI 49677**

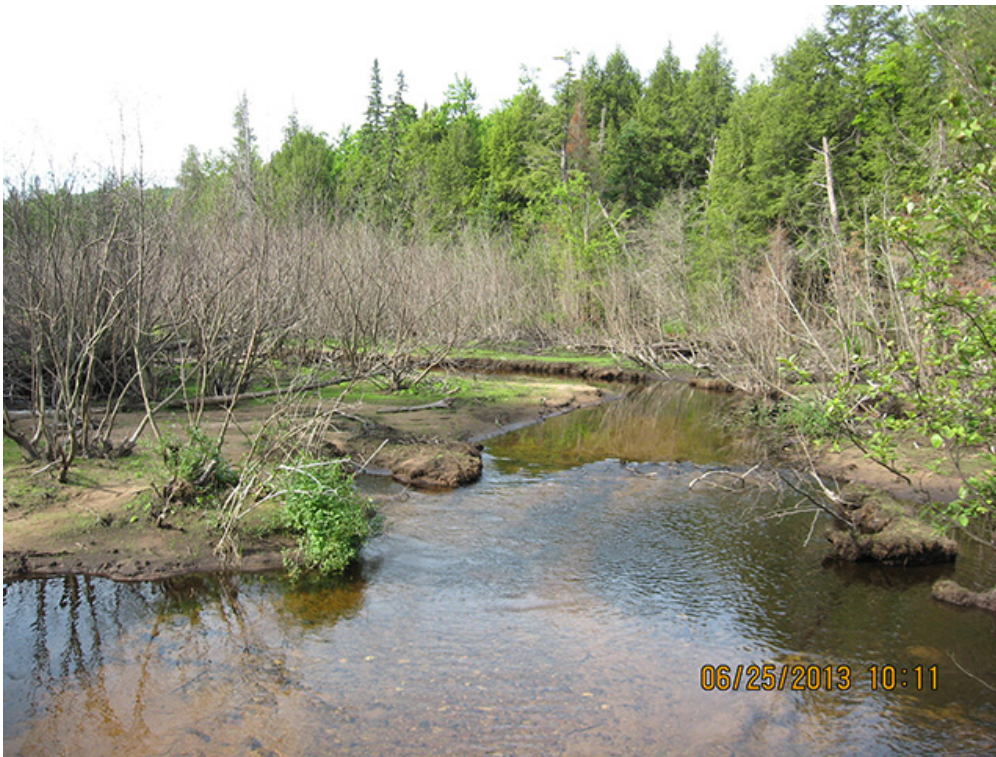
Photograph C-1. Cedar Creek upstream of Northwestern Road. South View, June, 2013.

2011 and 2012 aquatic surveys and prohibited the aquatic survey in the location that was originally established for this project. The beaver dam was removed sometime prior to the 2013 aquatic survey, (Photograph C-1). Because of high water conditions caused by beaver activity, the 2011 and 2012 aquatic surveys were conducted north (downstream) of Northwestern Road. Although the beaver dam was removed prior to the 2013 aquatic survey, which permitted access to the original Station 4 survey location for project, the 2013 survey was conducted in the same location as the 2011 and 2012 surveys to maintain consistency with recent surveys. In addition, because of a channel braiding that occurred throughout much of the station, adequate blocking with nets was not possible. Therefore, a single pass removal was conducted in Station 4.

The beaver dam located upstream of Northwestern Road appeared to have recently been removed from Cedar Creek prior to the 2013 aquatic survey. Habitat complexity in the upstream portion of Station 4 was probably temporarily affected by the removal of the beaver dam. Sand and silt presumably from the upstream section affected by the beaver dam, appeared to have filled in some of the small pools at the upstream extent of the station.

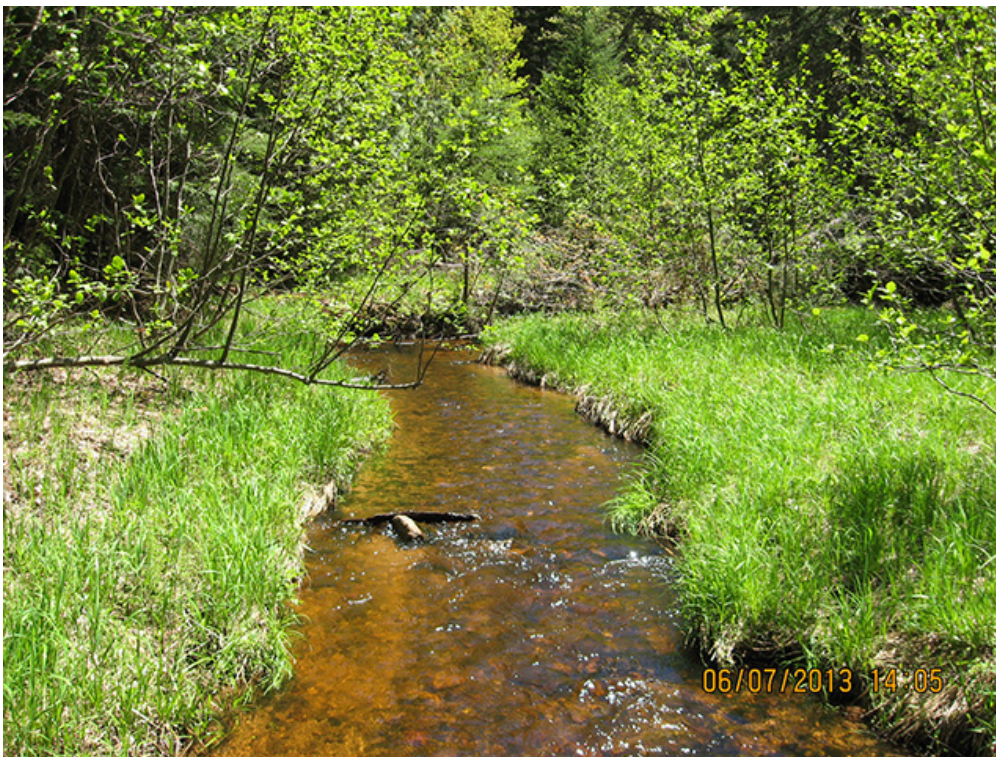
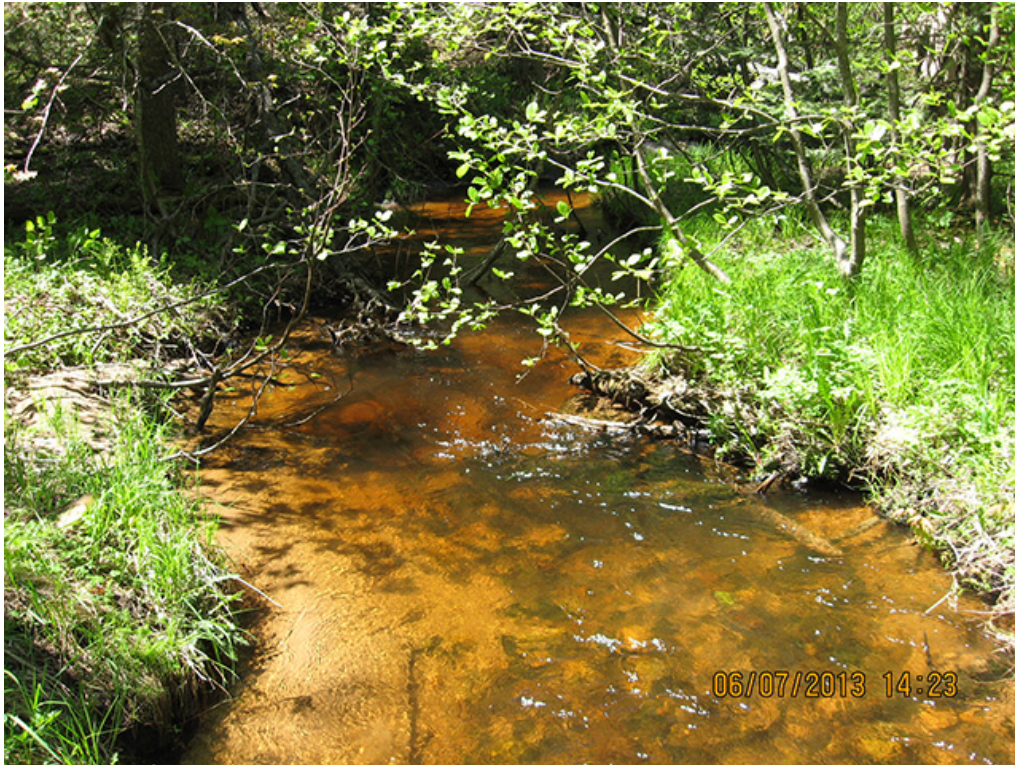
The streambanks of Station 1 appeared consistent with conditions observed in previous surveys, and were vegetated with herbaceous and woody vegetation (Photographs C-2 and C-3). The streambed was characterized by a relatively steep gradient and the substrate was comprised of a variety of particles including sand, gravel, cobble, and boulders (Photographs C-2 and C-3). Woody debris was frequently observed throughout the station and appeared consistent with conditions observed in 2012.

Photograph C-2. Station 1 – Downstream Extent South View, June, 2013.

Photograph C-3. Station 1 - Upstream Extent View North, June, 2013.

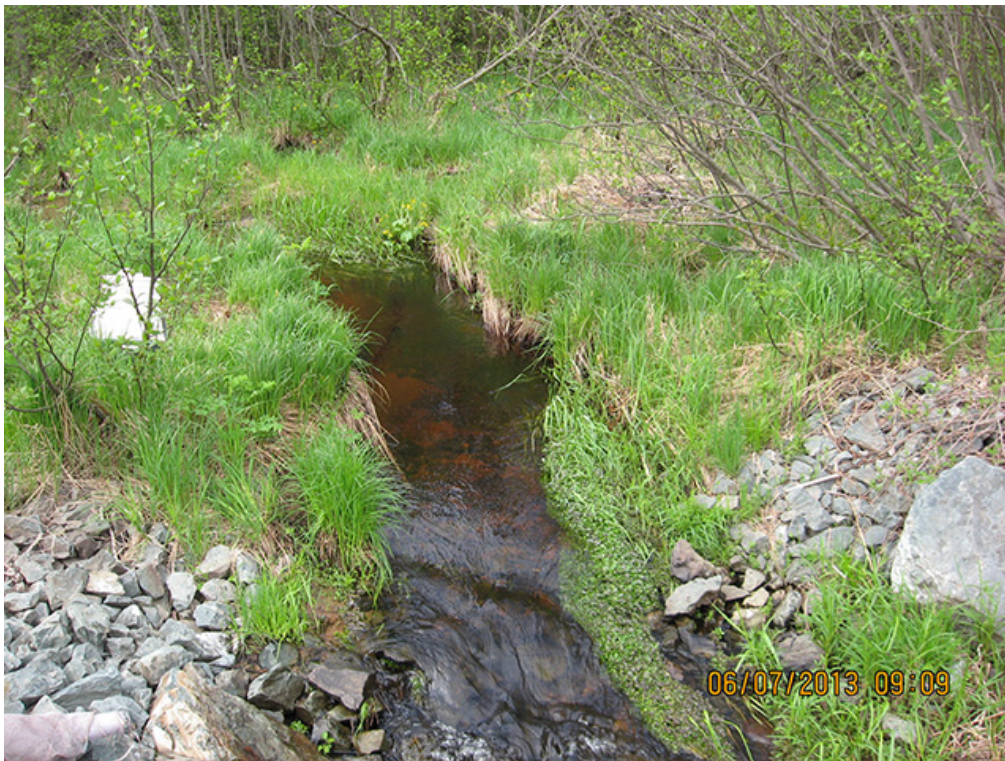
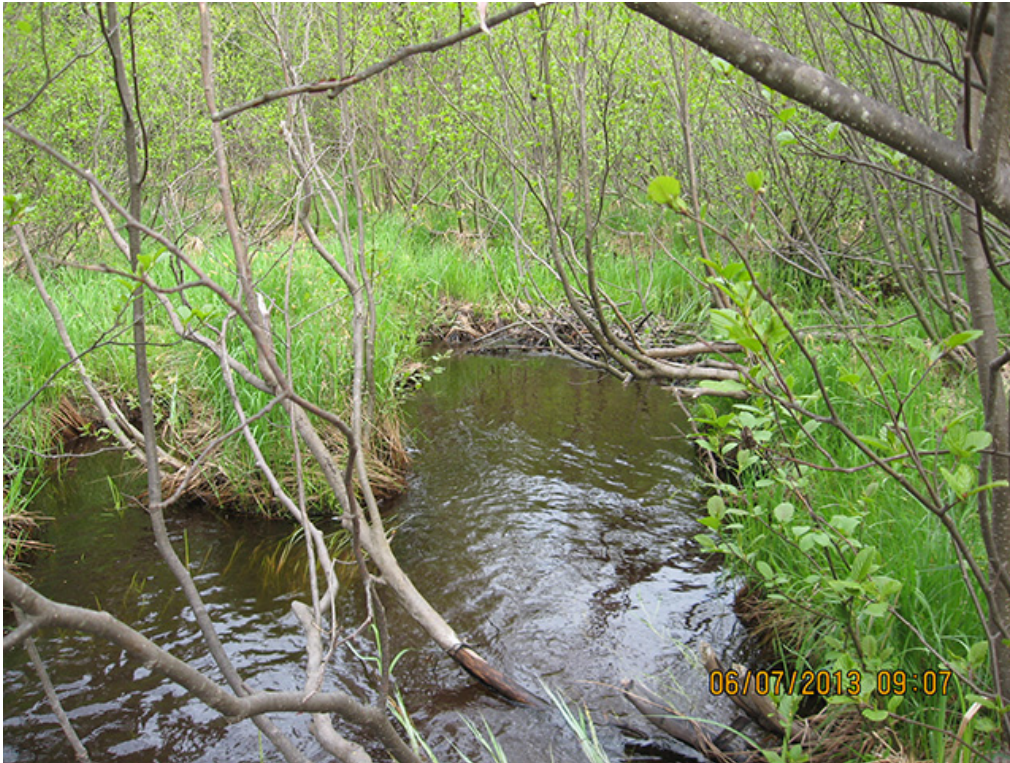
Station 2 was surrounded by an abundance of speckled alder (*Alnus rugosa*) and bluejoint grass (*Calamagrostis canadensis*, Photographs C-4 to C-5). Habitat conditions of Station 2 were consistent with 2012 observations. Evidence of beaver activity was present with the upstream extent of Station 2 and two partially constructed dams were

present within the stream channel. Silt and organic matter appeared to be more abundant within the upstream extent of Station 2.

Photograph C-4. Station 2 – Downstream Extent View South, June, 2013.

Photograph C-5. Station 2 – Upstream Extent View Northwest, June, 2013.

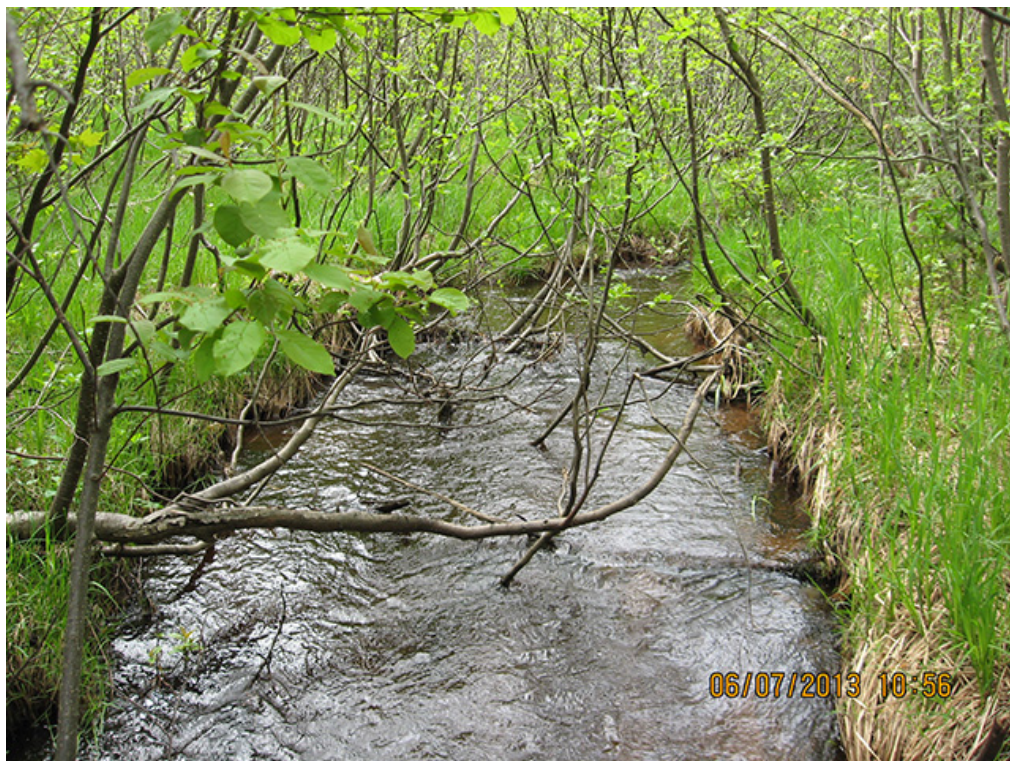
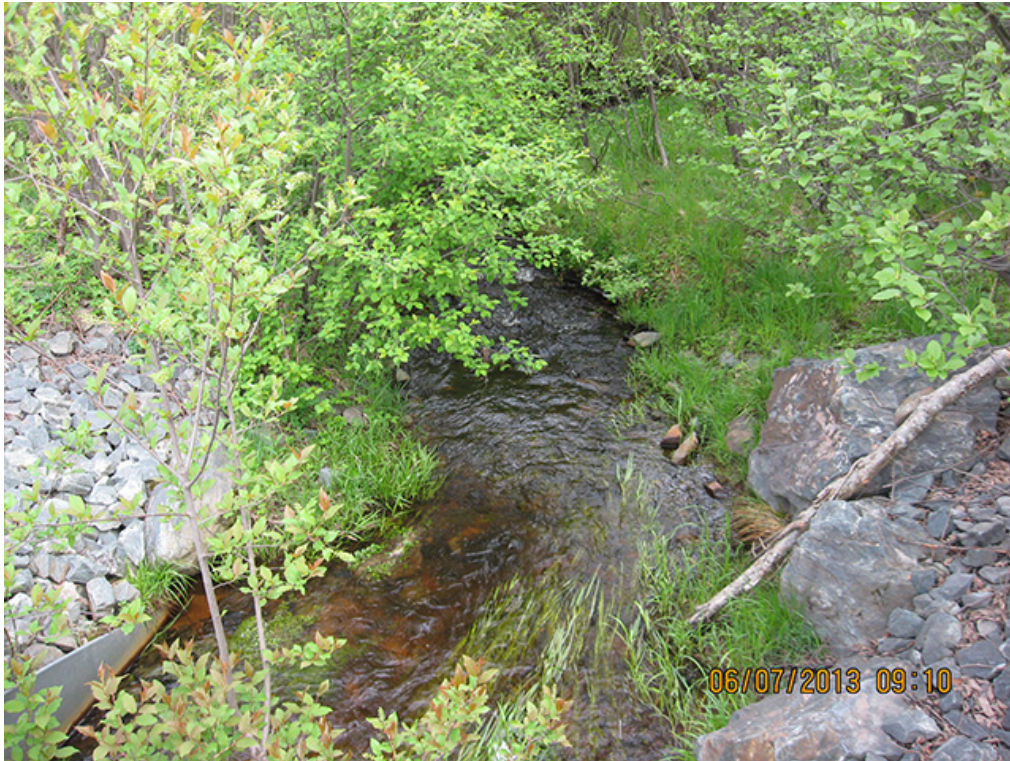
The streambank vegetation within Station 3 appeared similar to conditions observed in 2012. The vegetation within Station 3 was predominantly speckled alder with an understory of bluejoint grass and sedge (*Carex* sp., Photographs C-6 to C-7). Watercress (*Nasturtium* sp.) was present within portions of the stream channel of Station 3.

Photograph C-6. Station 3 – Downstream Extent View South, June, 2013.

Photograph C-7. Station 3 –Upstream Extent View North, June, 2013.

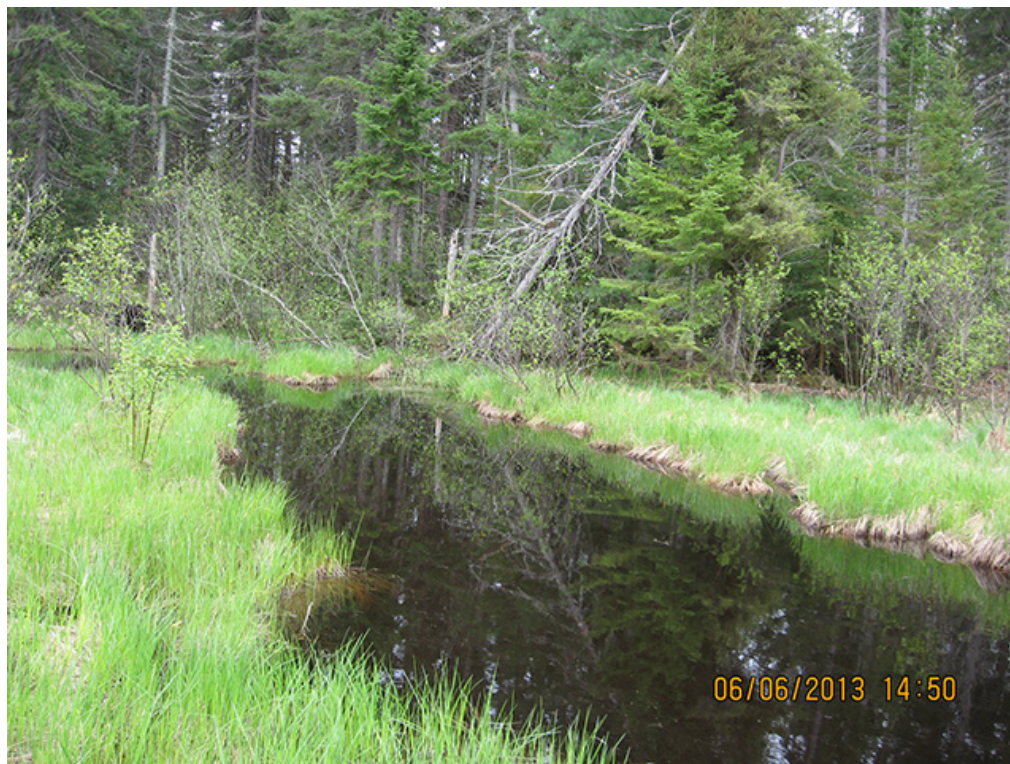
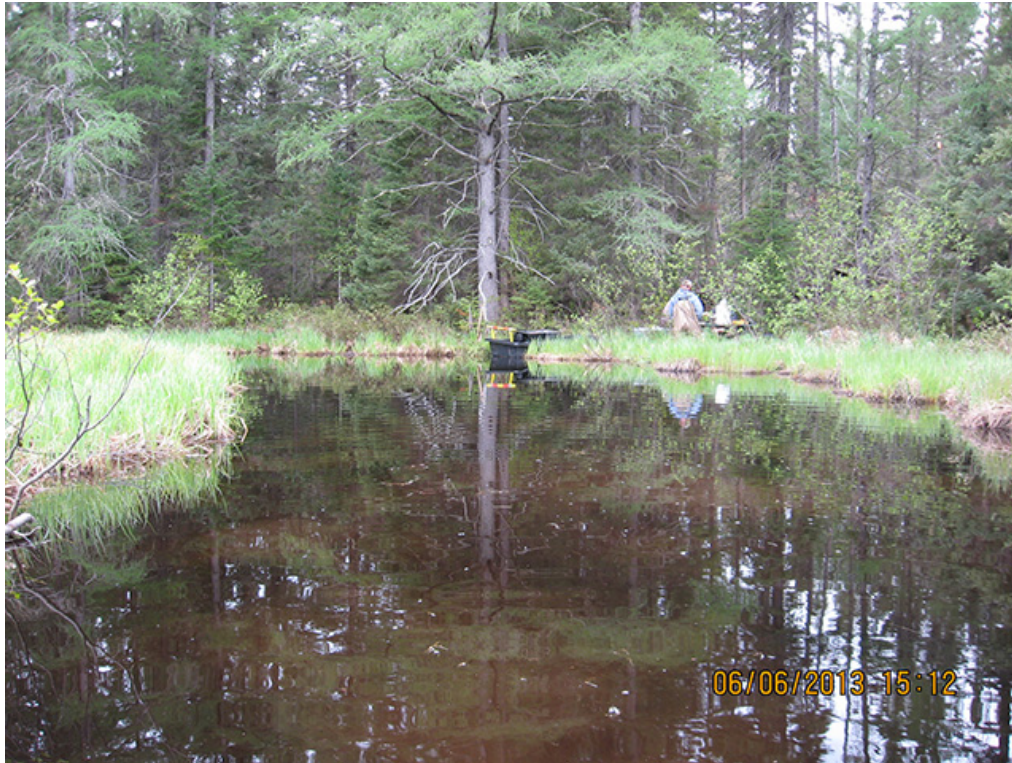
The streambanks in Station 6 appeared similar to conditions observed in 2012, and were characterized by tussock sedge (*Carex stricta*), iris (*Iris* sp.), rush (*Juncus* sp.), willows (*Salix* sp.) and speckled alder (Photographs C-8 to C-9). Much of the aquatic vegetation seen during the summer sampling event was growing on organic matter that appeared to function as a floating mat of vegetation. The substrate of Station 6 was predominantly comprised of organic matter and fine sediments, such as silt and clay. Woody debris was present throughout the stream channel.

Photograph C-8. Station 6 – Downstream Extent View South, June, 2013.

Photograph C-9. Station 6 – Upstream Extent View Southwest, June, 2013.

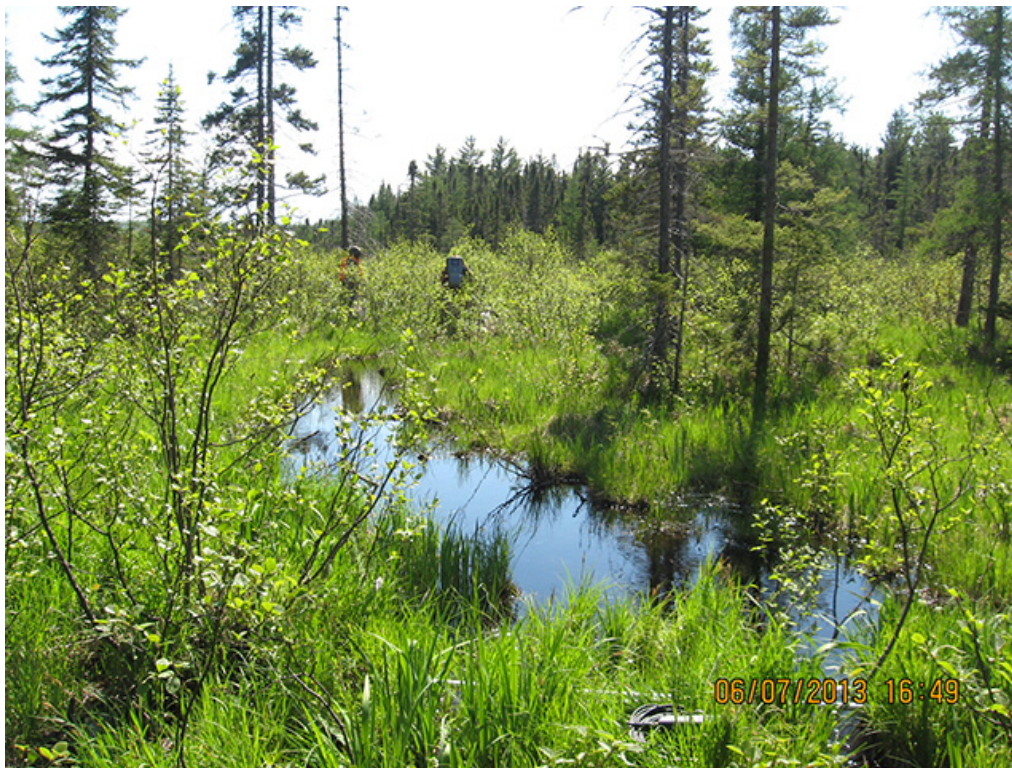
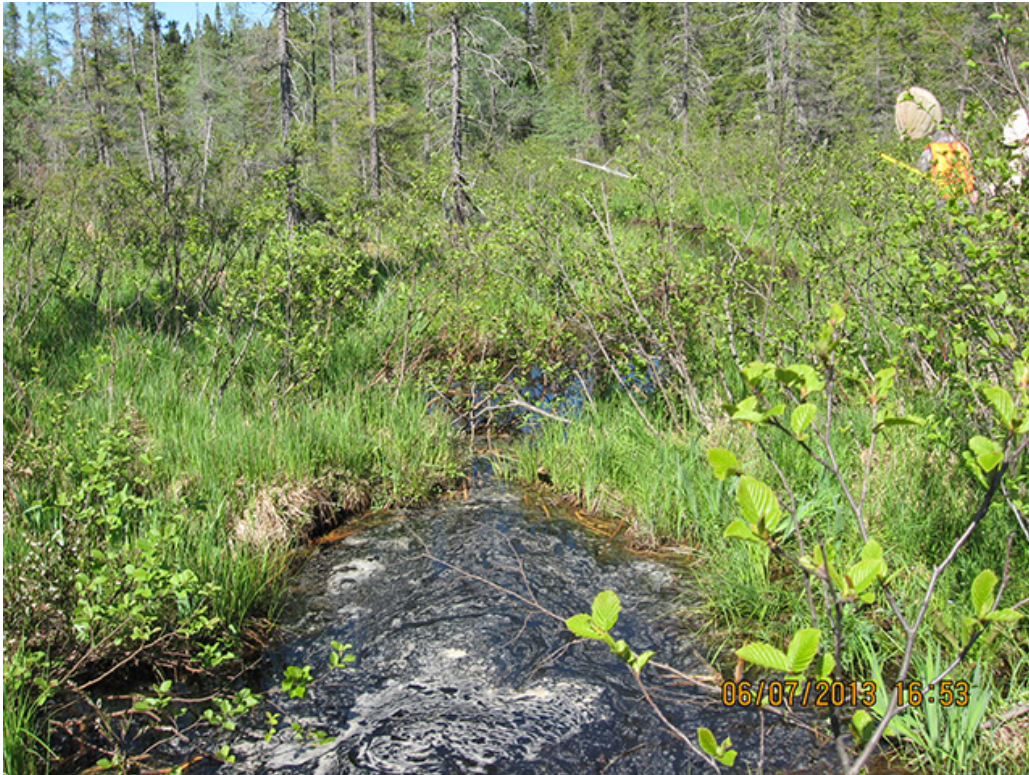
The streambanks of Station 7 were vegetated with speckled alder, tussock sedge, rush, and iris (Photographs C-10 and C-11), and appeared similar to conditions observed in 2012. The substrate was comprised of organic matter and silt. Woody debris was abundant throughout this station.

Photograph C-10. Station 7 – Downstream Extent View Southwest, June, 2013.

Photograph C-11. Station 7 – Upstream Extent View North, June, 2013.

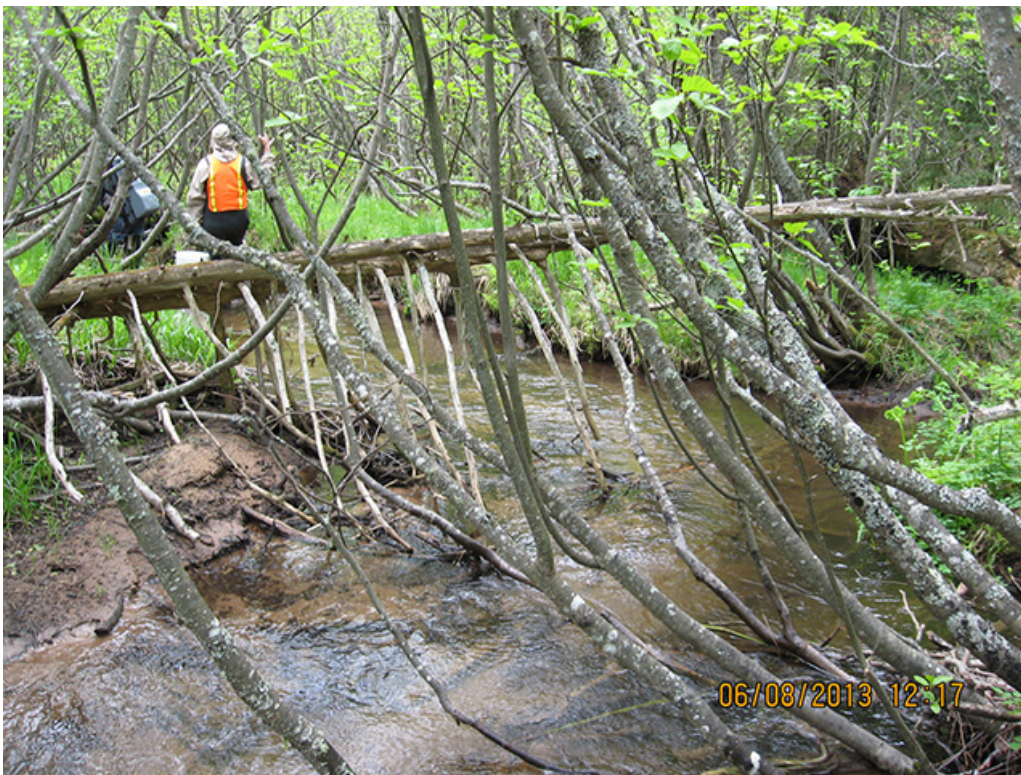
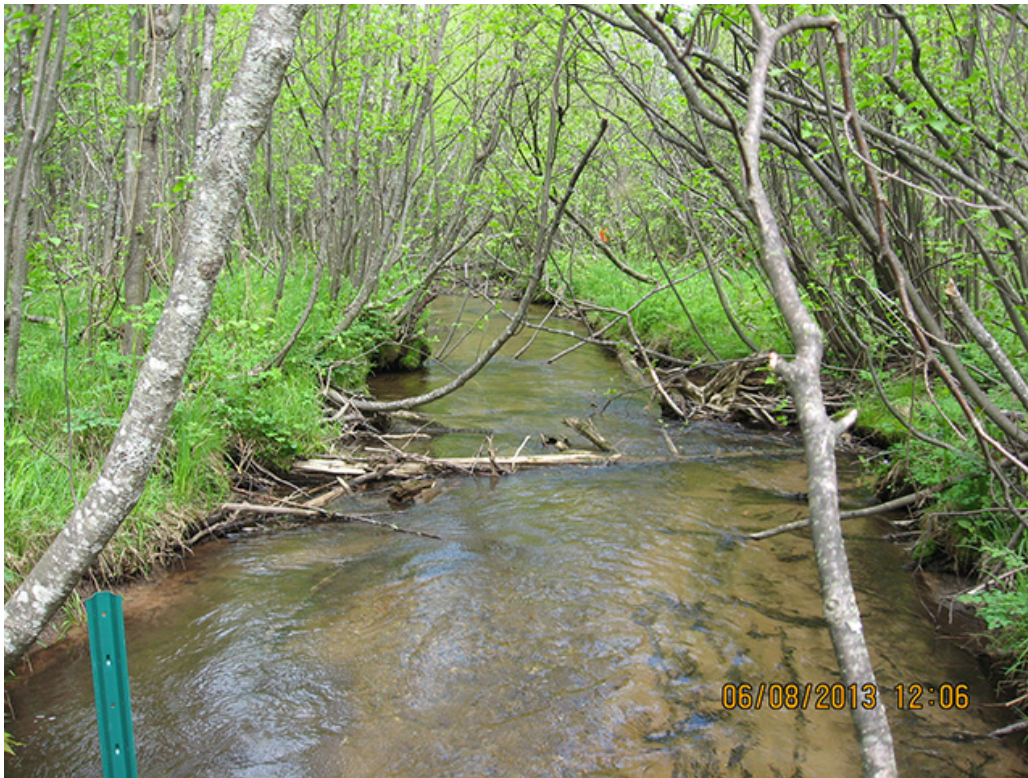
The stream channel of Station 8 was largely shaded by a dense canopy of speckled alder with an abundance of sedge growing along the streambank (Photographs C-12 and C-13). Small woody debris and undercut banks were present throughout the station, and the stream substrate was predominantly comprised of sand and small gravel.

Photograph C-12. Station 8 – Downstream Extent View Southwest, June, 2013.

Photograph C-13. Station 8 – Upstream Extent View North, June, 2013.

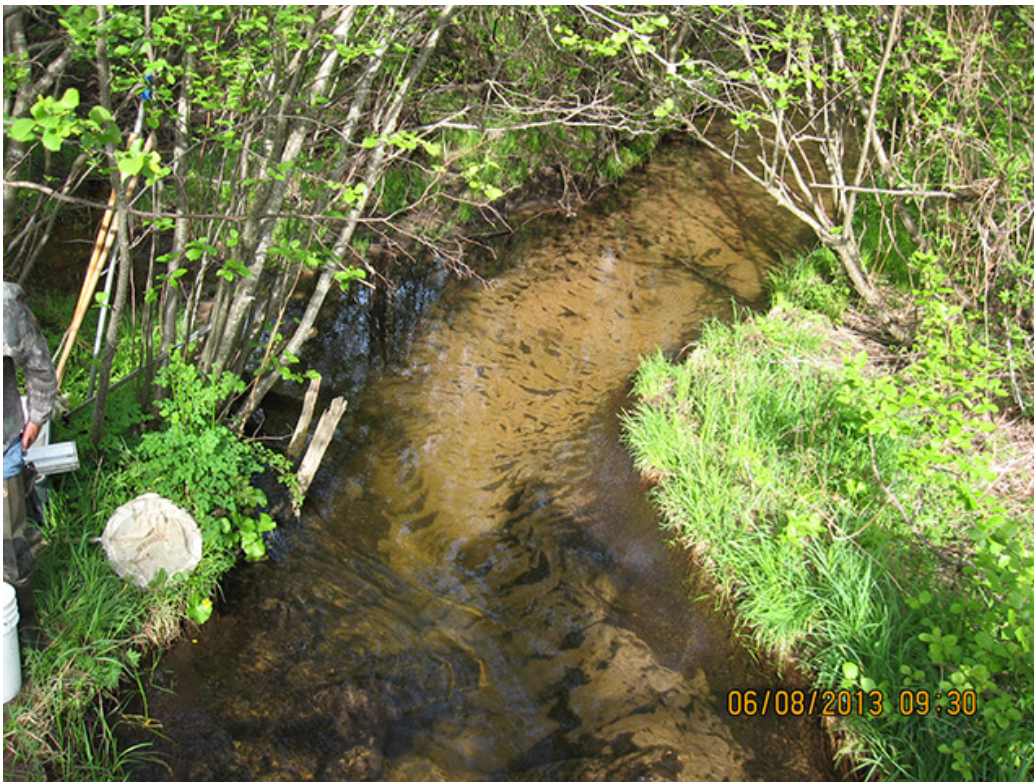
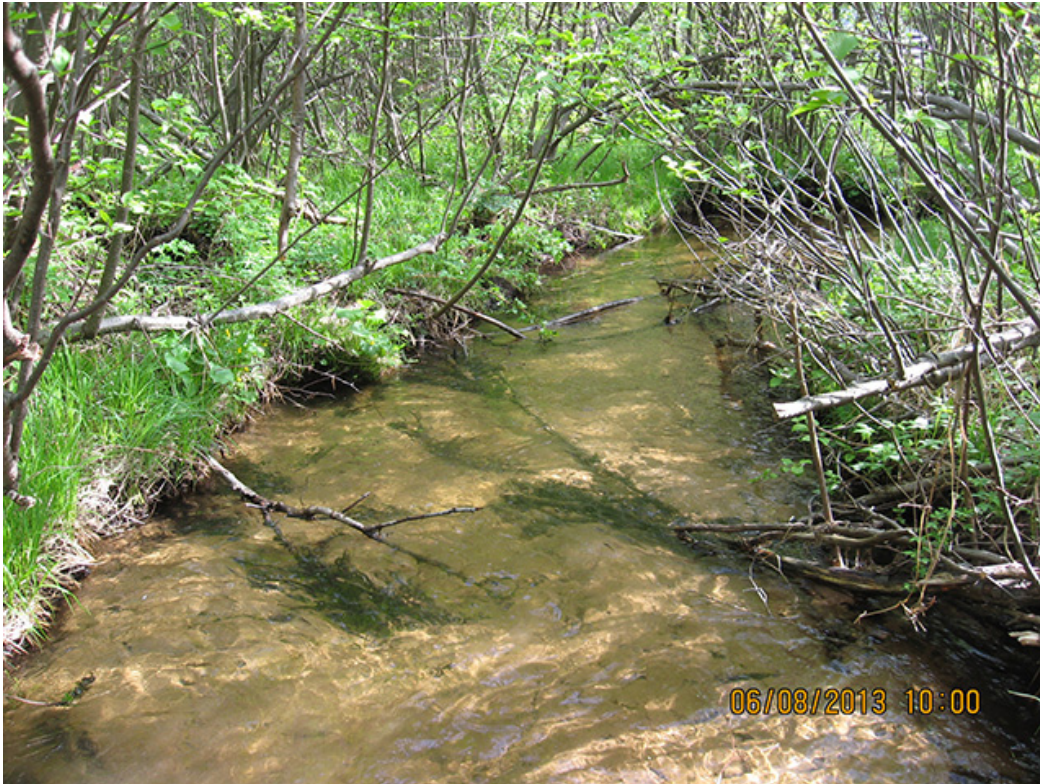
Habitat conditions within Station 9 generally appeared similar to conditions observed in 2012. The understory of Station 9 was predominately sedge, while speckled alder covered much of the stream channel and contributed to in-stream cover (Photographs C-14 to C-15). The substrate was predominantly comprised of sand and silt.

Photograph C-14. Station 9 – Downstream Extent View South, June, 2013.

Photograph C-15. Station 9 – Upstream Extent View North, June, 2013.

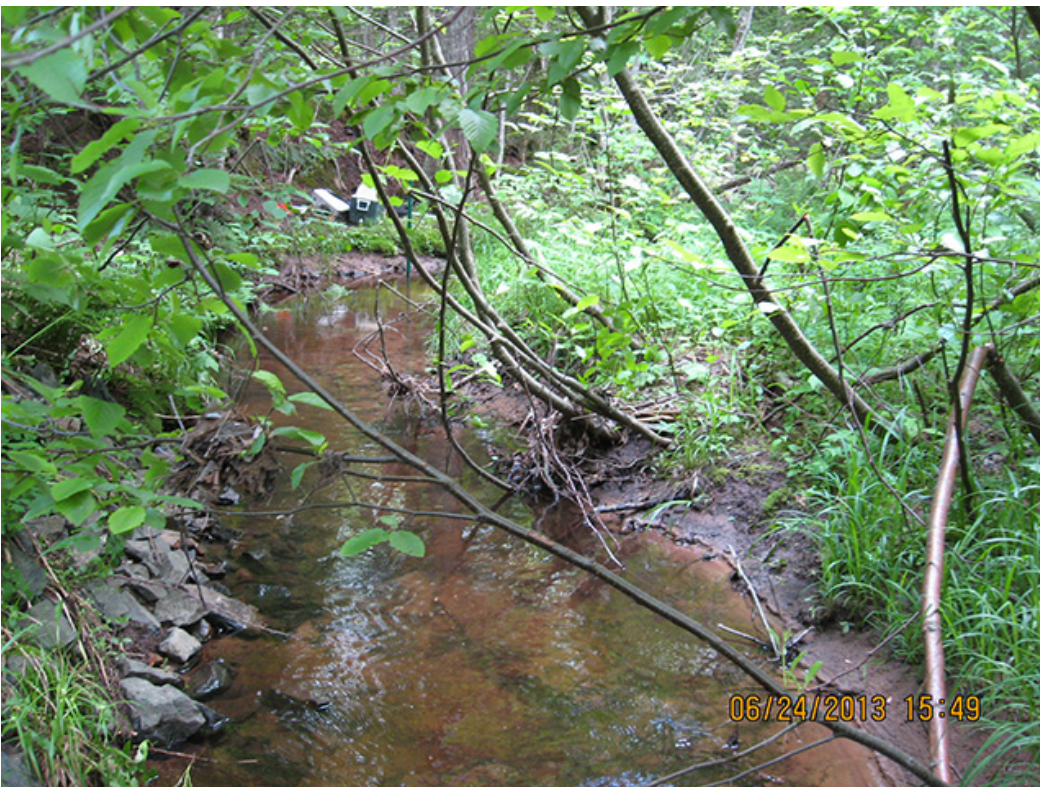
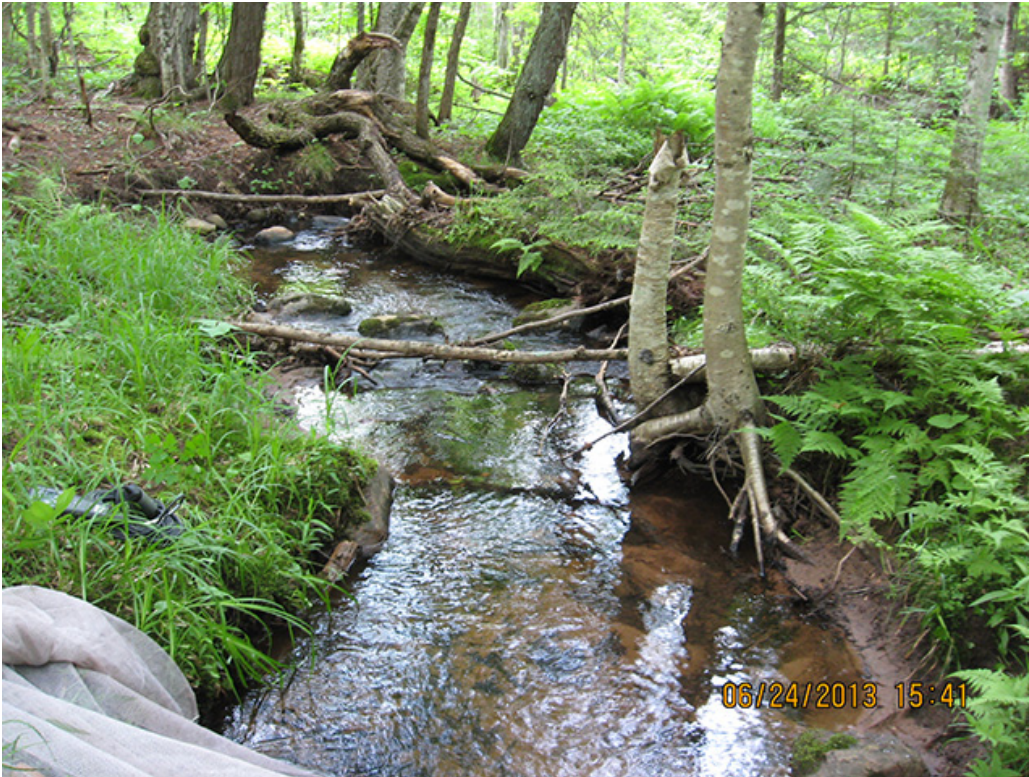
The streambanks within Station 10 were vegetated with large deciduous trees, speckled alder, and other herbaceous vegetation (Photographs C-16 and C-17), and appeared similar to conditions observed in 2012. Woody debris and undercut banks provided in-stream cover throughout this station. The substrate was predominantly comprised of sand, silt and some gravel; although cobble and large boulders were also present.

Photograph C-16. Station 10 – Downstream Extent View Southwest, June, 2013.

Photograph C-17. Station 10 – Upstream Extent View Northeast, June, 2013.

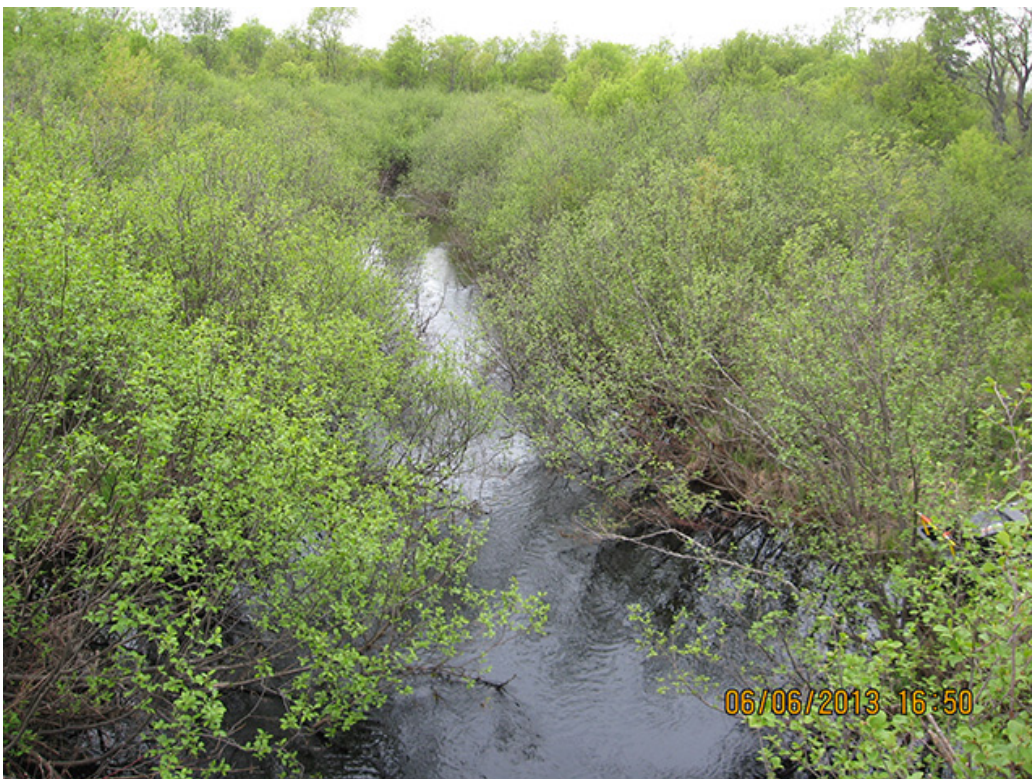
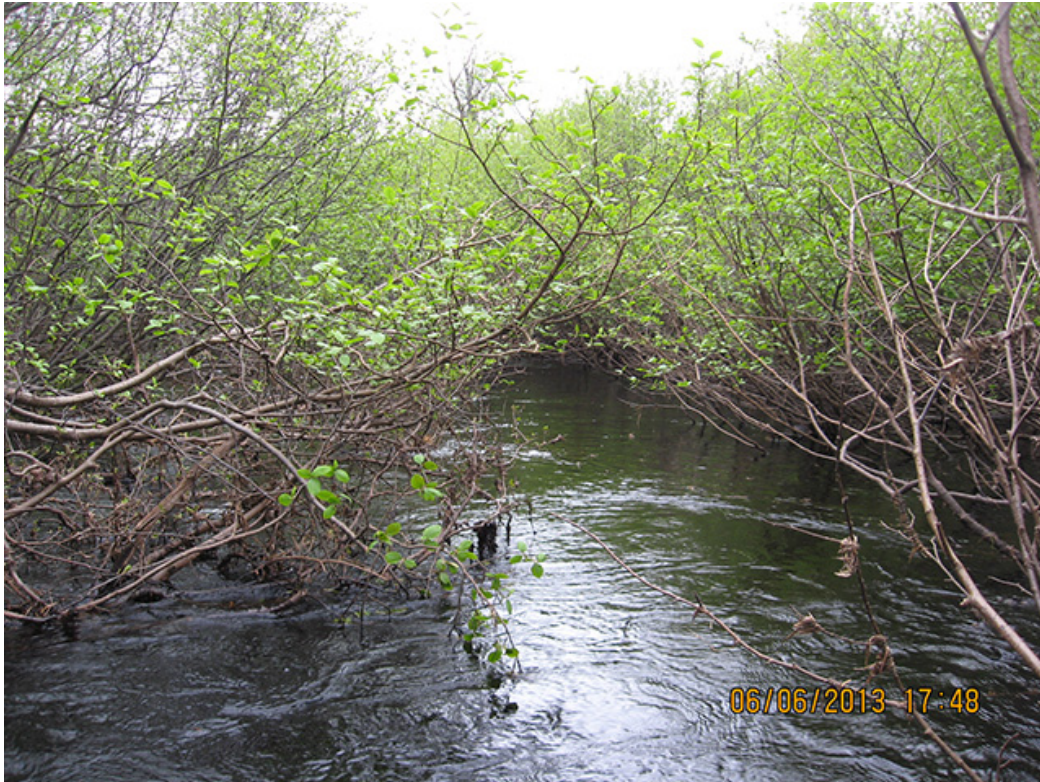
Streambanks appeared consistent with the 2012 survey and were vegetated with a dense covering of speckled alder, which contributed to in-stream cover and woody debris within the channel (Photographs C-18 to C-19). The substrate was predominantly comprised of sand and silt.

Photograph C-18. Station 5 – Downstream Extent View West, June, 2013.

Photograph C-19. Station 5 – Upstream Extent View Southeast, June, 2013.

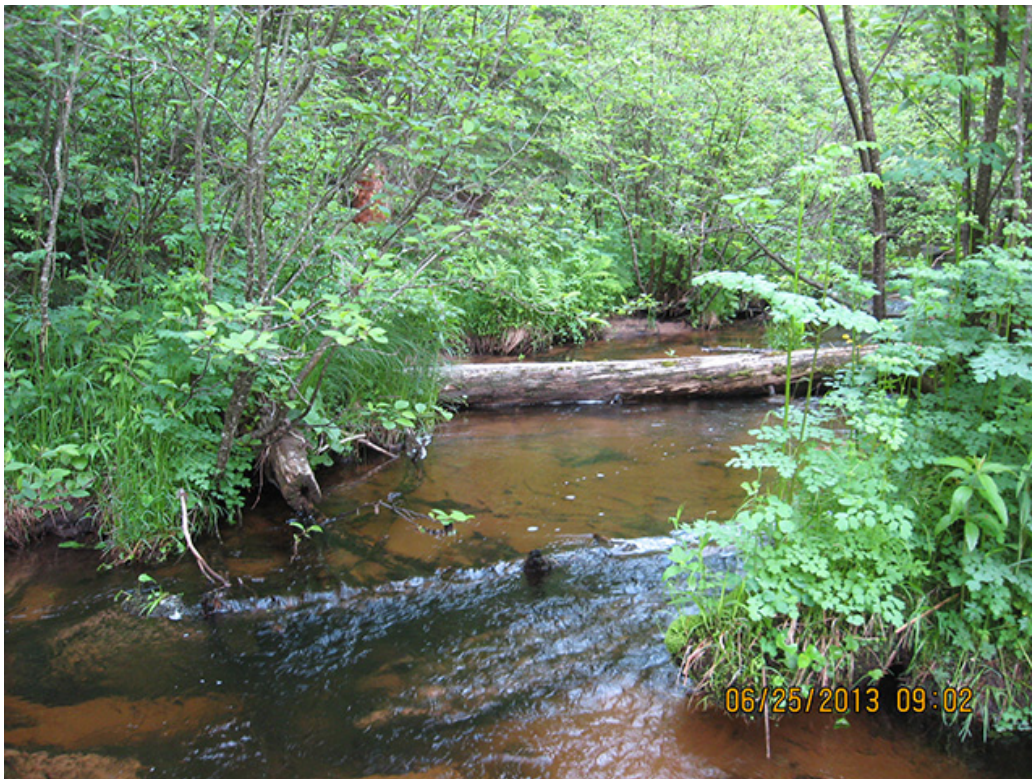
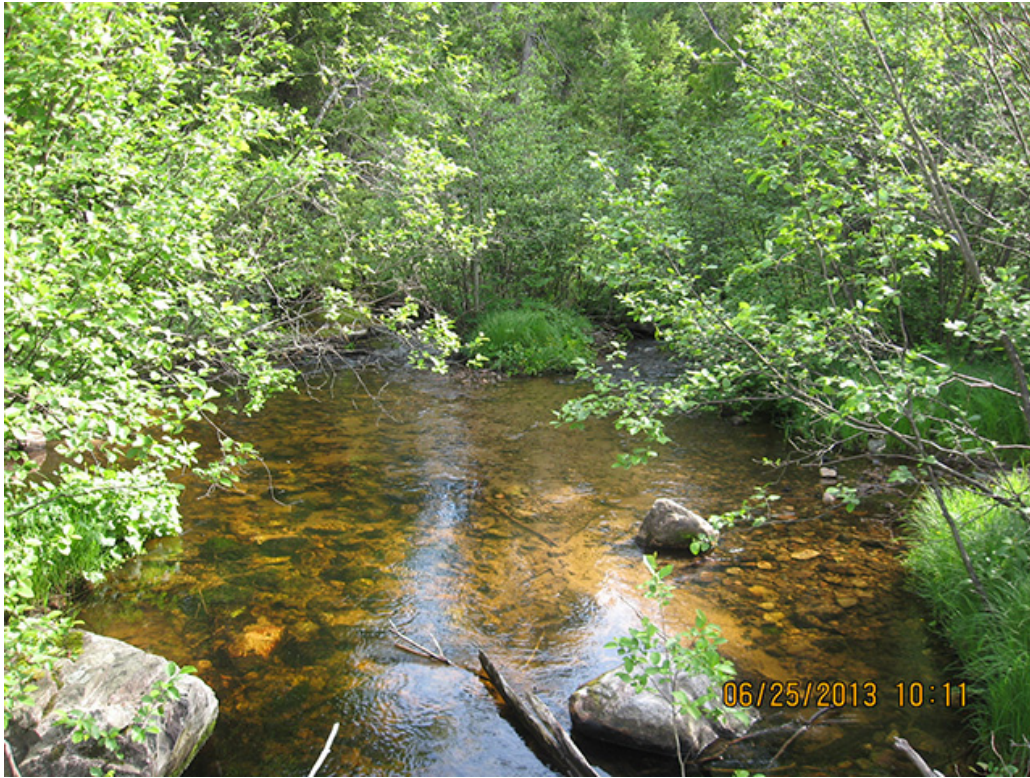
The riparian vegetation throughout much of the relocated Station 4 was mature northern white cedars (*Thuja occidentalis*), and white pines (*Pinus strobus*). Speckled alder was

also present along the stream channel in the upstream and downstream extents of the station (Photographs C-20 and C-21). The river channel was braided throughout the middle portion of the station, with frequent undercut banks, large woody debris and variety of substrate, including sand, gravel, cobble and boulders contributing to habitat complexity.

Photograph C-20. Station 4 – Downstream Extent View South, June, 2013.

Photograph C-21. Station 4 – Upstream Extent View North, June, 2013.
