# **Investigation of the Aquatic Communities of the Salmon Trout River, Yellow Dog River, and Cedar Creek in Marquette County, Michigan, 2014.**

**December 30, 2014**

**Eagle Mine**

**ADVANCED ECOLOGICAL MANAGEMENT  
22071 7 Mile Road  
Reed City, MI 49677**

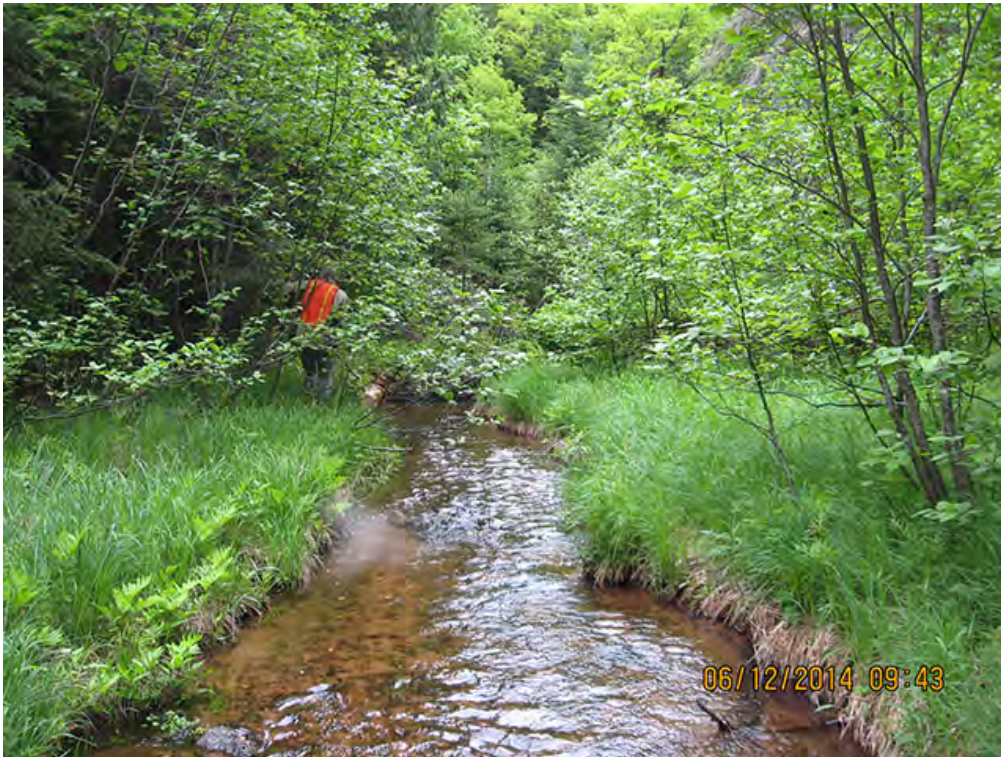
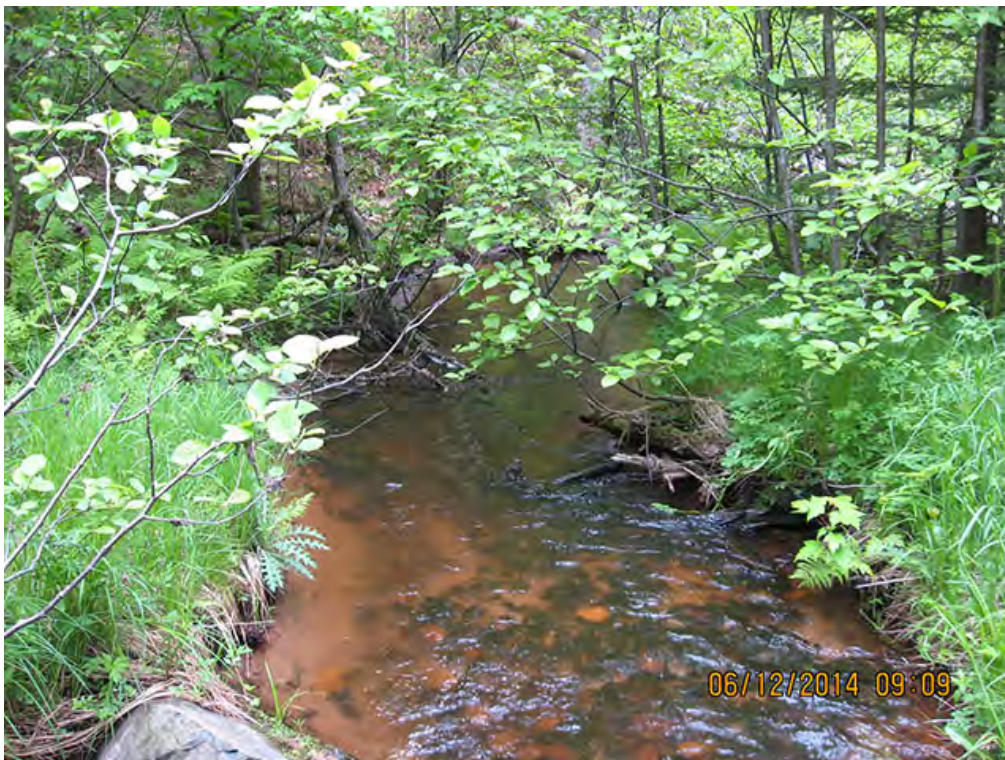
The streambanks of Station 1 appeared consistent with conditions observed in previous surveys, and were vegetated with herbaceous and woody vegetation (Photographs C-1 and C-2). The streambed was characterized by a relatively steep gradient and the substrate was comprised of a variety of particles including sand, gravel, cobble, and boulders (Photographs C-1 and C-2). Woody debris was frequently observed throughout the station and appeared consistent with conditions observed in 2013.

**Photograph C-1. Station 1 - Downstream Extent View South, June, 2014.**

**Photograph C-2. Station 1 - Upstream Extent View North, June, 2014.**

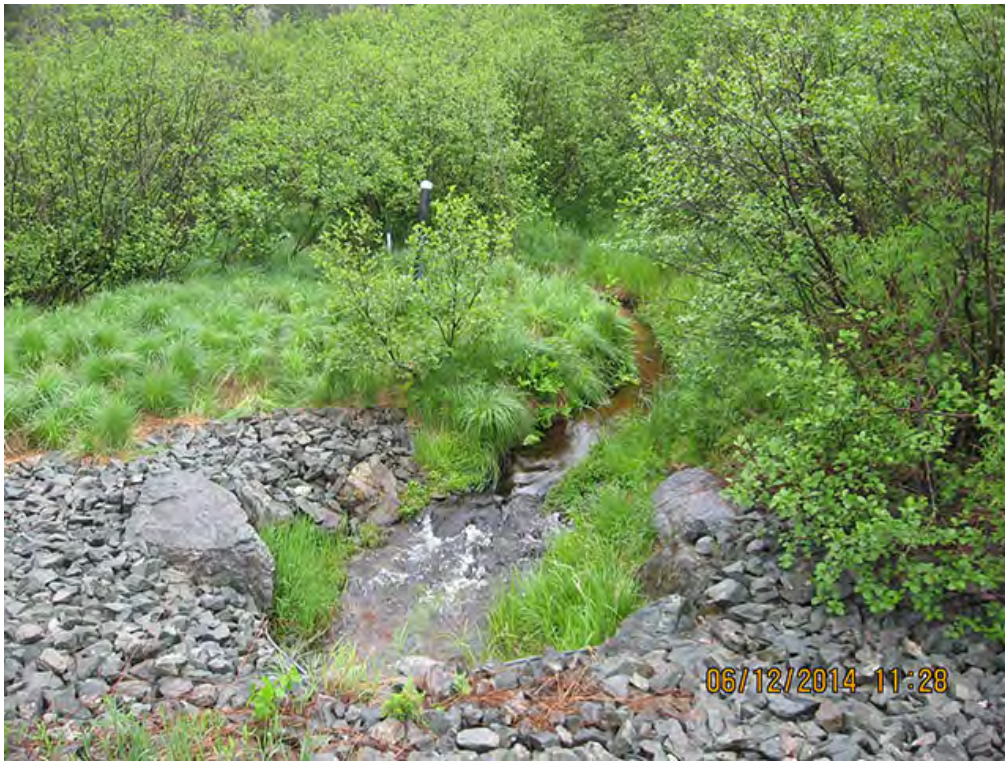
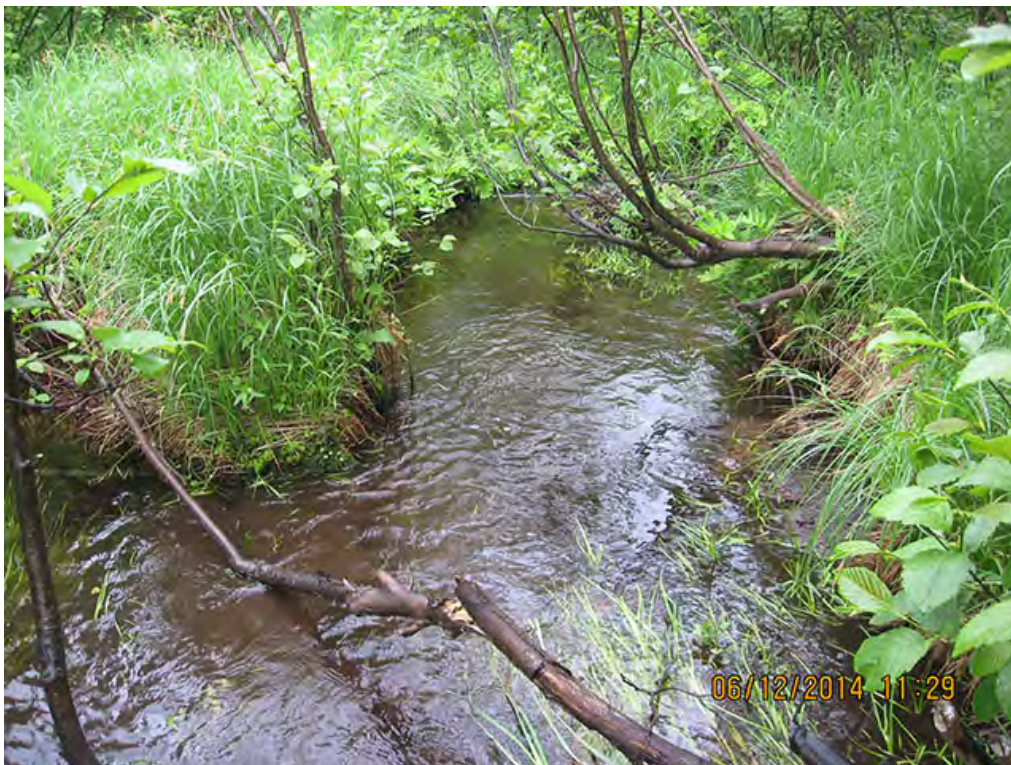
Station 2 was surrounded by an abundance of speckled alder (*Alnus rugosa*) and bluejoint grass (*Calamagrostis canadensis*, Photographs C-3 to C-4). Habitat conditions

of Station 2 were consistent with 2013 observations. Evidence of beaver activity was present with the upstream extent of Station 2 and two partially constructed dams were present within the stream channel. Silt and organic matter appeared to be more abundant within the upstream extent of Station 2.

**Photograph C-3. Station 2 – Downstream Extent View South, June, 2014.**

**Photograph C-4. Station 2 – Upstream Extent View Northwest, June, 2014.**

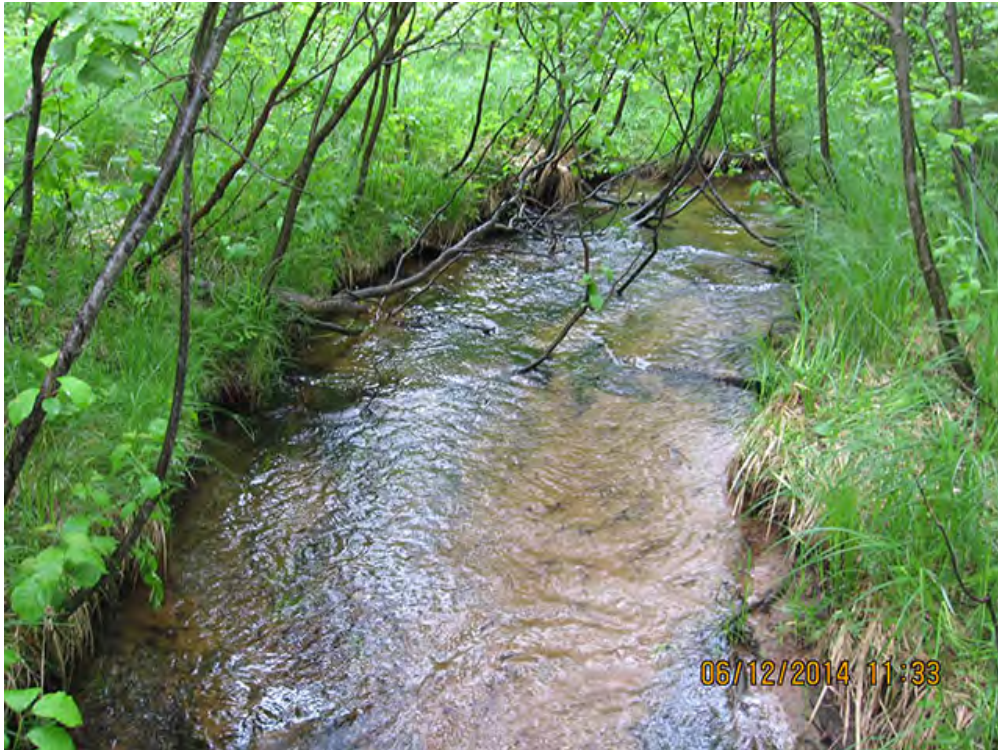
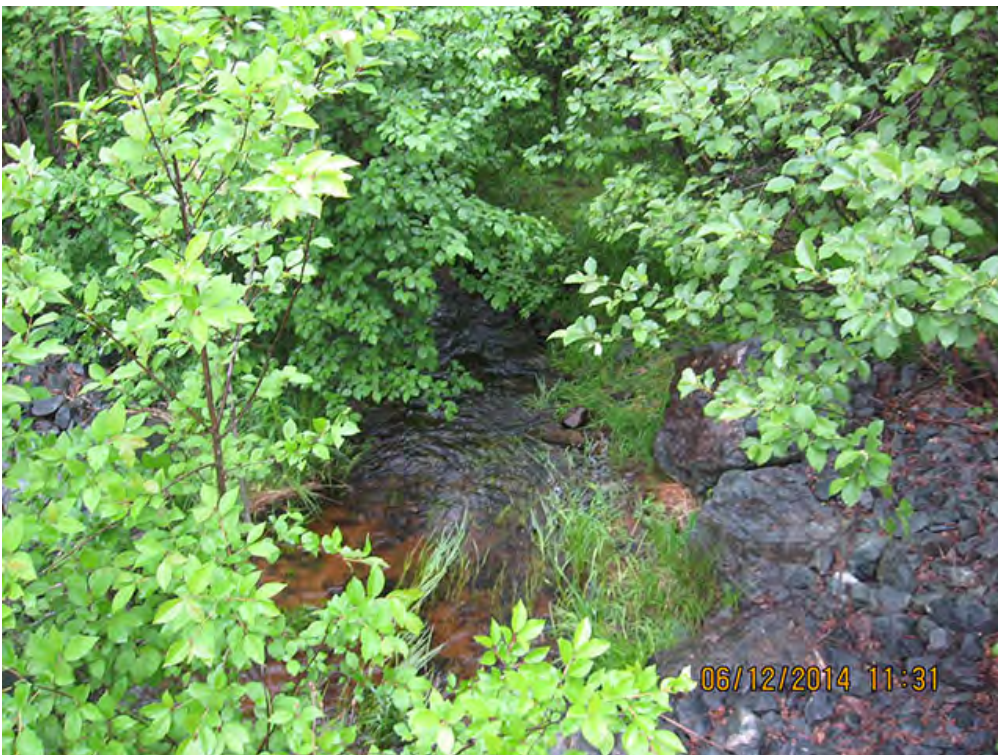
The streambank vegetation within Station 3 appeared similar to conditions observed in 2013. The vegetation within Station 3 was predominantly speckled alder with an understory of bluejoint grass and sedge (*Carex* sp., Photographs C-5 to C-6). Watercress (*Nasturtium* sp.) was present within portions of the stream channel of Station 3.

**Photograph C-5. Station 3 – Downstream Extent View South, June, 2014.**

**Photograph C-6. Station 3 –Upstream Extent View North, June, 2014.**

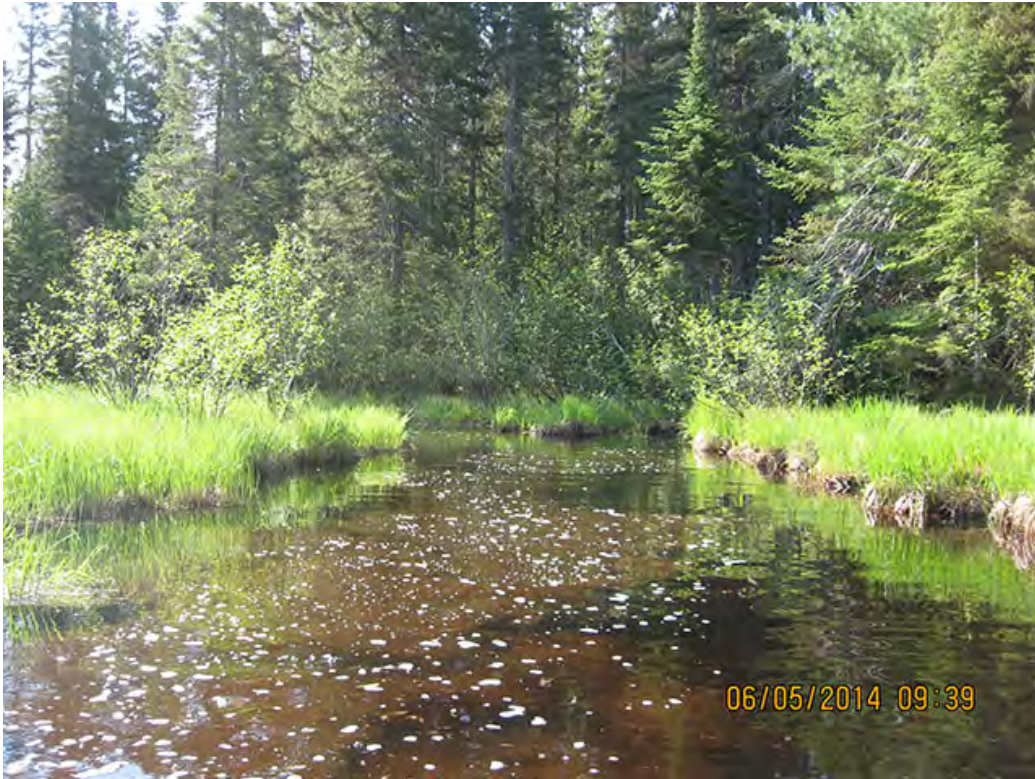
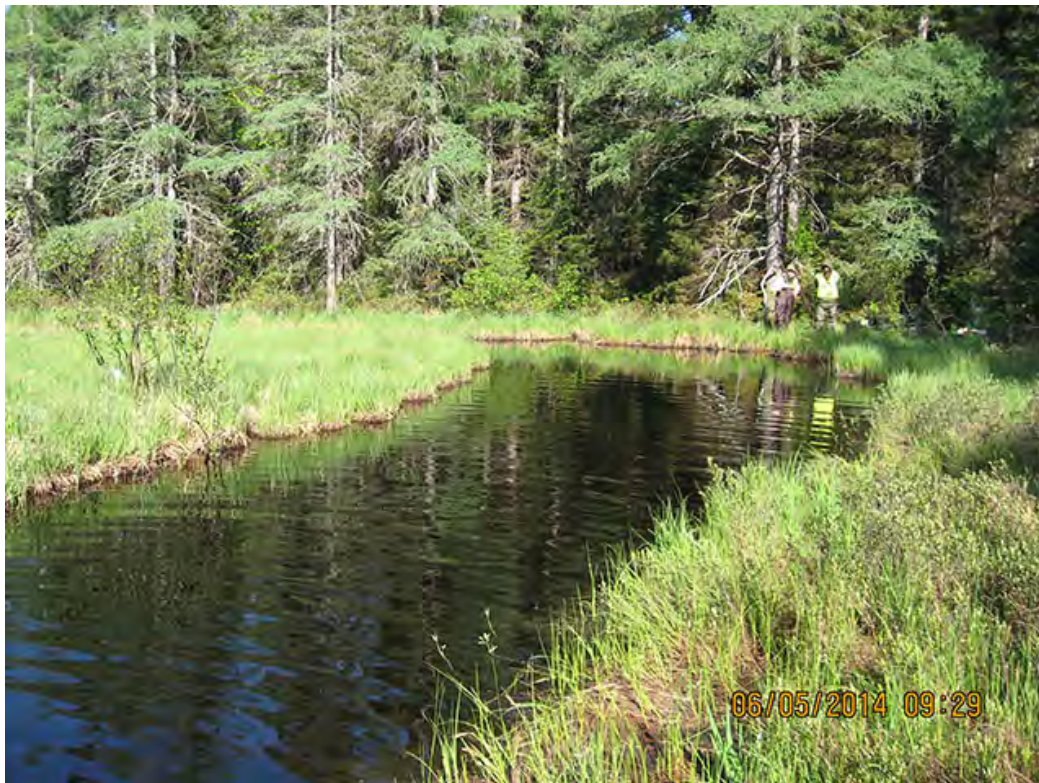
The streambanks in Station 6 appeared similar to conditions observed in 2013, and were characterized by tussock sedge (*Carex stricta*), iris (*Iris* sp.), rush (*Juncus* sp.), willows (*Salix* sp.) and speckled alder (Photographs C-7 to C-8). Much of the aquatic vegetation seen during the summer sampling event was growing on organic matter that appeared to function as a floating mat of vegetation. The substrate of Station 6 was predominantly comprised of organic matter and fine sediments, such as silt and clay. Woody debris was present throughout the stream channel.

**Photograph C-7. Station 6 – Downstream Extent View South, June, 2014.**

**Photograph C-8. Station 6 – Upstream Extent View Southwest, June, 2014.**

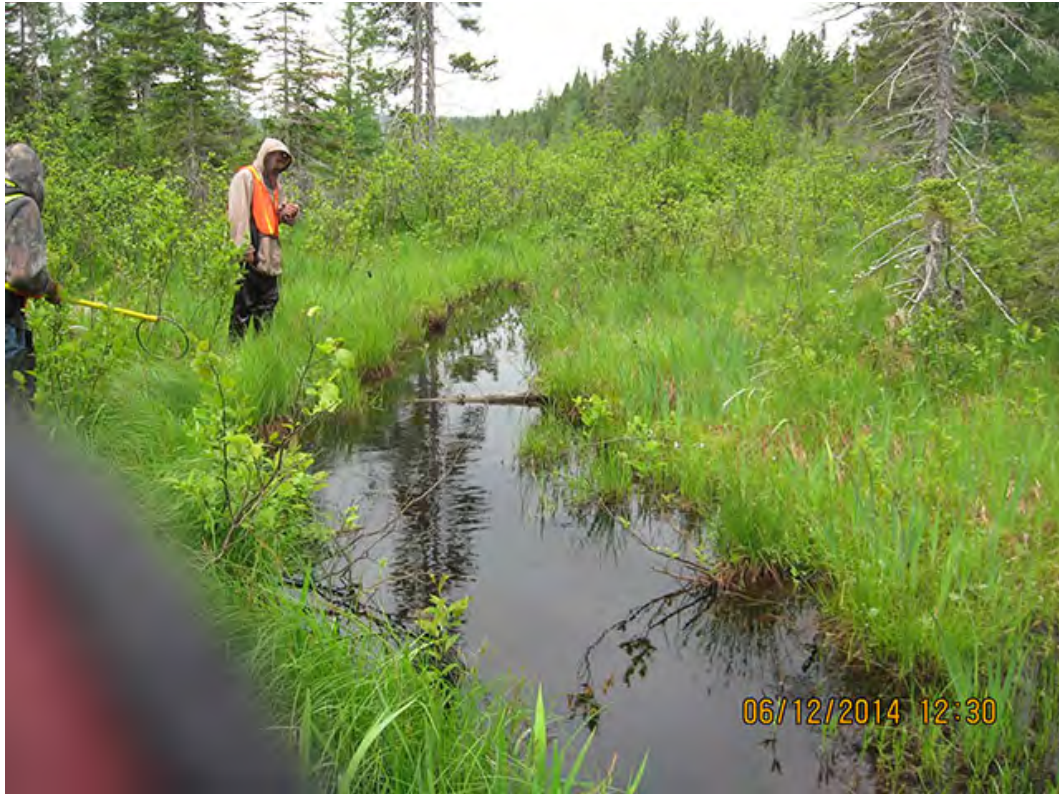
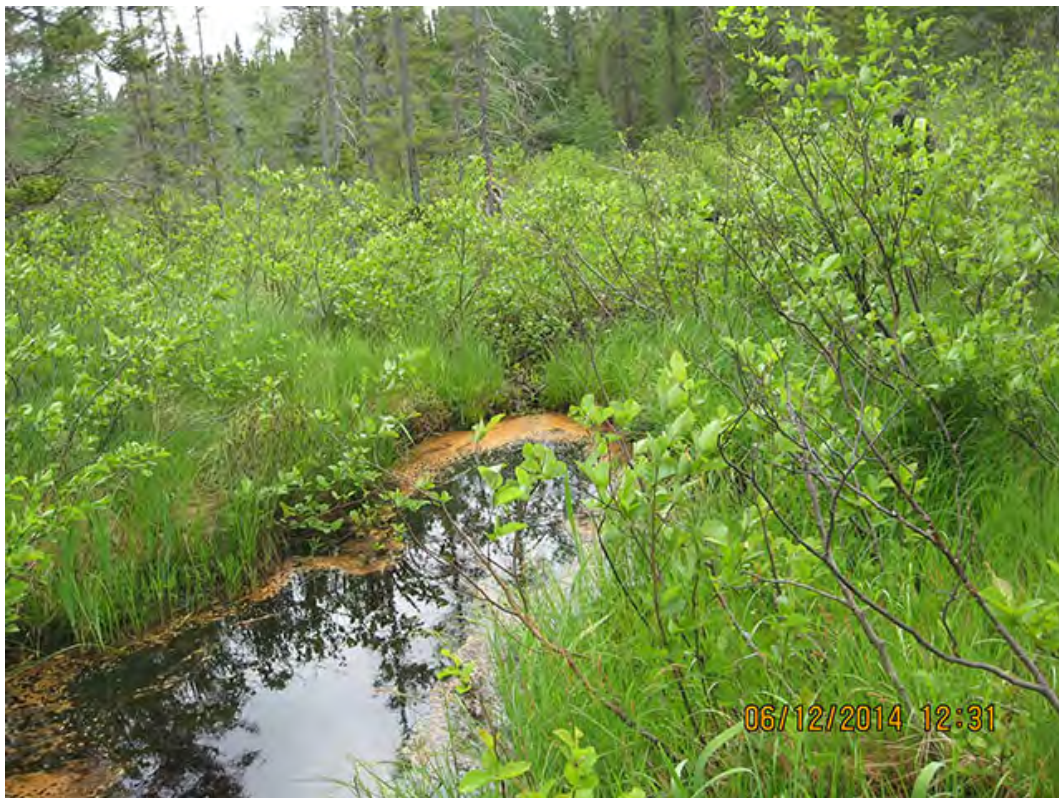
The streambanks of Station 7 were vegetated with speckled alder, tussock sedge, rush, and iris (Photographs C-9 and C-10), and appeared similar to conditions observed in 2013. The substrate was comprised of organic matter and silt. Woody debris was abundant throughout this station.

**Photograph C-9. Station 7 – Downstream Extent View Southwest, June, 2014.**

**Photograph C-10. Station 7 – Upstream Extent View North, June, 2014.**

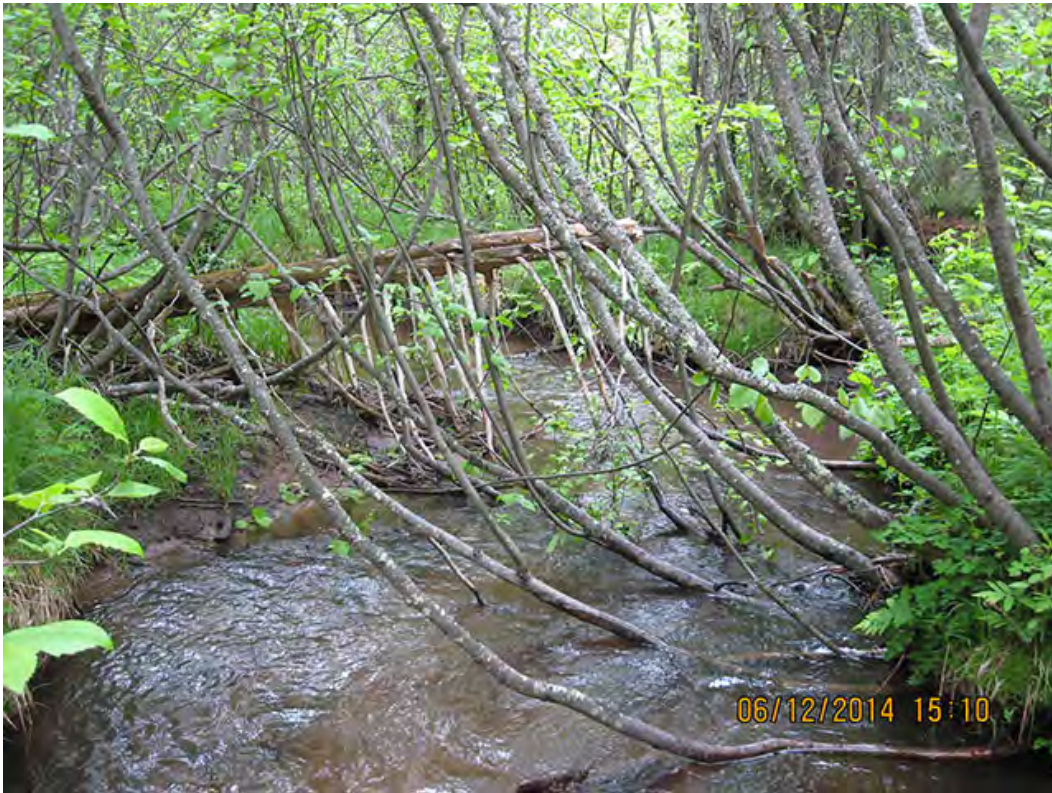
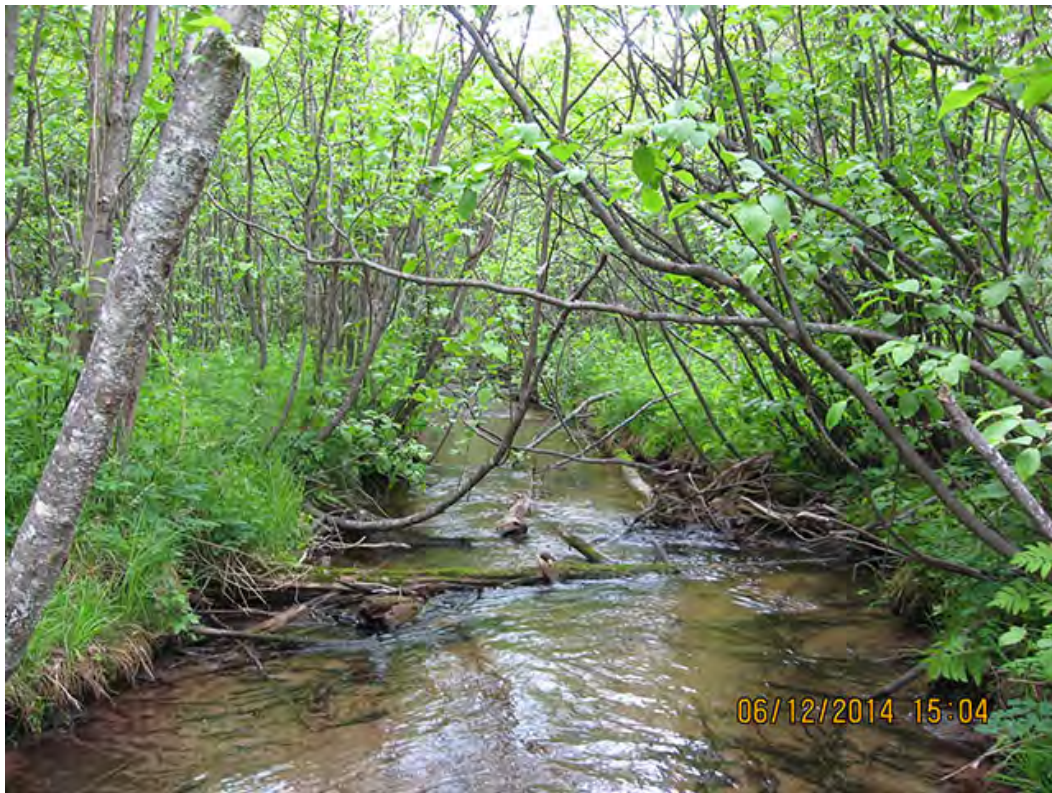
The stream channel of Station 8 was largely shaded by a dense canopy of speckled alder with an abundance of sedge growing along the streambank (Photographs C-11 and C-12). Small woody debris and undercut banks were present throughout the station, and the stream substrate was predominantly comprised of sand and small gravel.

**Photograph C-11. Station 8 – Downstream Extent View Southwest, June, 2014.**

**Photograph C-12. Station 8 – Upstream Extent View North, June, 2014.**

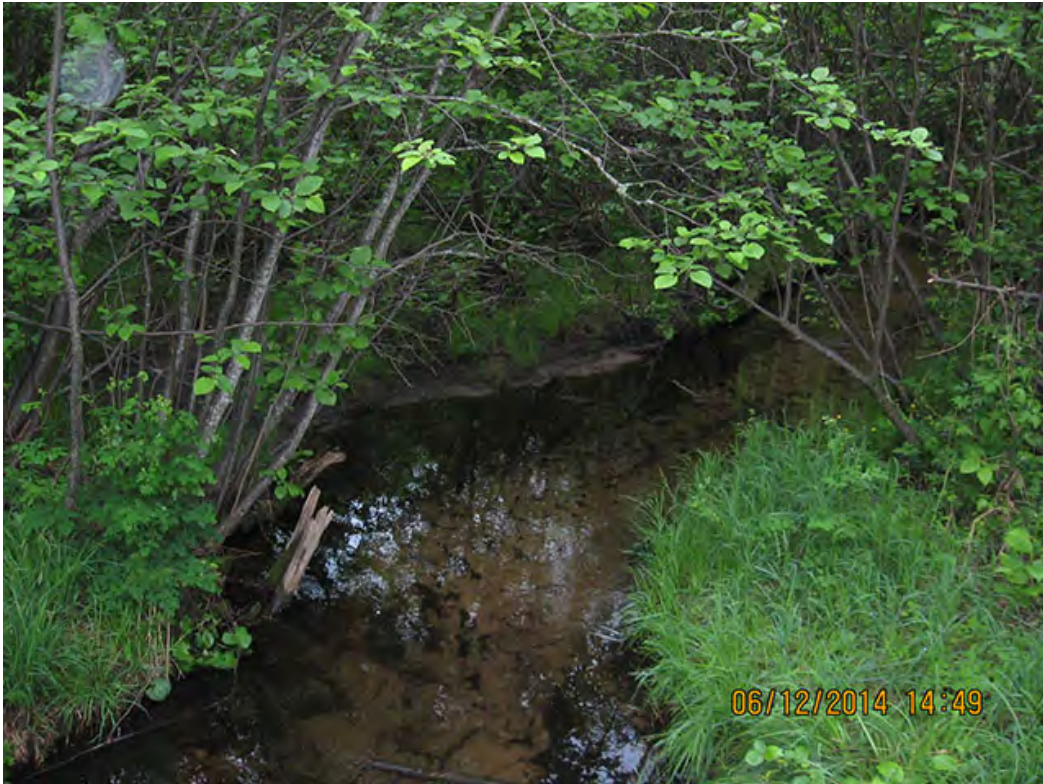
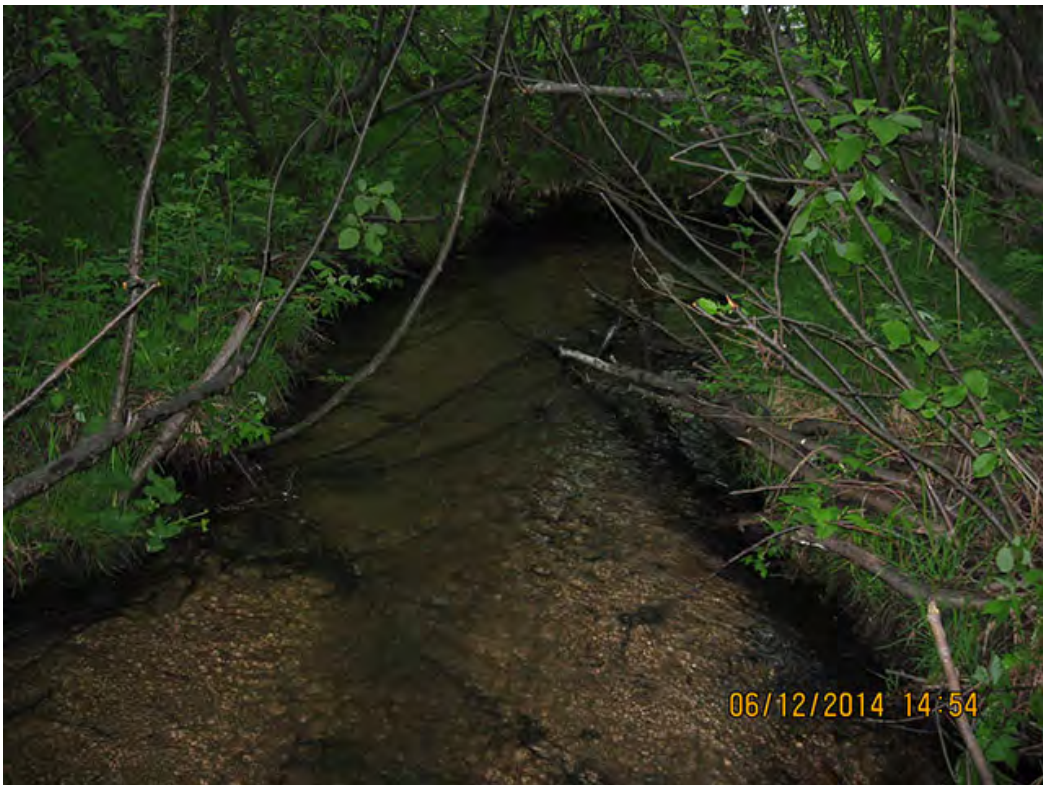
Many of the small pools within Station 9 appeared to have filled in with sand since the 2013 aquatic survey. Riparian habitat appeared consistent with the 2013 survey where the understory of Station 9 was predominately sedge, while speckled alder covered much of the stream channel and contributed to in-stream cover (Photographs C-13 to C-14). The substrate throughout the station was predominantly comprised of sand and silt.

**Photograph C-13. Station 9 – Downstream Extent View South, June, 2014.**

**Photograph C-14. Station 9 – Upstream Extent View North, June, 2014.**

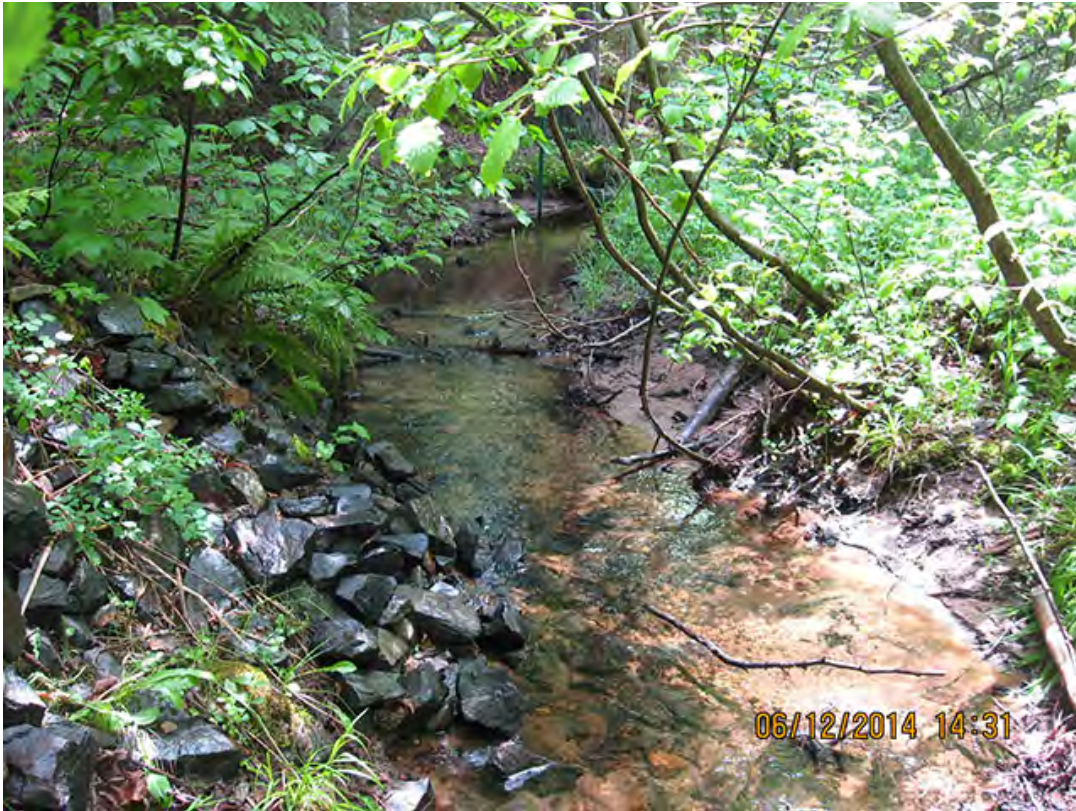
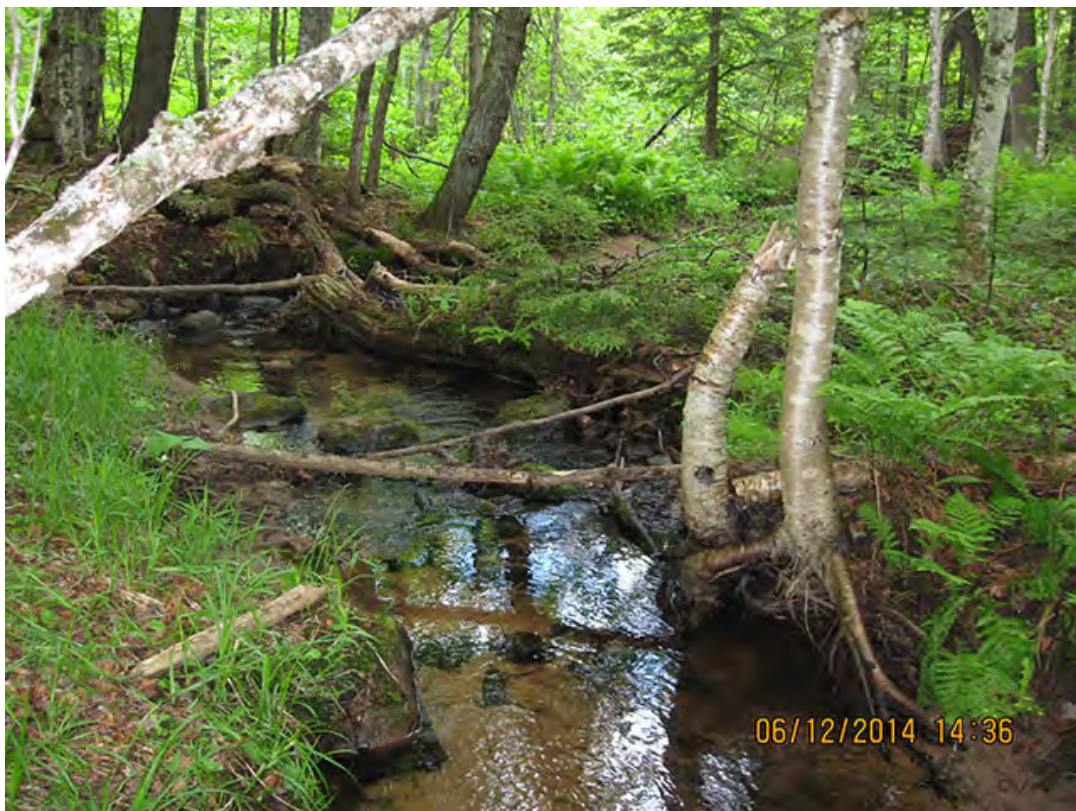
The streambanks within Station 10 were vegetated with large deciduous trees, speckled alder, and other herbaceous vegetation (Photographs C-15 and C-16), and appeared similar to conditions observed in 2013. Woody debris and undercut banks provided in-stream cover throughout this station. The substrate was predominantly comprised of sand, silt and some gravel; although cobble and large boulders were also present.

**Photograph C-15. Station 10 – Downstream Extent View Southwest, June, 2014.**

**Photograph C-16. Station 10 – Upstream Extent View Northeast, June, 2014.**

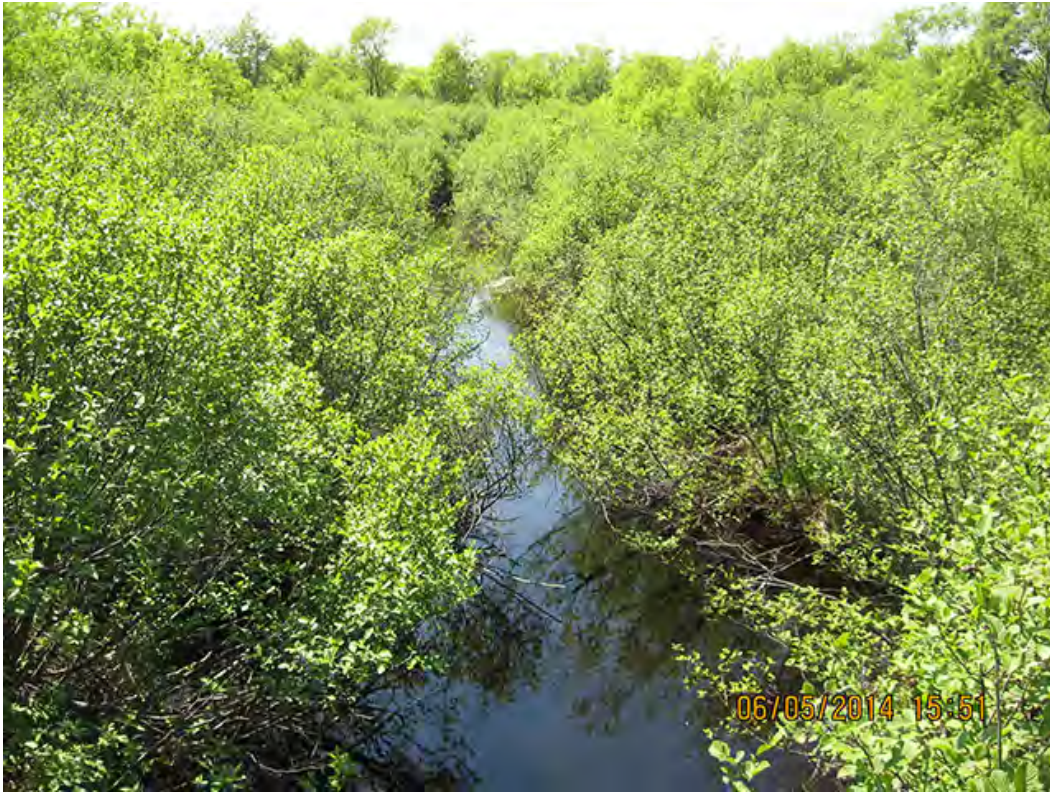
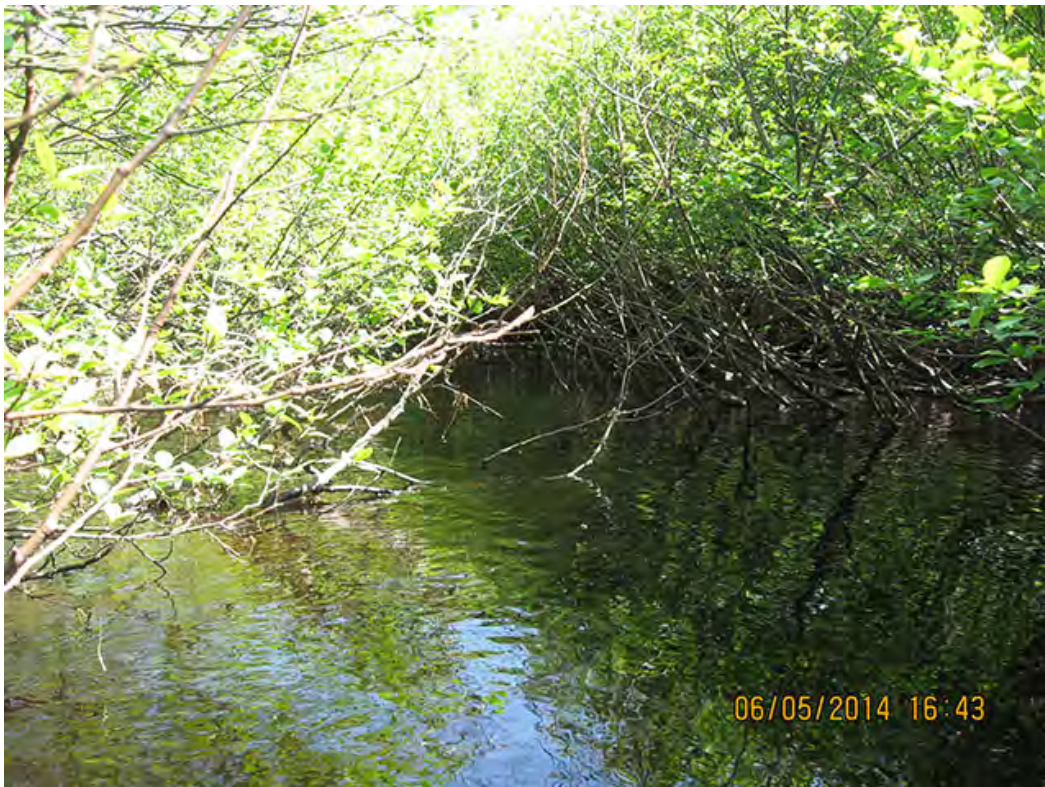
Streambanks appeared consistent with the 2013 survey and were vegetated with a dense covering of speckled alder, which contributed to in-stream cover and woody debris within the channel (Photographs C-17 to C-18). The substrate was predominantly comprised of sand and silt.

**Photograph C-17. Station 5 – Downstream Extent View West, June, 2014.**

**Photograph C-18. Station 5 – Upstream Extent View Southeast, June, 2014.**

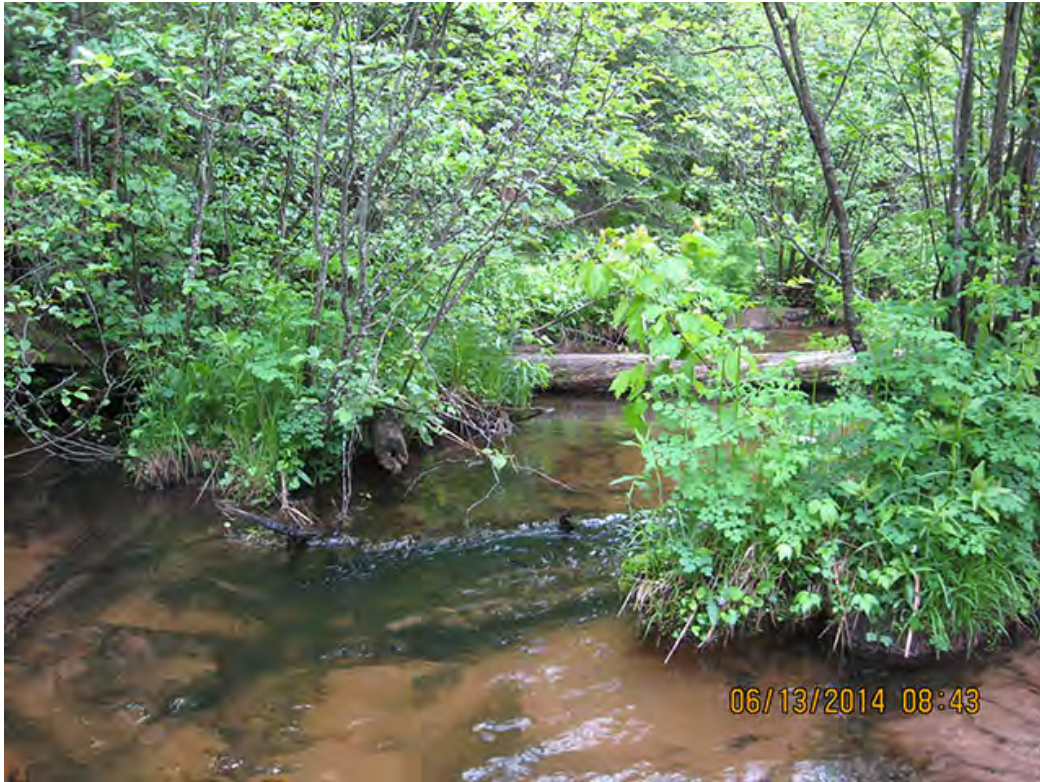
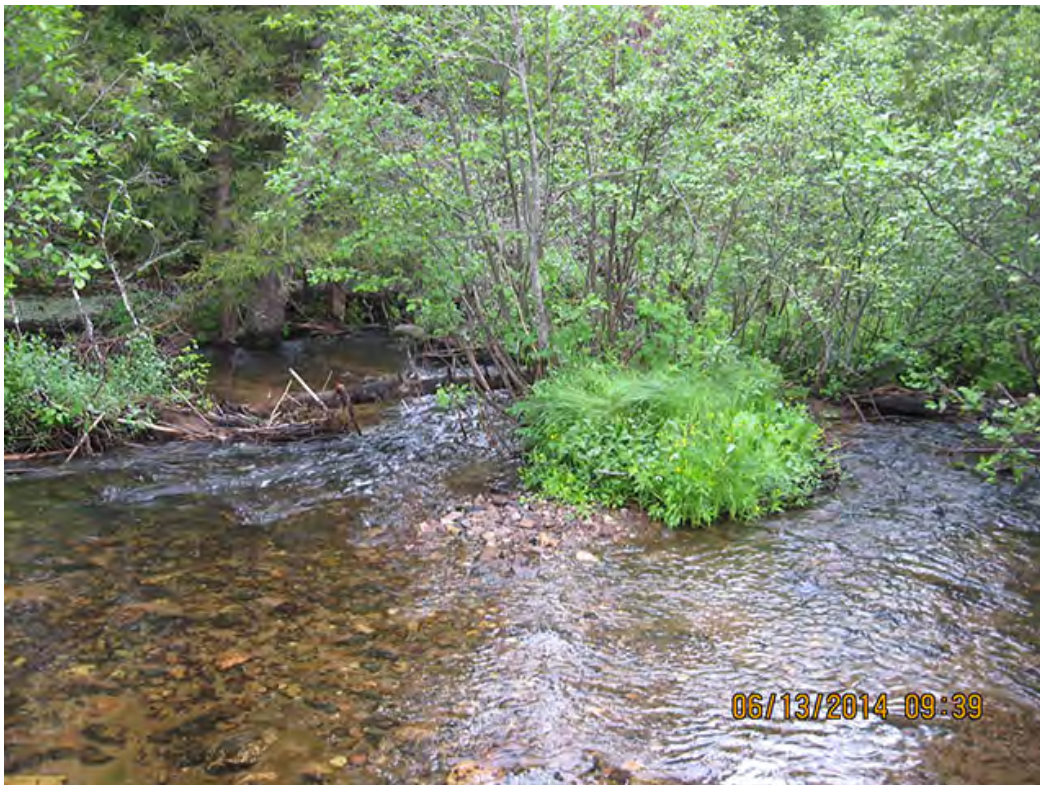
The riparian vegetation throughout much of the relocated Station 4 was mature northern white cedars (*Thuja occidentalis*), and white pines (*Pinus strobus*). Speckled alder was also present along the stream channel in the upstream and downstream extents of the station (Photographs C-19 and C-20). The river channel was braided throughout the middle portion of the station, with frequent undercut banks, large woody debris and variety of substrate, including sand, gravel, cobble and boulders contributing to habitat complexity.

**Photograph C-19. Station 4 – Downstream Extent View South, June, 2014.**

**Photograph C-20. Station 4 – Upstream Extent View North, June, 2014.**
