Investigation of the Aquatic Communities of the Salmon Trout River, Yellow Dog River, and Cedar Creek in Marquette County, Michigan, 2015.

December 17, 2015

Eagle Mine

**ADVANCED ECOLOGICAL MANAGEMENT
22071 7 Mile Road
Reed City, MI 49677**

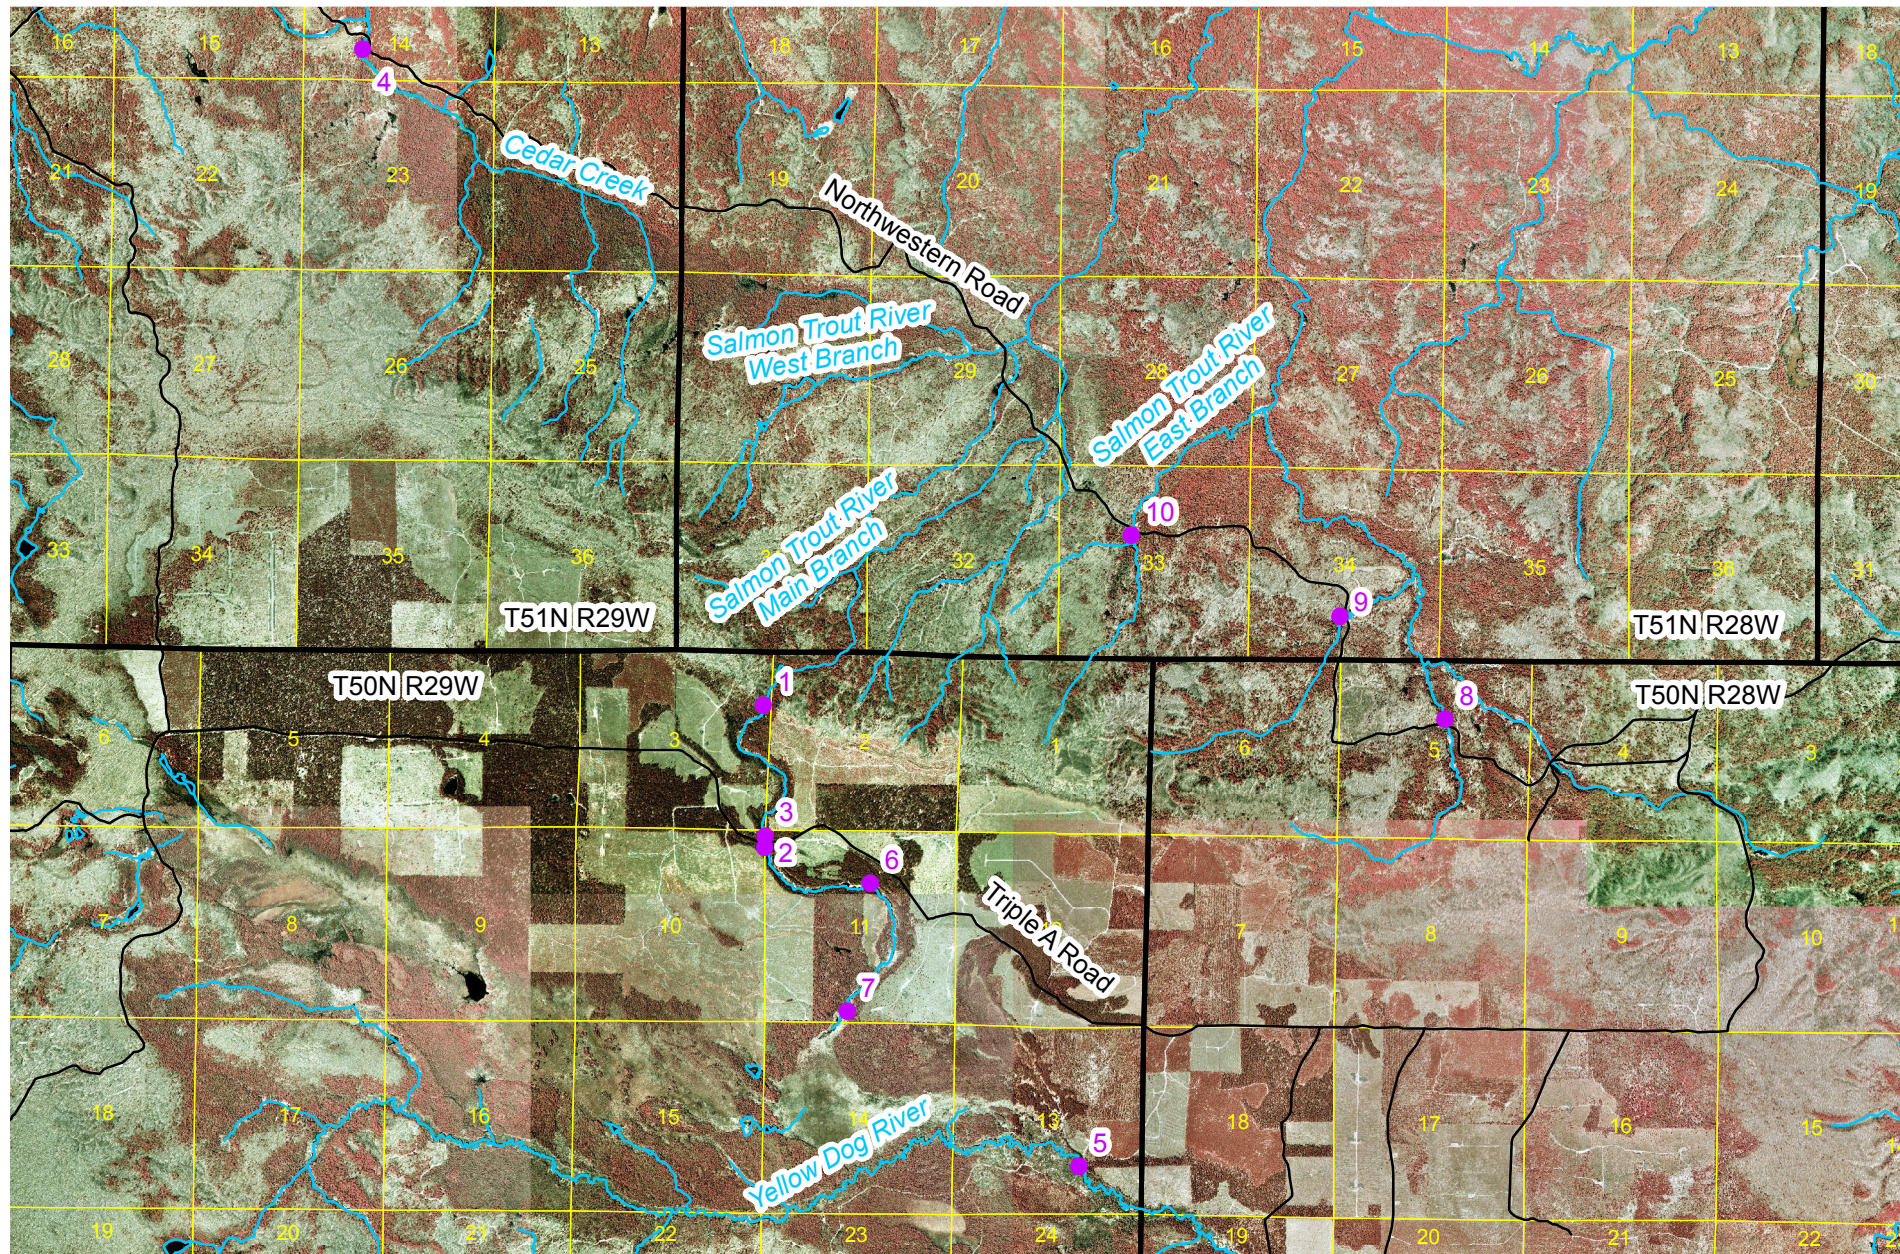
More recently, sample station locations have remained consistent since 2011 (Figure 1-2). Aquatic surveys were conducted in ten stations, including five stations within the Salmon Trout River, three stations within tributaries of the East Branch of the Salmon Trout River, one station in the Yellow Dog River, and one station in Cedar Creek.

The principle area investigated for this study included portions of the Salmon Trout River and its tributaries, the Yellow Dog River, and Cedar Creek (Figure 1-2). These systems are all coldwater streams that flow through relatively undeveloped watersheds that are predominantly forested. The ore body and mine site are located near the headwaters of the Salmon Trout River Main Branch, which flows in a northeastern direction (Figure 1-2). The Salmon Trout River is characterized by a variety of habitat types in the vicinity of the stream segments investigated and includes slow-flowing segments with a silt substrate that have been heavily influenced by beaver activity (e.g., Stations 6 and 7), and high-gradient segments flowing through forested and hilly terrain with beaver dams intermittent throughout the watershed (e.g., Stations 1 and 8).

The Yellow Dog River flows to the west along the southern boundary of the Yellow Dog Plains (Figure 1-2). Cedar Creek flows to the north and is not located within the same watershed as the Eagle mining project. Cedar Creek serves as a reference stream for the Eagle Project.

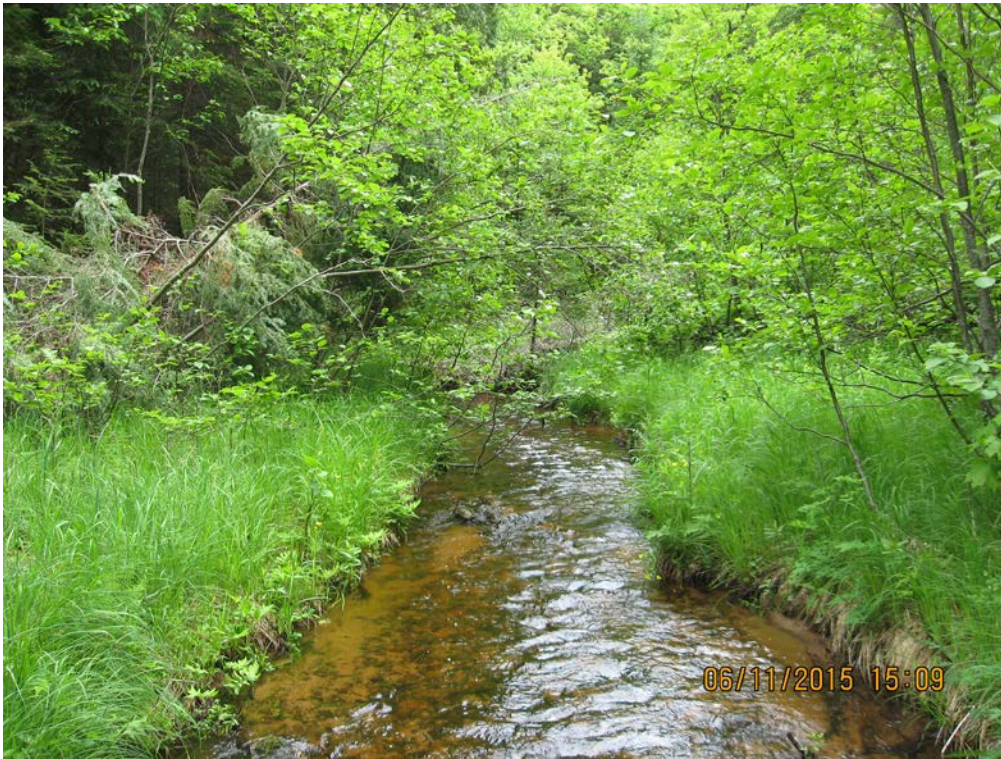
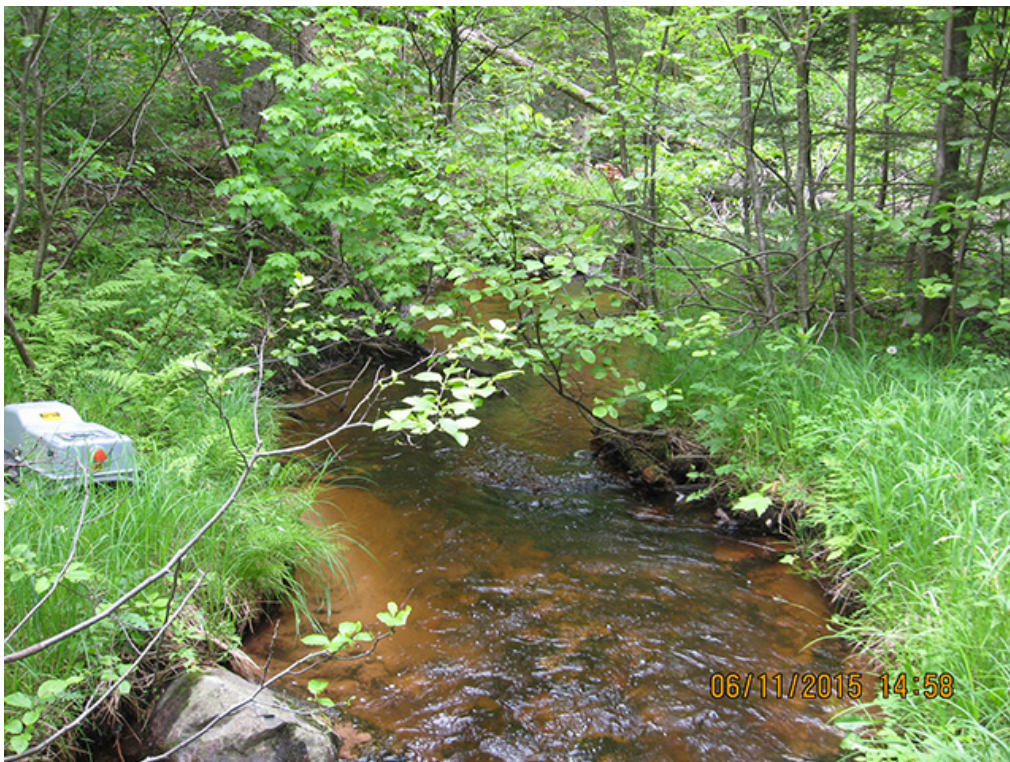
The streambanks of Station 1 appeared consistent with conditions observed in previous surveys, and were vegetated with herbaceous and woody vegetation (Photographs C-1 and C-2). The streambed was characterized by a relatively steep gradient and the substrate was comprised of a variety of particles including sand, gravel, cobble, and boulders (Photographs C-1 and C-2). Woody debris was frequently observed throughout the station and appeared consistent with conditions observed in 2013 and 2014.

Photograph C-1. Station 1 - Downstream Extent View South, June, 2015.

Photograph C-2. Station 1 - Upstream Extent View North, June, 2015.

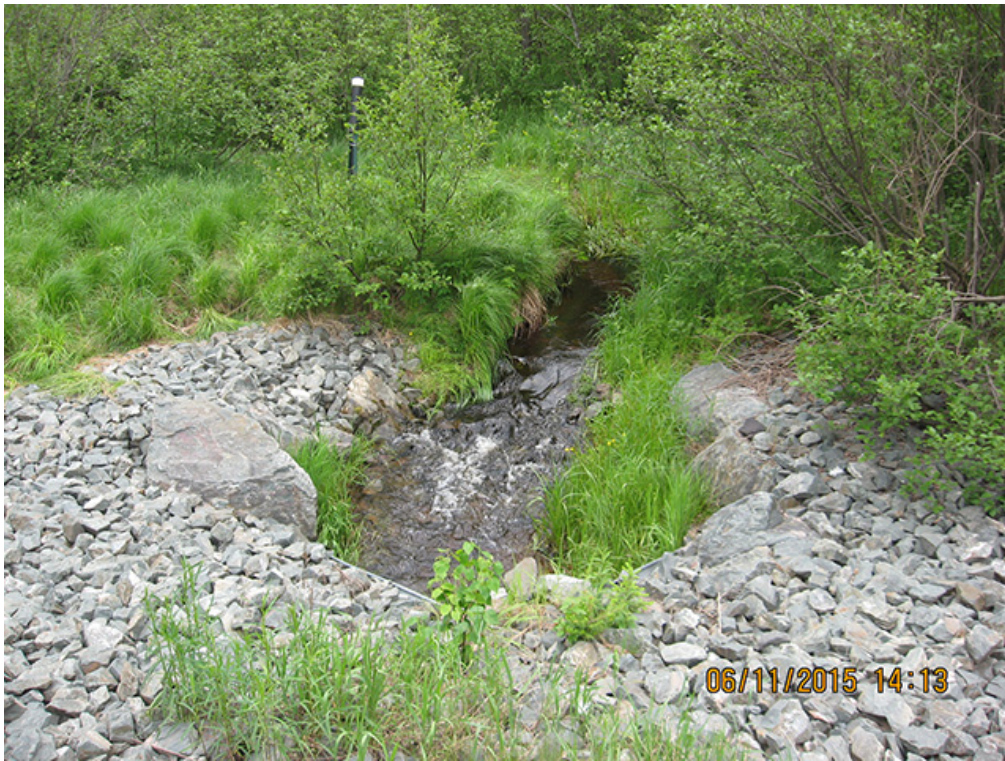
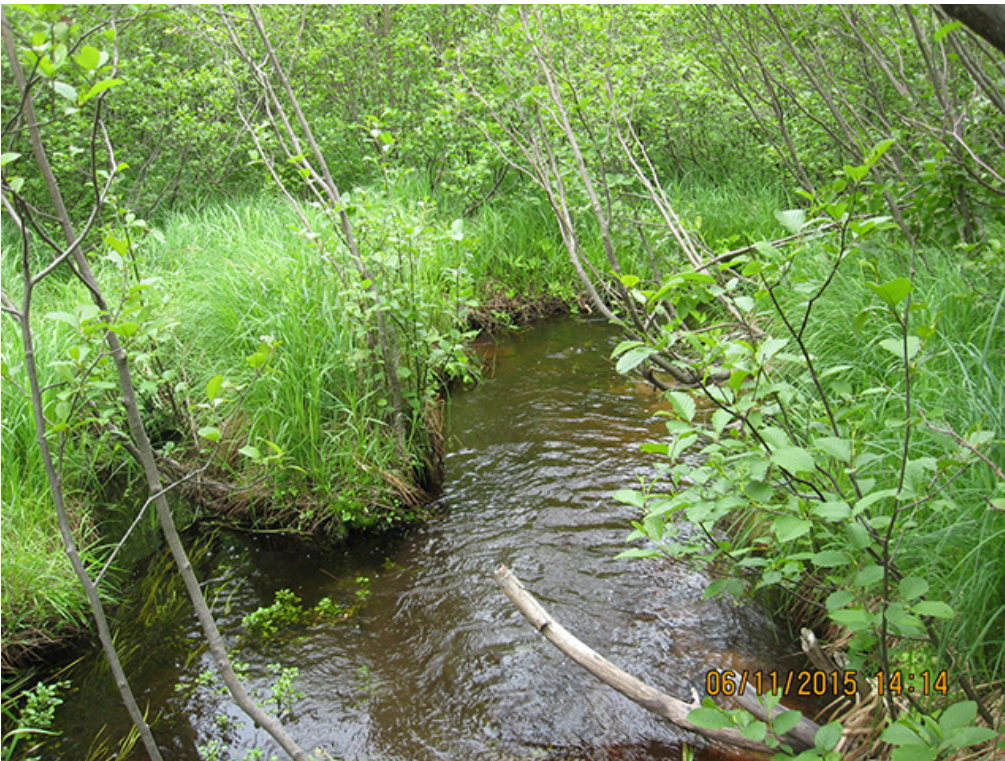
Station 2 was surrounded by an abundance of speckled alder (*Alnus rugosa*) and bluejoint grass (*Calamagrostis canadensis*, Photographs C-3 to C-4). Habitat conditions of Station 2 were consistent with 2014 observations. Evidence of beaver activity was present with the upstream extent of Station 2 and two partially constructed dams were present within the stream channel. Silt and organic matter appeared to be more abundant within the upstream extent of Station 2.

Photograph C-3. Station 2 – Downstream Extent View South, June, 2015.

Photograph C-4. Station 2 – Upstream Extent View Northwest, June, 2015.

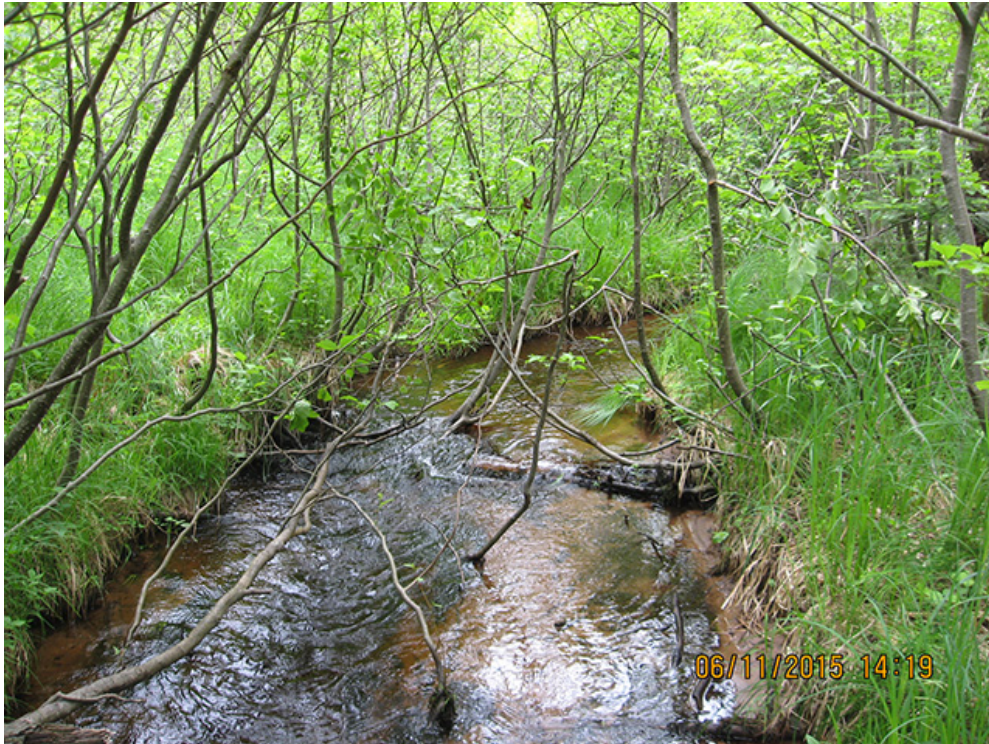
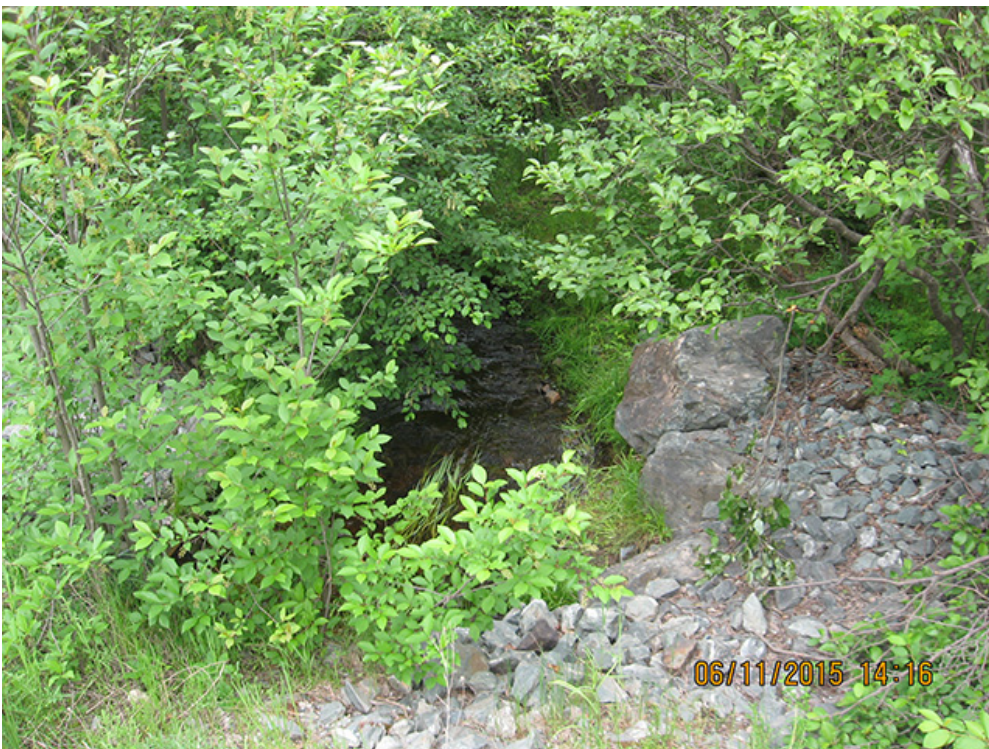
The streambank vegetation within Station 3 appeared similar to conditions observed in 2014. The vegetation within Station 3 was predominantly speckled alder with an understory of bluejoint grass and sedge (*Carex* sp., Photographs C-5 to C-6). Watercress (*Nasturtium* sp.) was present within portions of the stream channel of Station 3.

Photograph C-5. Station 3 – Downstream Extent View South, June, 2015.

Photograph C-6. Station 3 –Upstream Extent View North, June, 2015.

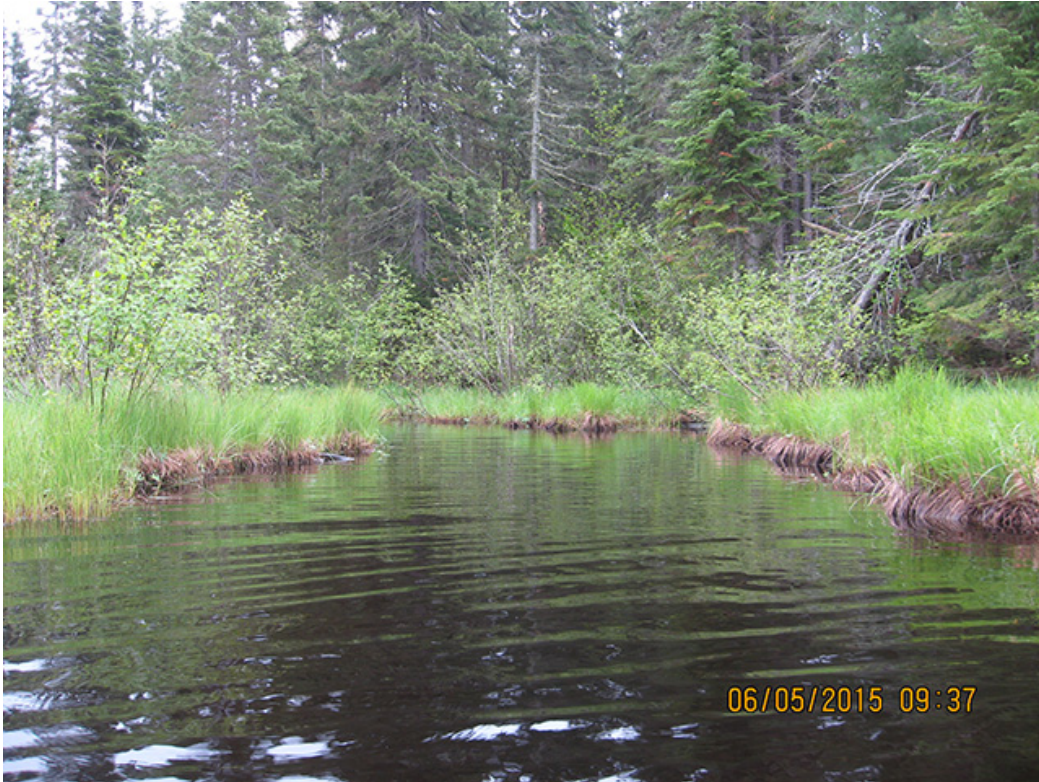
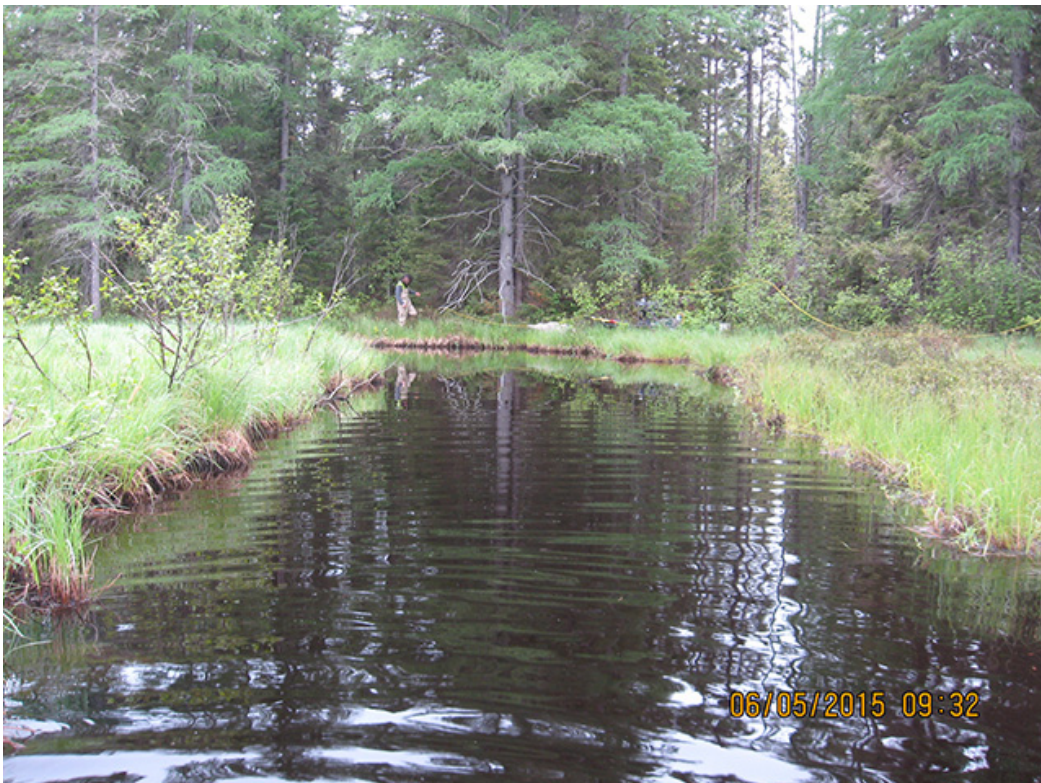
The streambanks in Station 6 appeared similar to conditions observed in 2014, and were characterized by tussock sedge (*Carex stricta*), iris (*Iris* sp.), rush (*Juncus* sp.), willows (*Salix* sp.) and speckled alder (Photographs C-7 to C-8). Much of the aquatic vegetation seen during the summer sampling event was growing on organic matter that appeared to function as a floating mat of vegetation. The substrate of Station 6 was predominantly comprised of organic matter and fine sediments, such as silt and clay. Woody debris was present throughout the stream channel.

Photograph C-7. Station 6 – Downstream Extent View South, June, 2015.

Photograph C-8. Station 6 – Upstream Extent View Southwest, June, 2015.

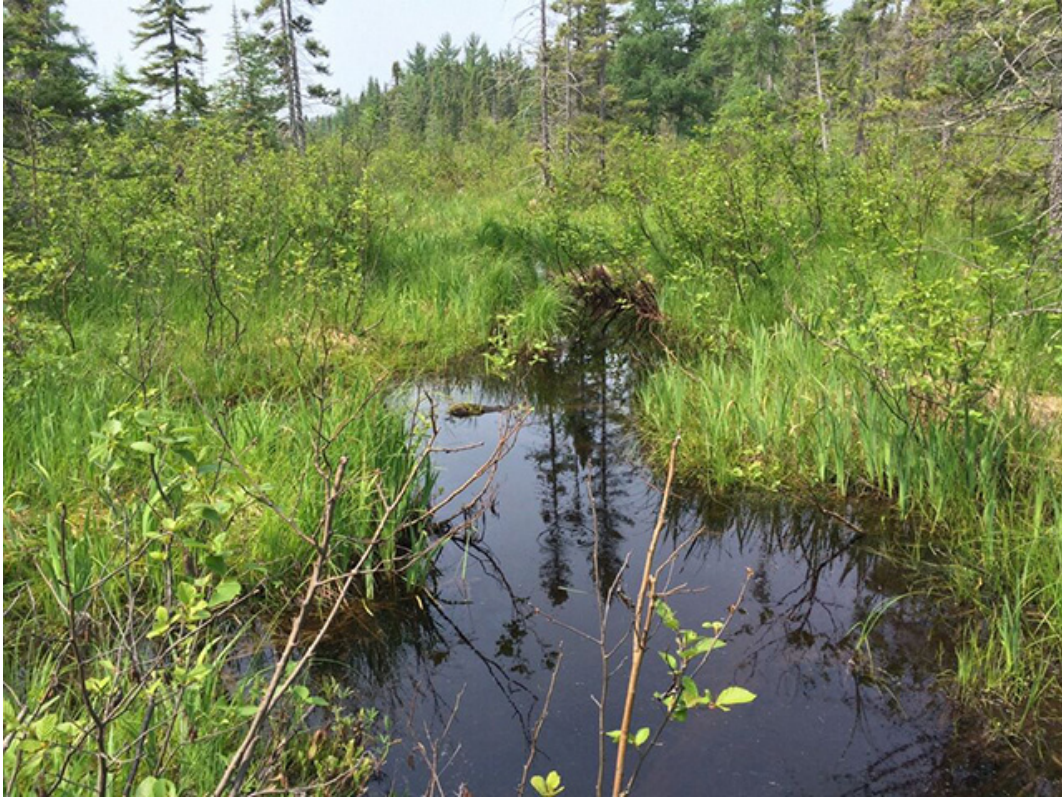
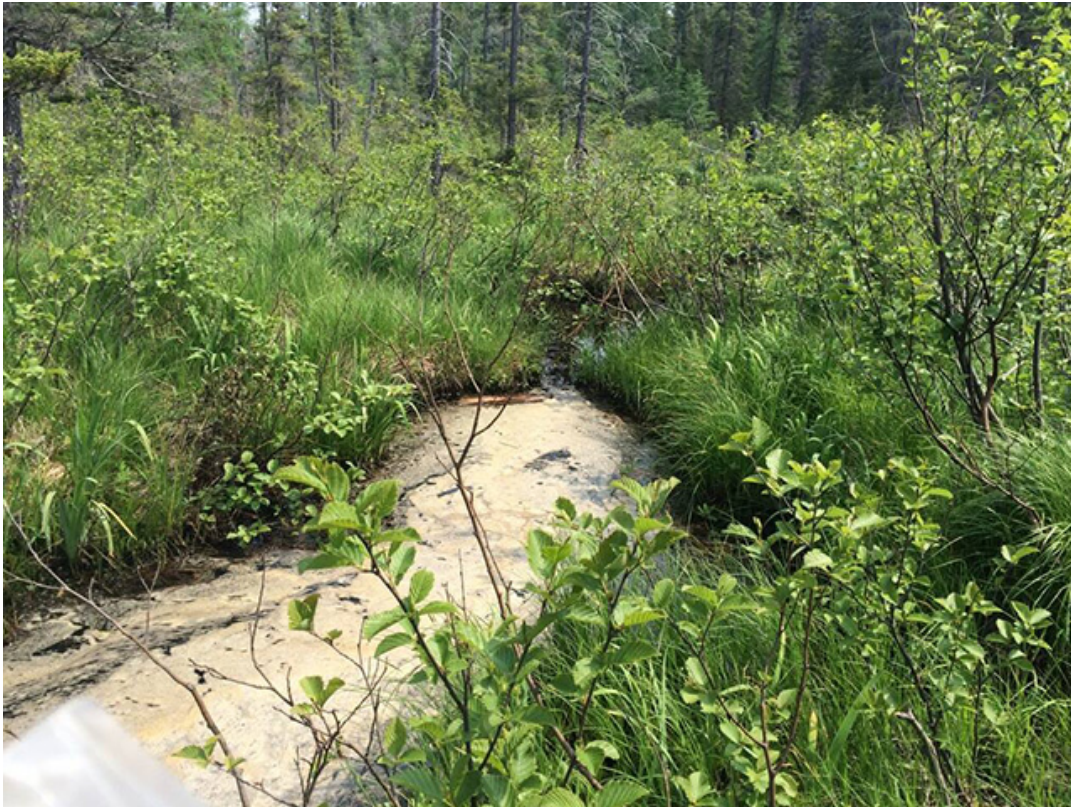
The streambanks of Station 7 were vegetated with speckled alder, tussock sedge, rush, and iris (Photographs C-9 and C-10), and appeared similar to conditions observed in 2014. The substrate was comprised of organic matter and silt. Woody debris was abundant throughout this station.

Photograph C-9. Station 7 – Downstream Extent View Southwest, June, 2015.

Photograph C-10. Station 7 – Upstream Extent View North, June, 2015.

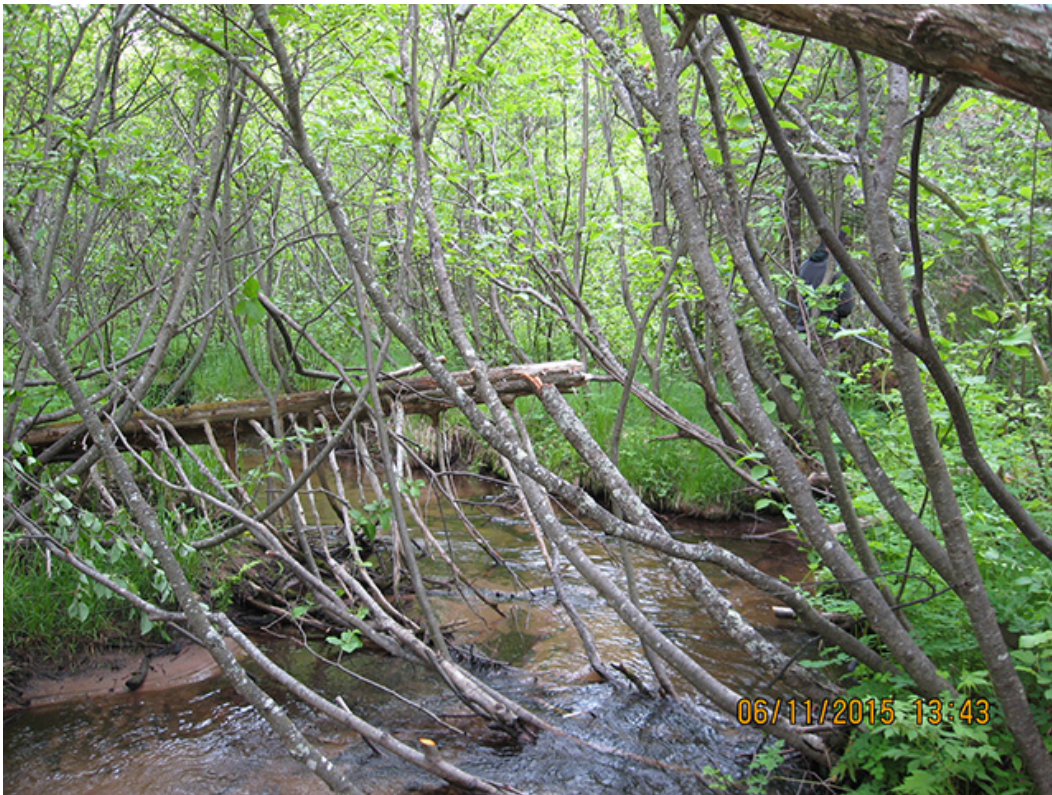
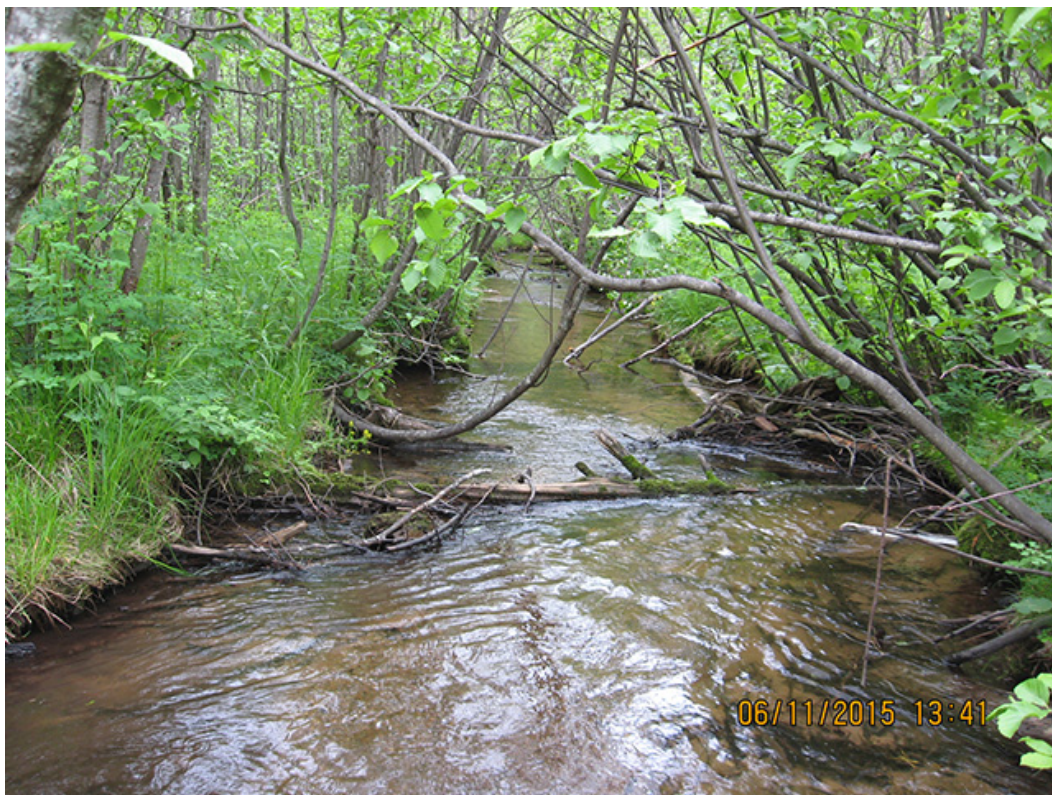
The stream channel of Station 8 was largely shaded by a dense canopy of speckled alder with an abundance of sedge growing along the streambank (Photographs C-11 and C-12). Small woody debris and undercut banks were present throughout the station, and the stream substrate was predominantly comprised of sand and small gravel. Habitat conditions observed at the time of the 2015 survey appeared consistent with previous surveys.

Photograph C-11. Station 8 – Downstream Extent View Southwest, June, 2015.

Photograph C-12. Station 8 – Upstream Extent View North, June, 2015.

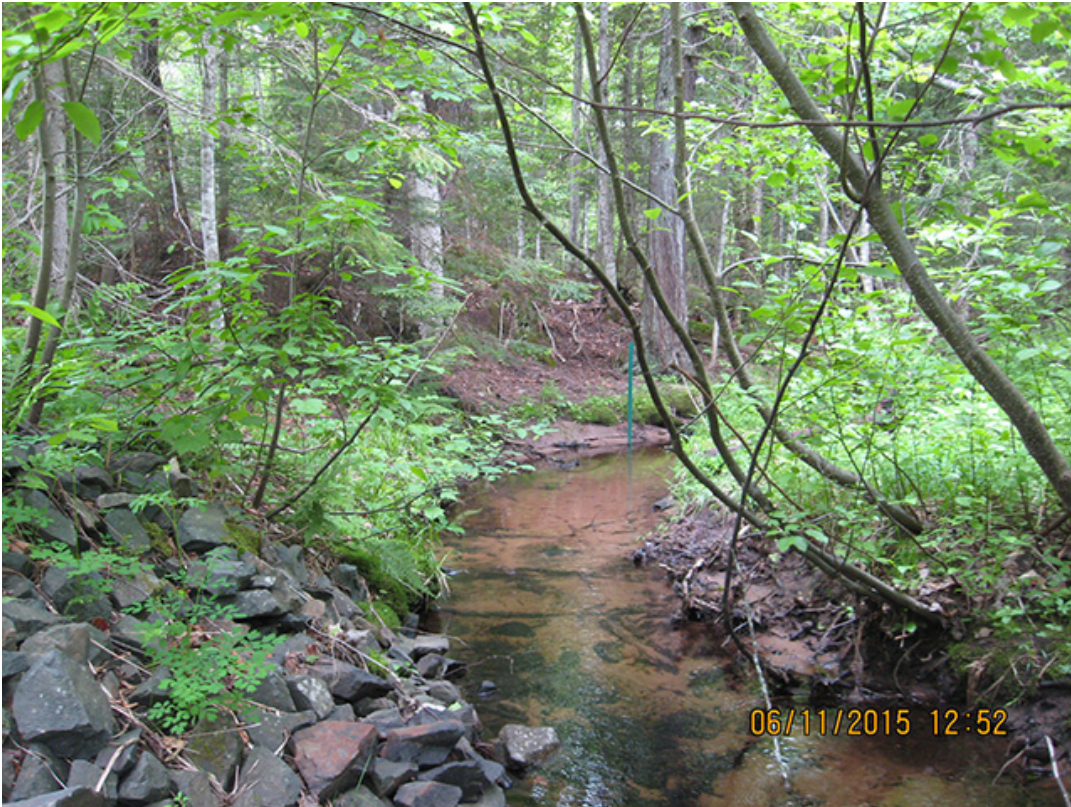
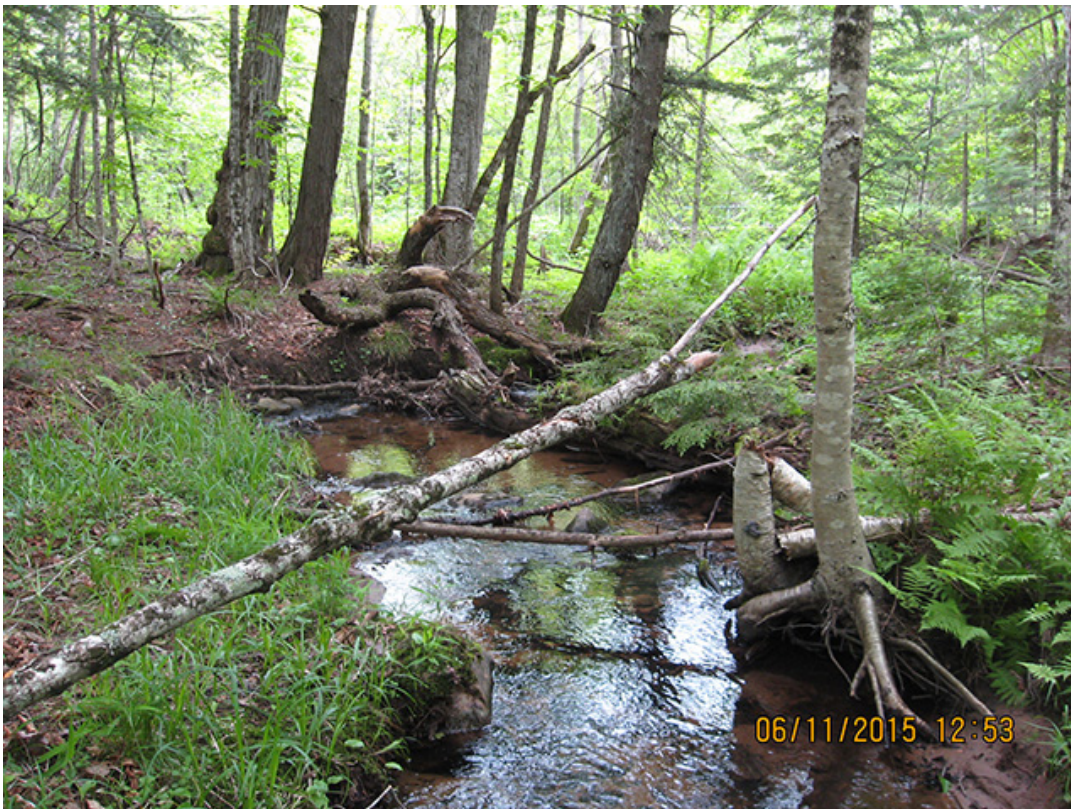
The streambanks within Station 10 were vegetated with large deciduous trees, speckled alder, and other herbaceous vegetation (Photographs C-15 and C-16), and appeared similar to conditions observed in 2014. Woody debris and undercut banks provided in-stream cover throughout this station. The substrate was predominantly comprised of sand, silt and some gravel; although cobble and large boulders were also present.

Photograph C-15. Station 10 – Downstream Extent View Southwest, June, 2015.

Photograph C-16. Station 10 – Upstream Extent View Northeast, June, 2015.

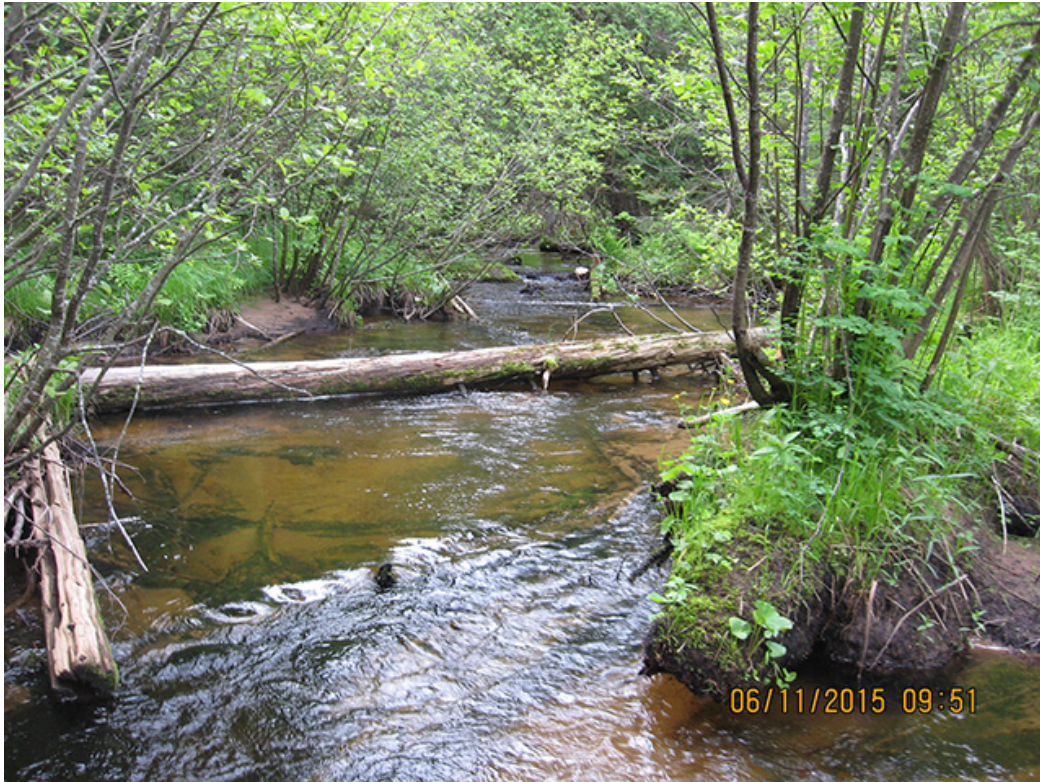
There was evidence of a recent high-water event in Station 4 at the time of the survey. Woody debris, presumably from a beaver dam failure/removal that was located upstream of Station 4 was lodged in the riparian vegetation and portions of the streambank received sediment deposition from the high-water event (Photograph C-19).

Photograph C-19. Station 4 – Downstream Extent View South, June, 2015.
