Investigation of the Aquatic Communities of the Salmon Trout River, Yellow Dog River, and Cedar Creek in Marquette County, Michigan, 2016.

February 1, 2017

Eagle Mine

**ADVANCED ECOLOGICAL MANAGEMENT
22071 7 Mile Road
Reed City, MI 49677**

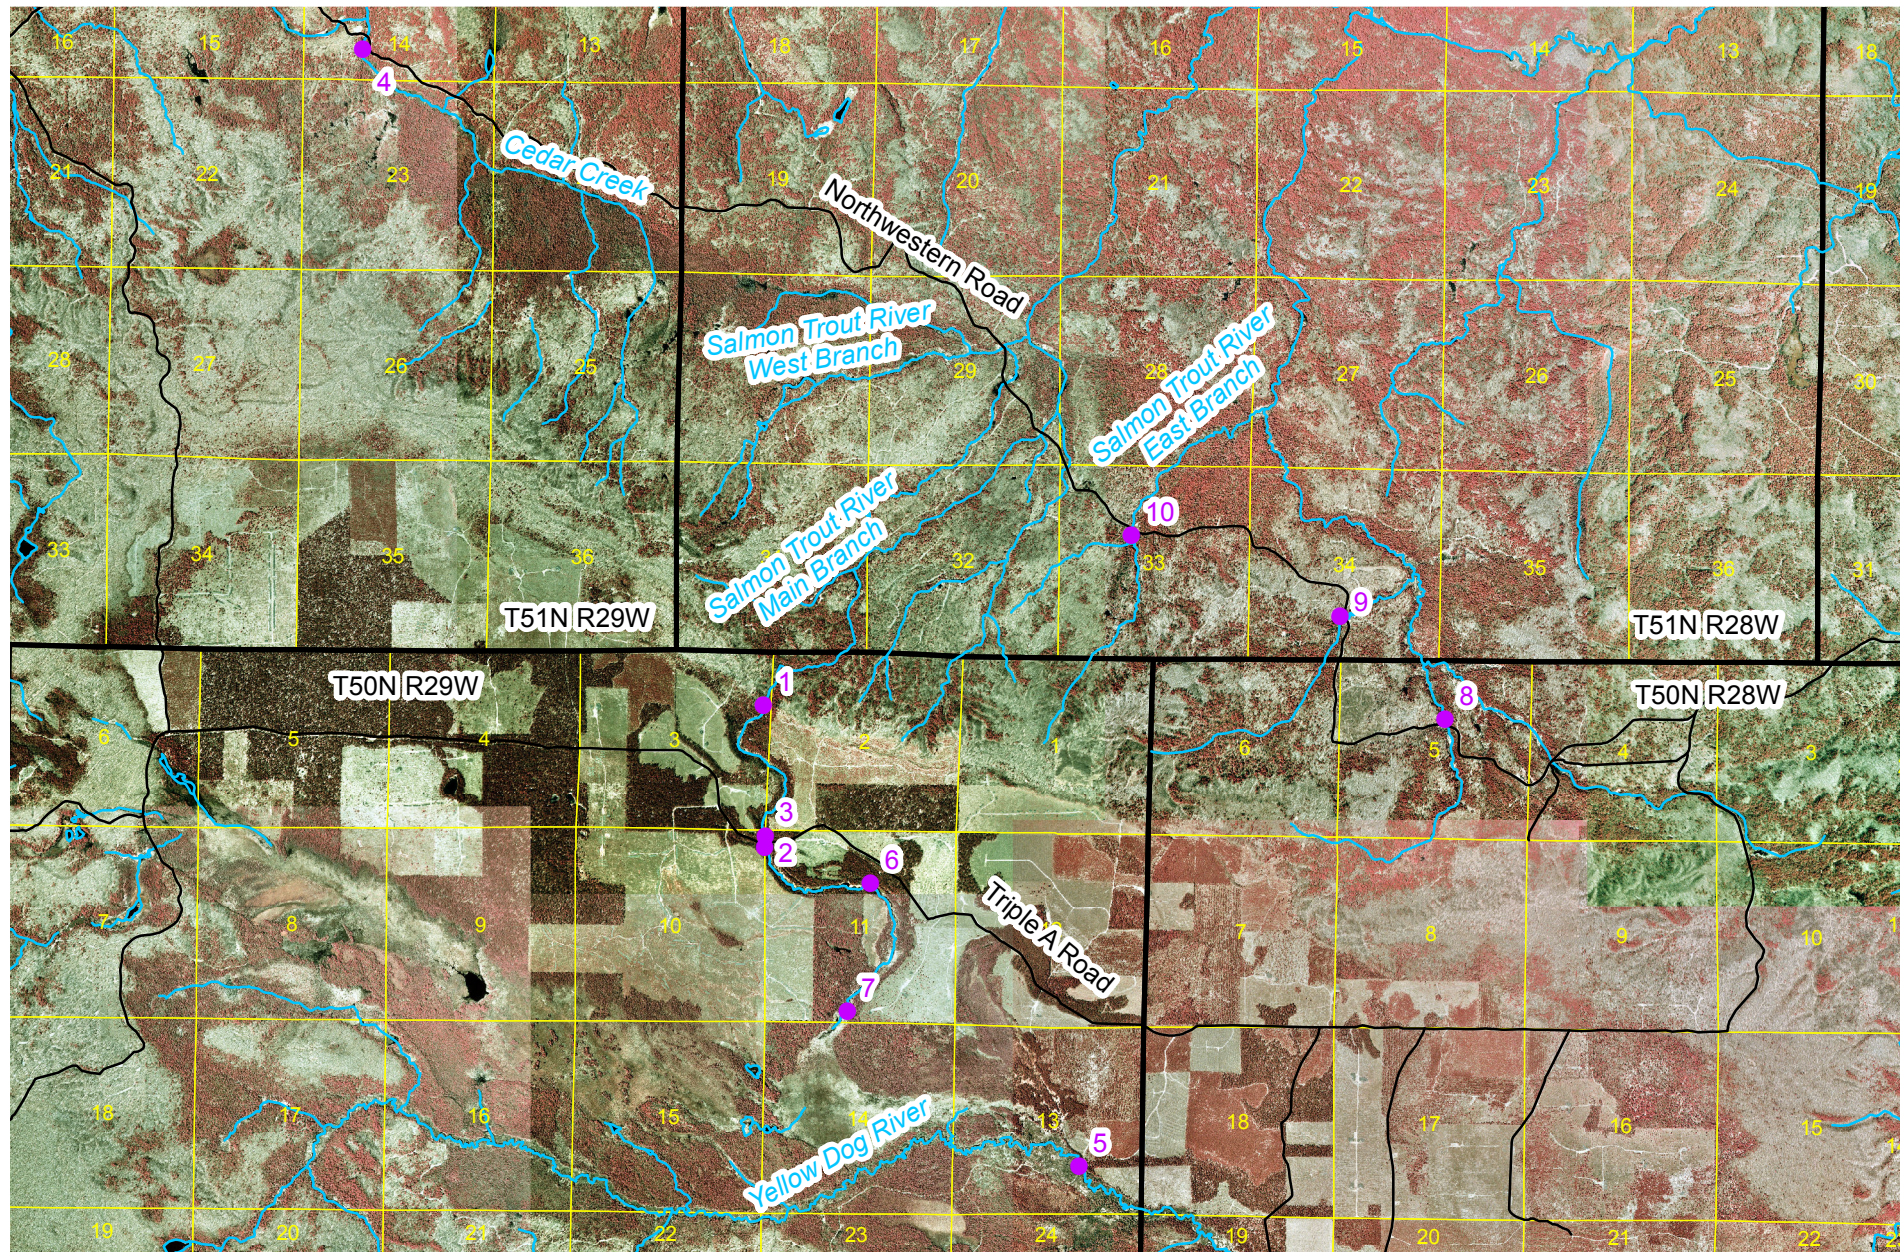
More recently, sample station locations have remained consistent since 2011 (Figure 1-2). Aquatic surveys were conducted in ten stations, including five stations within the Salmon Trout River, three stations within tributaries of the East Branch of the Salmon Trout River, one station in the Yellow Dog River, and one station in Cedar Creek.

The principle area investigated for this study included portions of the Salmon Trout River and its tributaries, the Yellow Dog River, and Cedar Creek (Figure 1-2). These systems are all coldwater streams that flow through relatively undeveloped watersheds that are predominantly forested. The ore body and mine site are located near the headwaters of the Salmon Trout River Main Branch, which flows in a northeastern direction (Figure 1-2). The Salmon Trout River is characterized by a variety of habitat types in the vicinity of the stream segments investigated and includes slow-flowing segments with a silt substrate that have been heavily influenced by beaver activity (e.g., Stations 6 and 7), and high-gradient segments flowing through forested and hilly terrain with beaver dams intermittent throughout the watershed (e.g., Stations 1 and 8).

Station 6 is located in the vicinity of the ore body (Figure 1-2). Station 6 is 300 feet in length and was influenced by beaver dams that were located downstream and upstream of the station. The average width of Station 6 was 17.3 feet ($n = 3$; $s = 2.9$ feet) and the average depth was 1.8 feet ($n = 9$; $s = 0.2$ feet, Table 5-5). Stream flow was measured at the middle extent of Station 6 and discharge was estimated at 652 gpm (Table 5-5), which was 132 gpm lower than the 2015 discharge measurement (784 gpm).

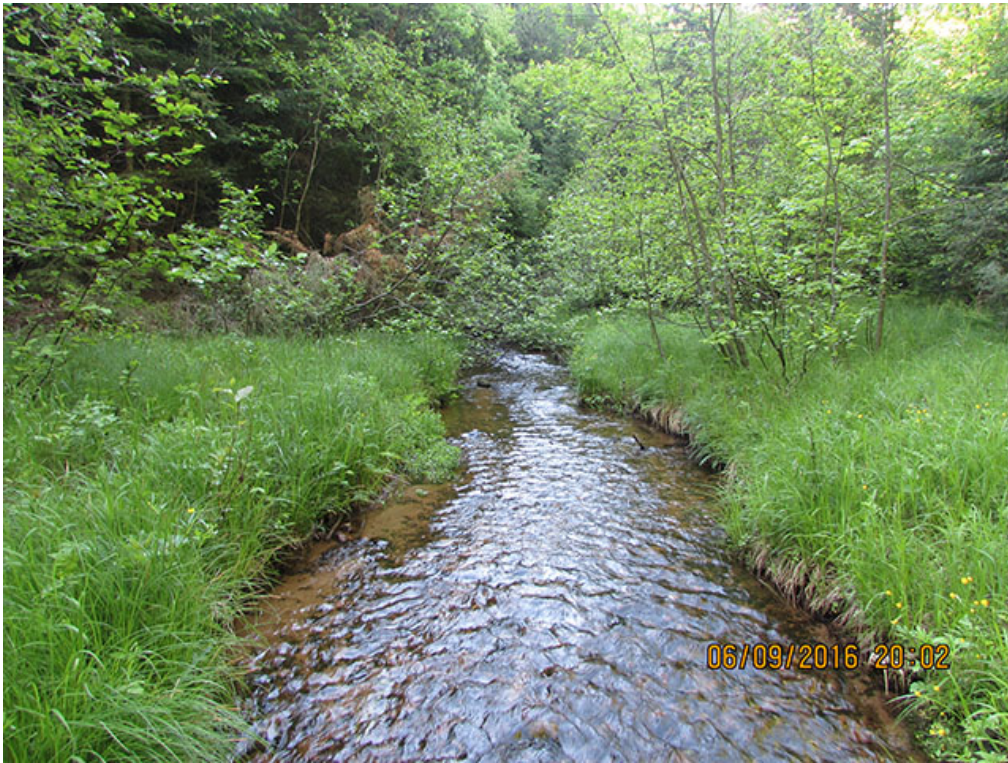
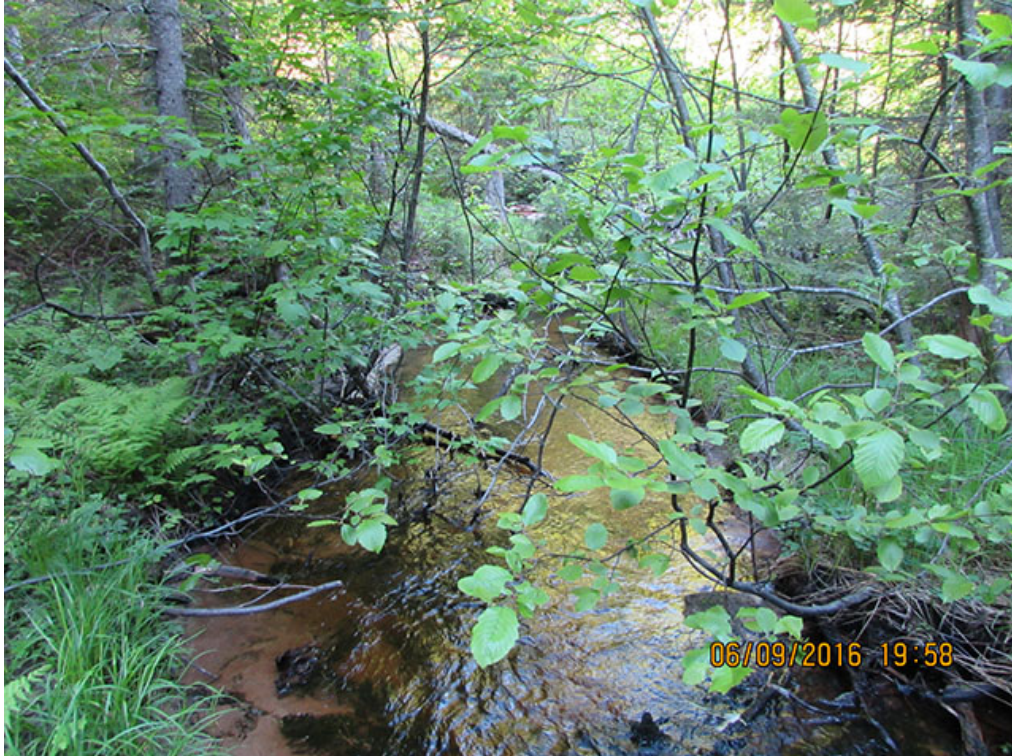
Photograph C-1. Station 1 - Downstream Extent View South, June, 2016.

The streambanks of Station 1 appeared consistent with conditions observed in previous surveys, and were vegetated with herbaceous and woody vegetation (Photographs C-1 and C-2). The streambed was characterized by a relatively steep gradient and the substrate was comprised of a variety of particles including sand, gravel, cobble, and

boulders (Photographs C-1 and C-2). Woody debris was frequently observed throughout the station and appeared consistent with conditions observed since 2013.

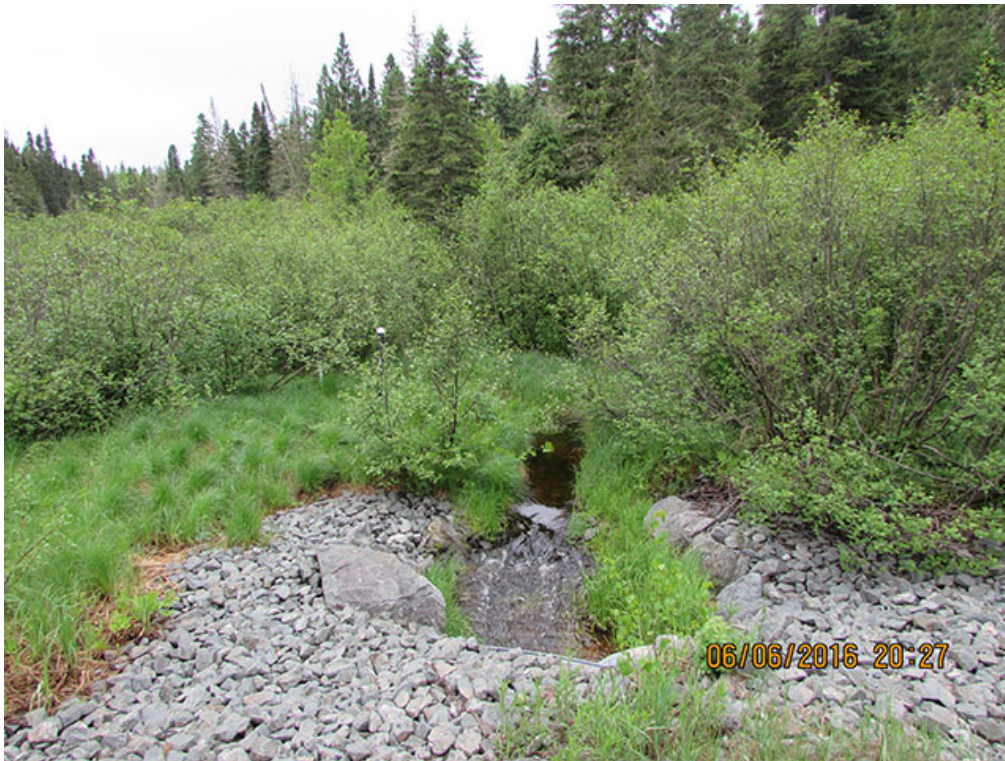
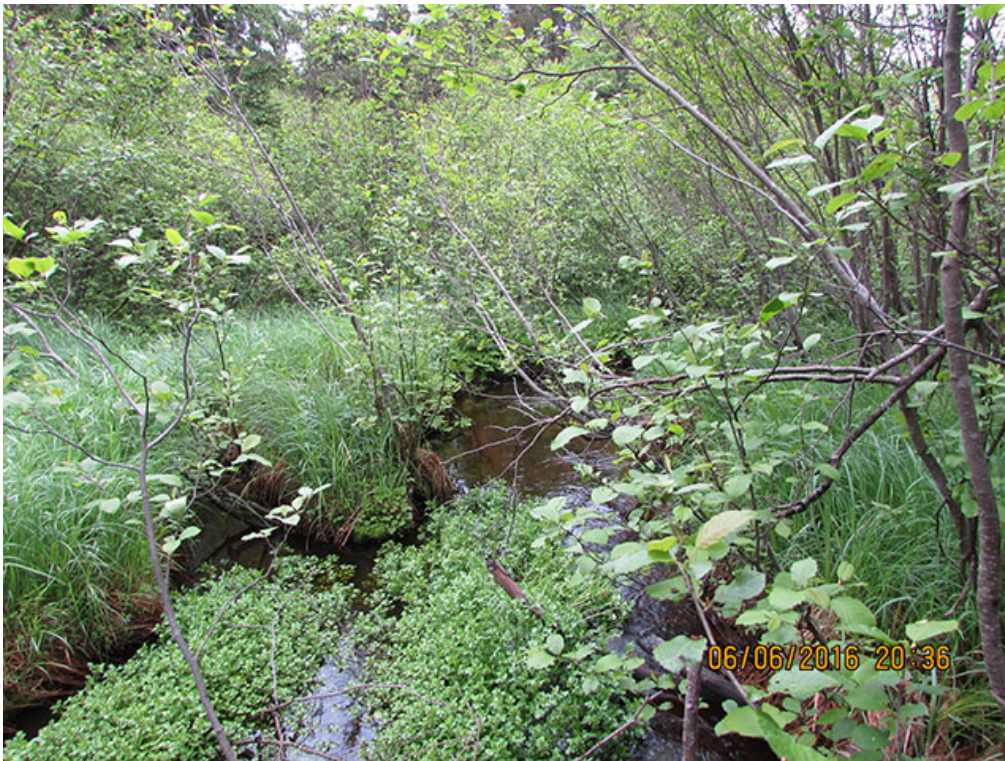
Photograph C-3. Station 2 – Downstream Extent View South, June, 2016.

Station 2 was surrounded by an abundance of speckled alder (*Alnus rugosa*) and bluejoint grass (*Calamagrostis canadensis*, Photographs C-3 to C-4). Habitat conditions of Station 2 were consistent with 2015 observations. Evidence of beaver activity was present with the upstream extent of Station 2 and two partially constructed dams were present within the stream channel. Silt and organic matter appeared to be more abundant within the upstream extent of Station 2.

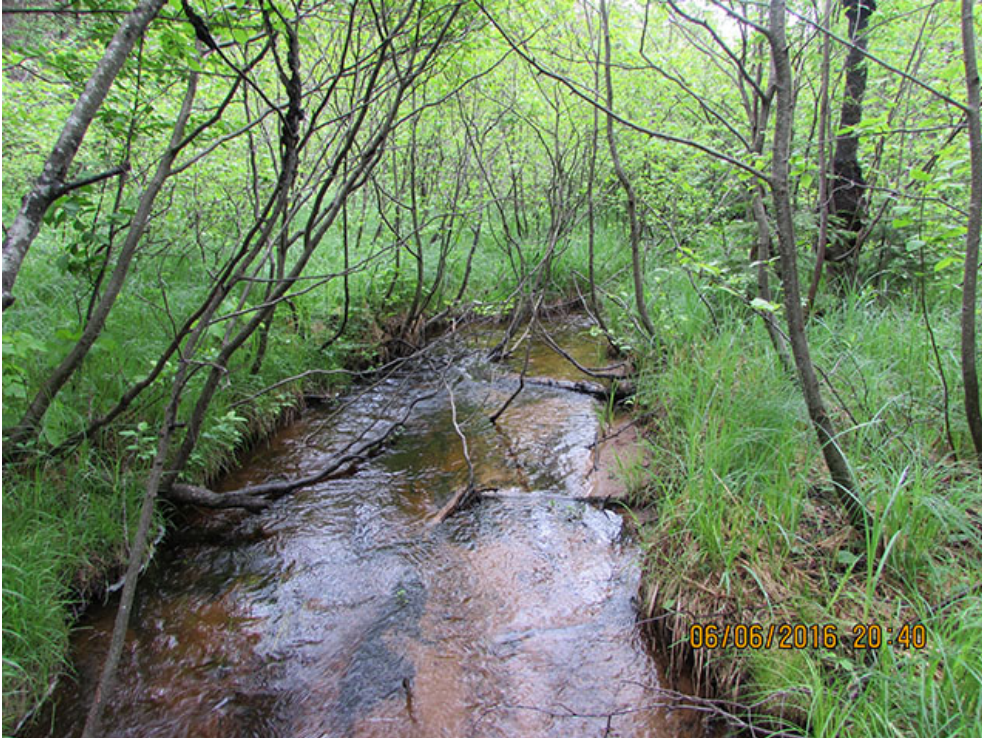
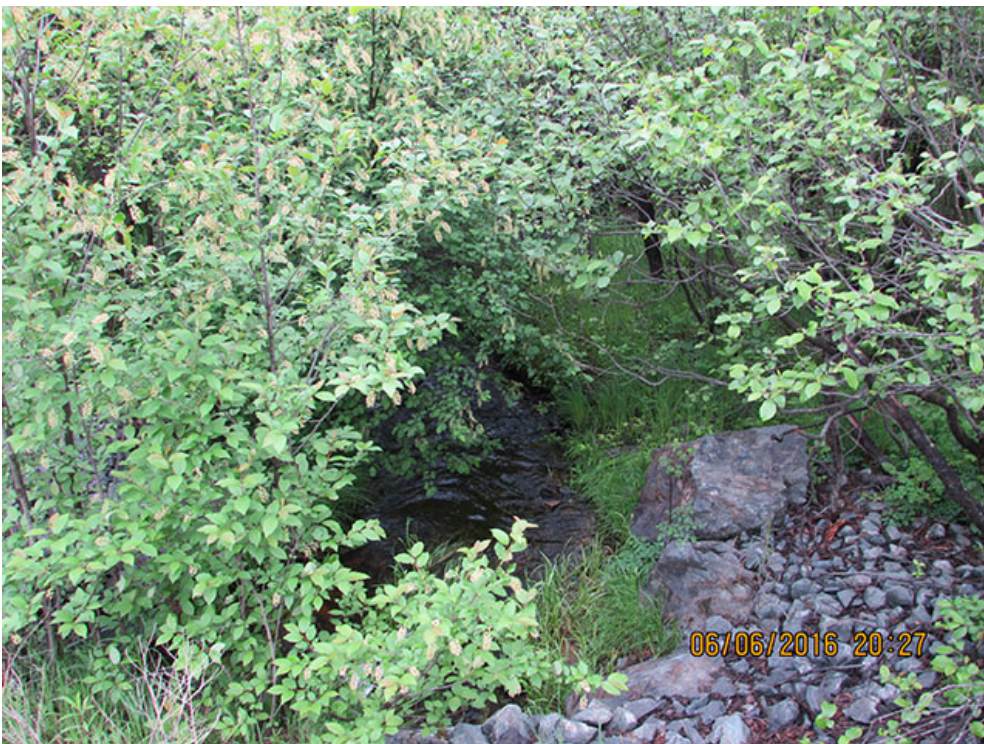
Photograph C-5. Station 3 – Downstream Extent View South, June, 2016.

The streambank vegetation within Station 3 appeared similar to conditions observed in 2015. The vegetation within Station 3 was predominantly speckled alder with an understory of bluejoint grass and sedge (*Carex* sp., Photographs C-5 to C-6). Watercress (*Nasturtium* sp.) was present within portions of the stream channel of Station 3.

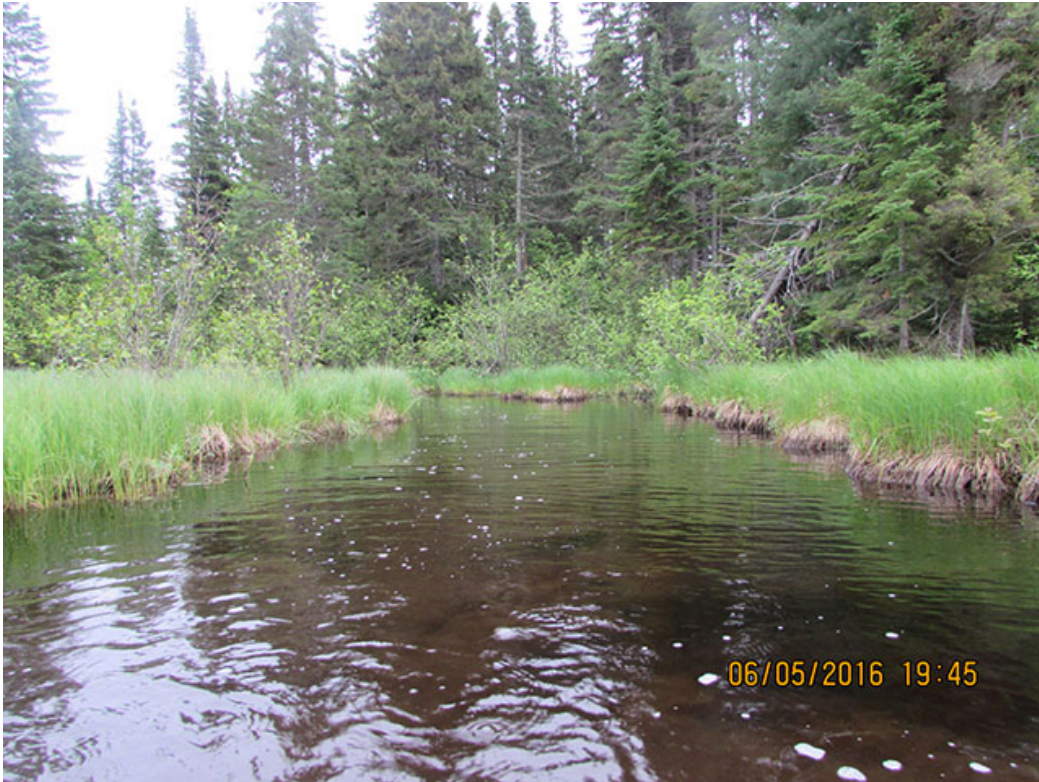
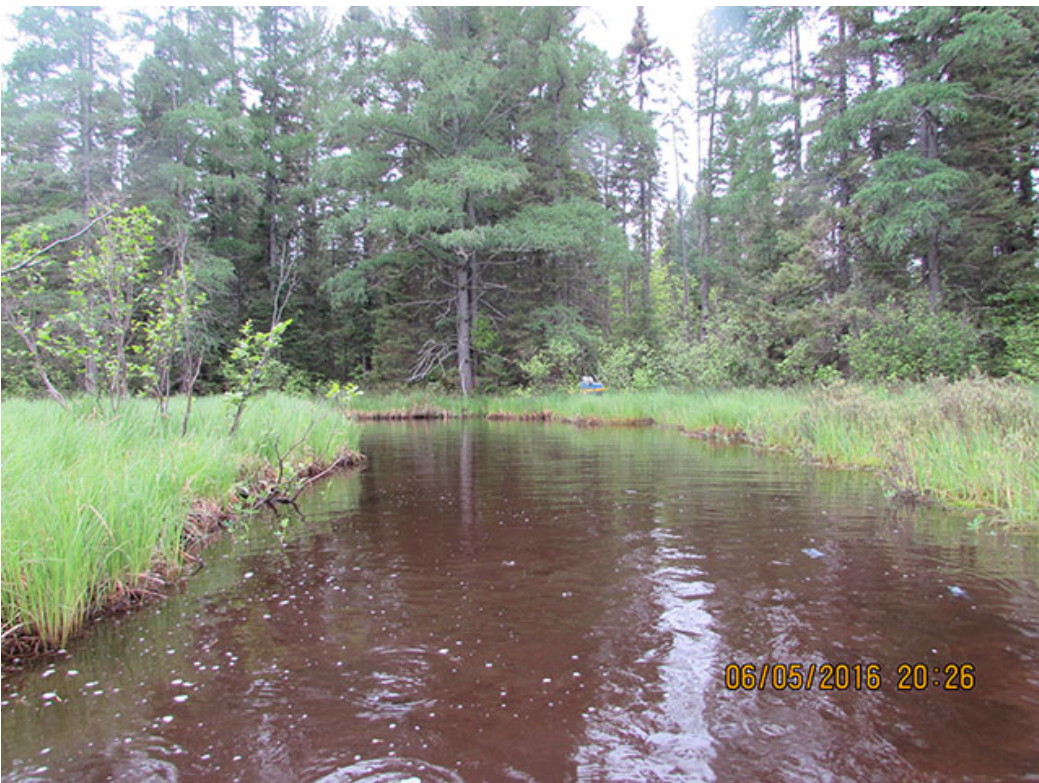
Photograph C-7. Station 6 – Downstream Extent View South, June, 2016.

The streambanks in Station 6 appeared similar to conditions observed throughout all annual aquatic surveys conducted by AEM, and were characterized by tussock sedge (*Carex stricta*), iris (*Iris* sp.), rush (*Juncus* sp.), willows (*Salix* sp.) and speckled alder (Photographs C-7 to C-8). Much of the aquatic vegetation observed during the aquatic

survey was growing on organic matter that appeared to function as a floating mat of vegetation. The substrate of Station 6 was predominantly comprised of organic matter and fine sediments, such as silt and clay. Woody debris was present throughout the stream channel.

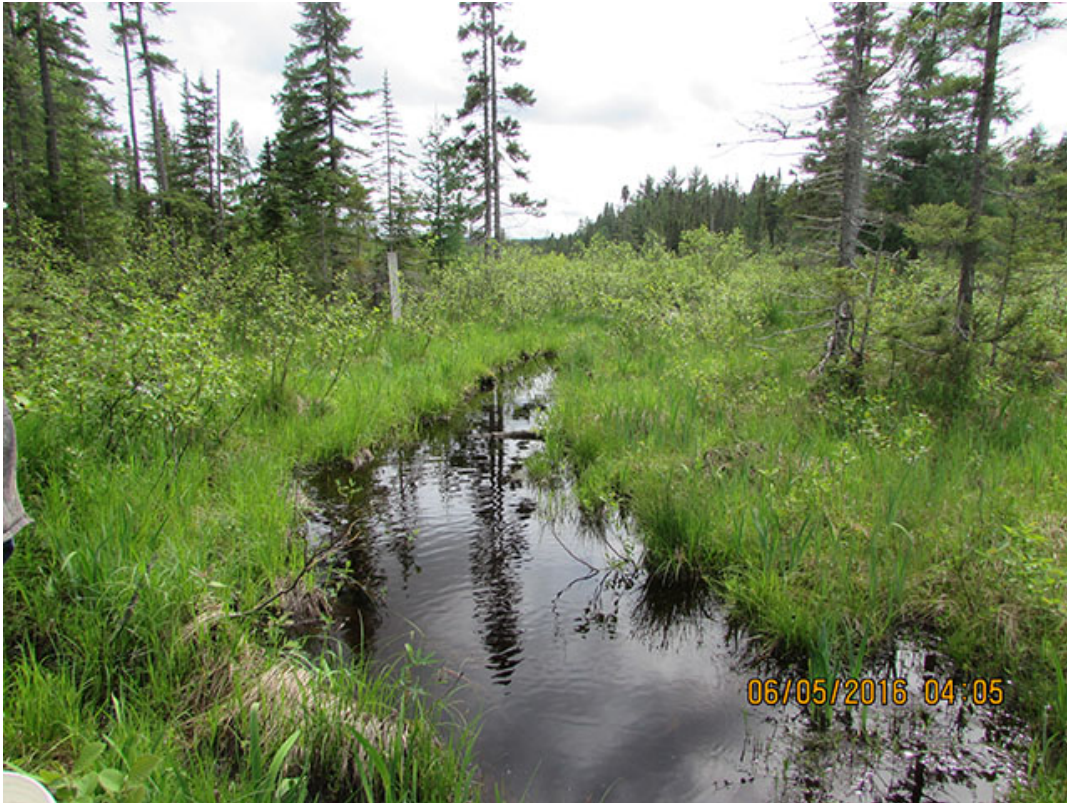
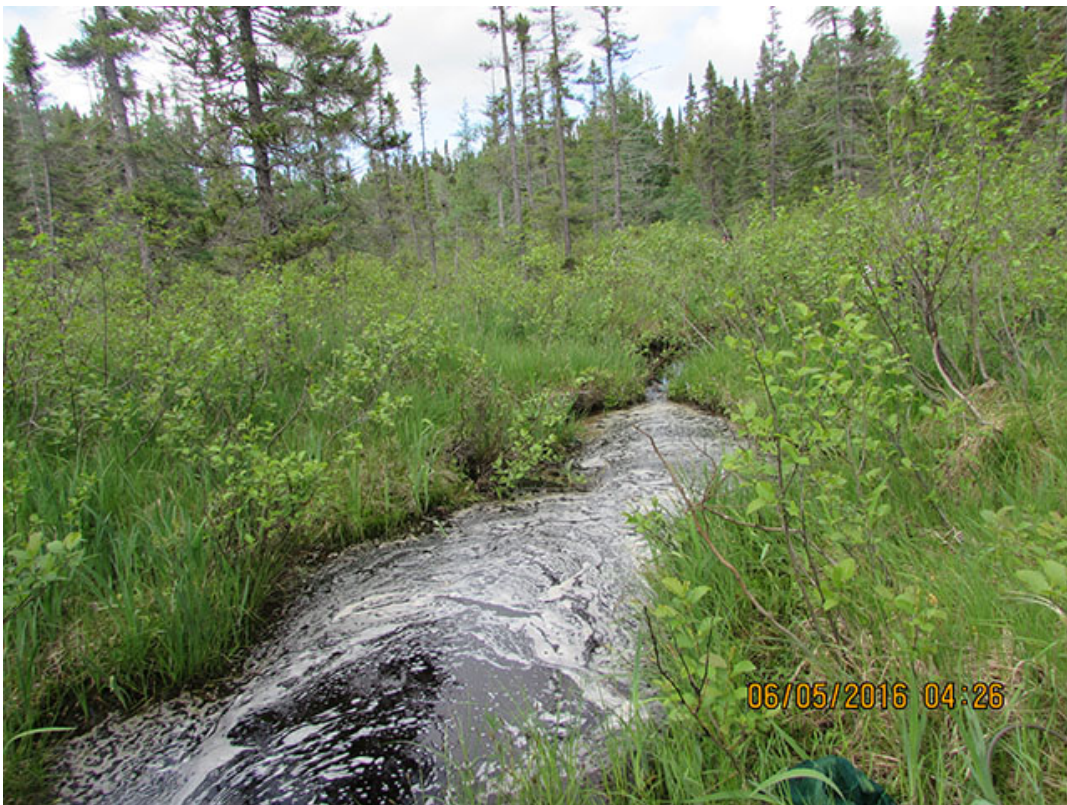
Photograph C-9. Station 7 – Downstream Extent View Southwest, June, 2016.

The streambanks of Station 7 were vegetated with speckled alder, tussock sedge, rush, and iris (Photographs C-9 and C-10), and appeared similar to conditions observed in 2015. The substrate was comprised of organic matter and silt. Woody debris was abundant throughout this station.

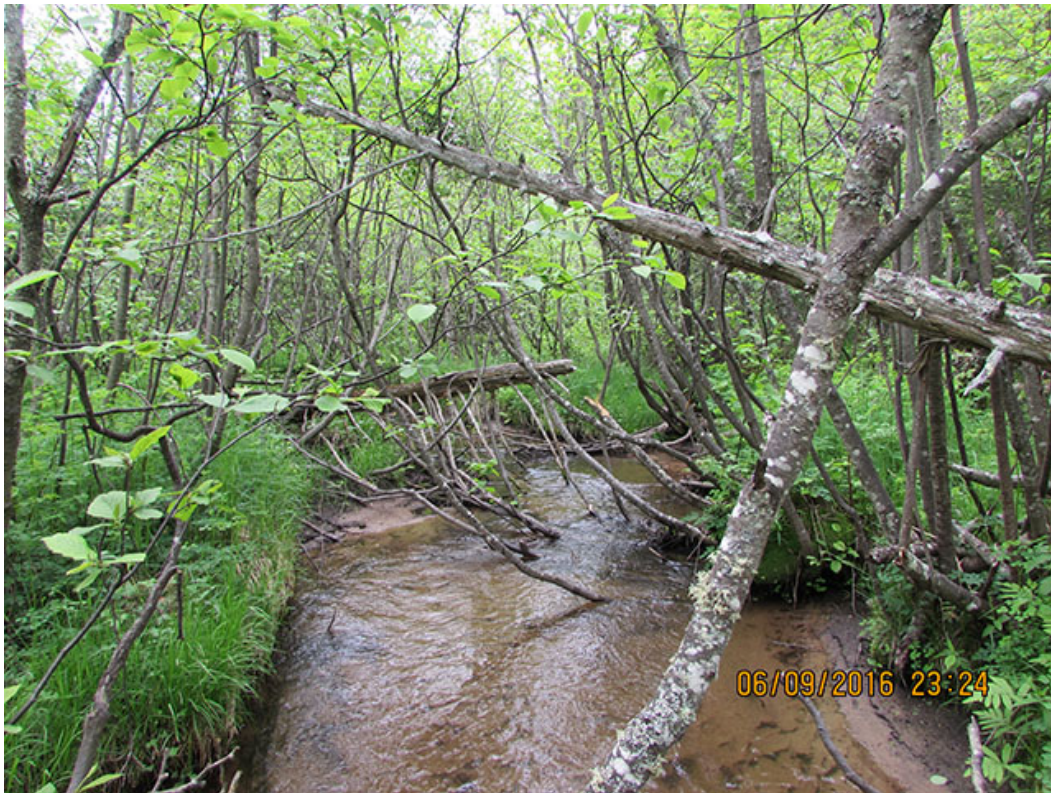
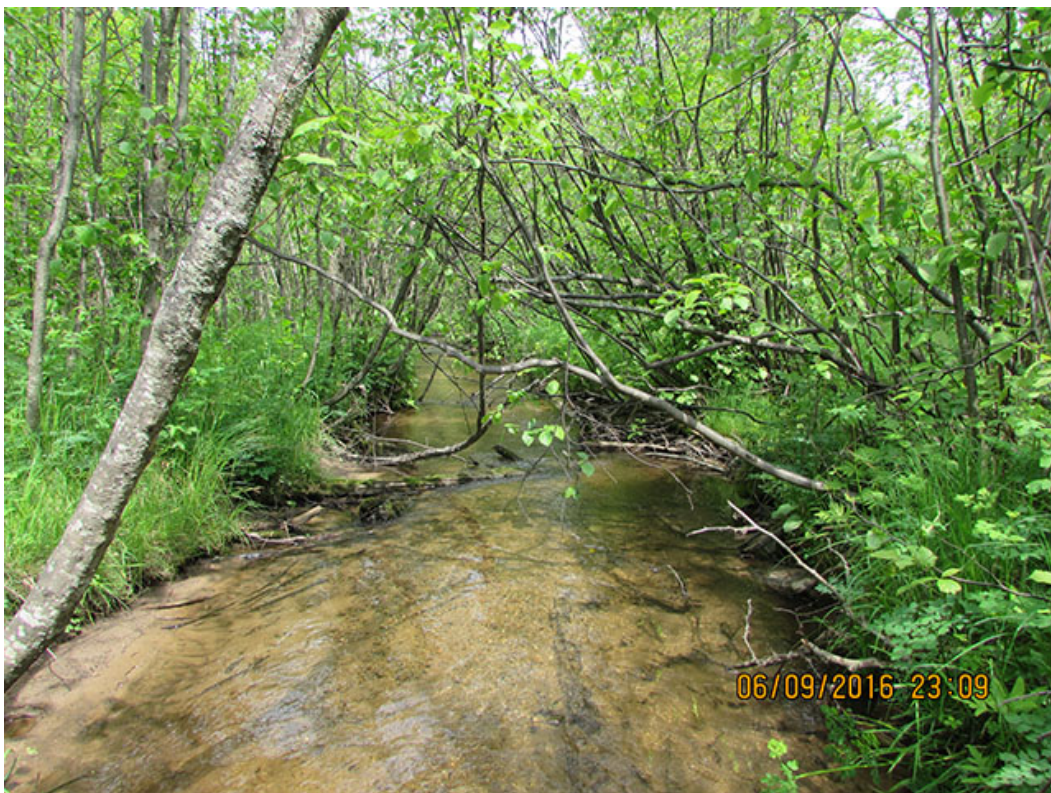
Photograph C-11. Station 8 – Downstream Extent View Southwest, June, 2016.

The stream channel of Station 8 was largely shaded by a dense canopy of speckled alder with an abundance of sedge growing along the streambank (Photographs C-11 and C-12). Small woody debris and undercut banks were present throughout the station, and the stream substrate was predominantly comprised of sand and small gravel. Habitat conditions observed at the time of the 2016 survey appeared consistent with previous surveys.

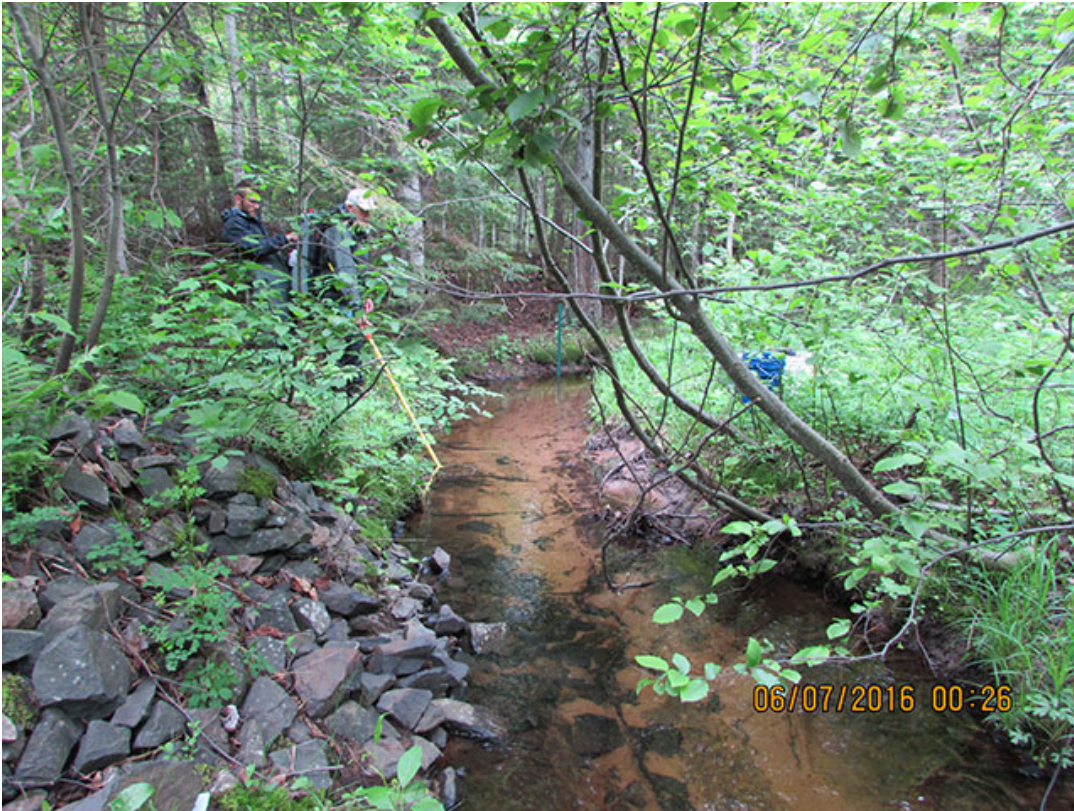
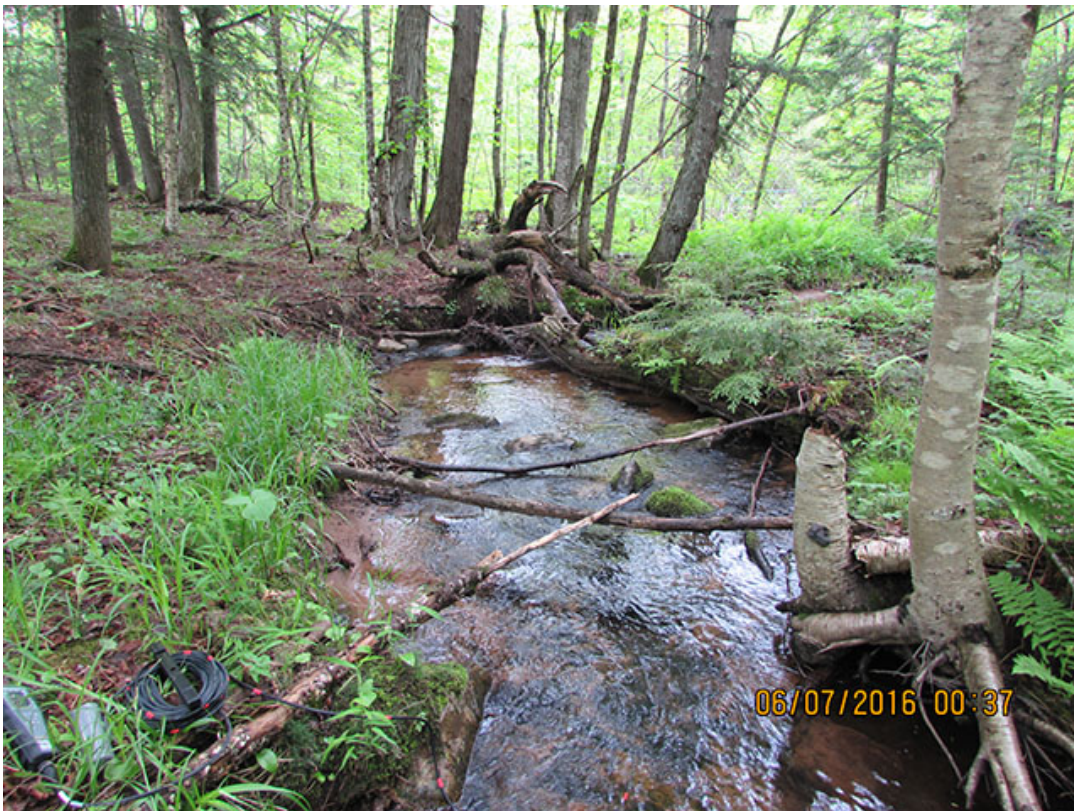
Photograph C-15. Station 10 – Downstream Extent View Southwest, June, 2016.

The streambanks within Station 10 were vegetated with large deciduous trees, speckled alder, and other herbaceous vegetation (Photographs C-15 and C-16), and appeared similar to conditions observed in 2015. Woody debris and undercut banks provided in-stream cover throughout this station. The substrate was predominantly comprised of sand, silt and some gravel; although cobble and large boulders were also present.
